Asbestos Management Survey Report

Whanganui Hospital Mortuary Management Survey

MORTUARY-EXTERIOR & INTERNAL

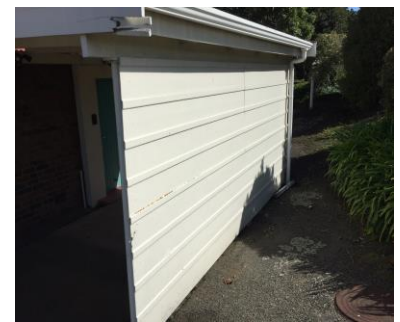
ID: CARD NO:001

Photograph No.	1
Location/Area	Exterior: Carport (Wall)
Suspected Material Identified	ACM Board
Condition of Material Identified	Good
Categories: (Assessment type). 1: ACM common characteristics or 2: Presumed ACM or 3: Sample collected for analysis	2: Presumed ACM
Sample No.	Sample Not Taken
Laboratory Analysis Findings	Analysis Not Conducted
Quantity of Material Identified	12.0m2

ID Card No	Photo No	Location/Area Description	Sample Ref Category No	Quantity	Product Description	Asbestos Type	Product Type	Condition	Surface Treatment	Asbestos Type	Material Risk Score	Normal Occupant Activity	Likelihood of Disturbance	Human Exposure Potential	Maintenance Activity	Priority Risk Score	Overall Risk Score	Action	
001	1	Exterior: Carport (Wall)	2	12.0m2	Wall Lining	ACM Board	1	0	0	1	0	0	0	0	0	0	0	Very low risk	Complete a Risk Assessment.
002	2	Exterior: Windows	2	27.5L/M	Window Framing	Putty Compound	1	0	0	1	0	0	0	0	0	0	0	Very low risk	Complete a Risk Assessment.
003	3	Internal: Chiller Room (Ceiling)	2	24.0m2	Ceiling Lining	ACM Board	1	0	0	1	0	0	0	0	0	0	0	Very low risk	Complete a Risk Assessment.
004	4	Internal: Waiting Room (Floor)	2	16.0m2	Vinyl Flooring	Vinyl or Backing Resin	1	0	0	1	0	0	0	0	0	0	0	Very low risk	Complete a Risk Assessment.
005	5	Internal: Waiting Room (Ceiling)	2	16.0m2	Ceiling Lining	ACM Board	1	0	0	1	0	0	0	0	0	0	0	Very low risk	Complete a Risk Assessment.

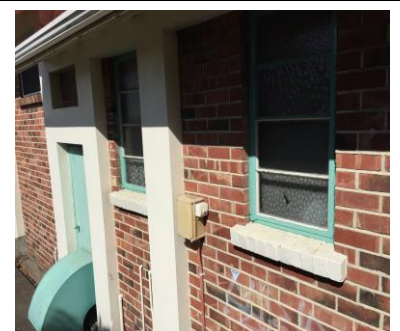
ID: CARD NO:002

Photograph No.	2
Location/Area	Exterior: Windows
Suspected Material Identified	Putty Compound
Condition of Material Identified	Good
Categories: (Assessment type). 1: ACM common characteristics or 2: Presumed ACM or 3: Sample collected for analysis	2: Presumed ACM
Sample No.	Sample Not Taken
Laboratory Analysis Findings	Analysis Not Conducted
Quantity of Material Identified	27.5L/M

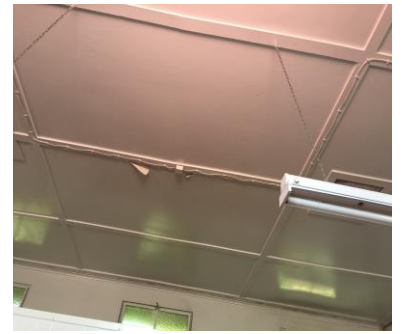
ID: CARD NO:003

Photograph No.	3
Location/Area	Internal: Chiller Room (Ceiling)
Suspected Material Identified	ACM Board
Condition of Material Identified	Good
Categories: (Assessment type). 1: ACM common characteristics or 2: Presumed ACM or 3: Sample collected for analysis	2: Presumed ACM
Sample No.	Sample Not Taken
Laboratory Analysis Findings	Analysis Not Conducted
Quantity of Material Identified	24.0m2

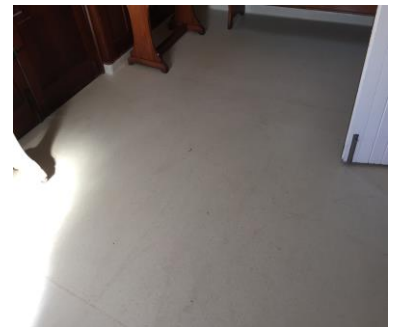
ID: CARD NO:004

Photograph No.	4
Location/Area	Internal: Waiting Room (Floor)
Suspected Material Identified	Vinyl Flooring
Condition of Material Identified	Good
Categories: (Assessment type). 1: ACM common characteristics or 2: Presumed ACM or 3: Sample collected for analysis	2: Presumed ACM
Sample No.	Sample Not Taken
Laboratory Analysis Findings	Analysis Not Conducted
Quantity of Material Identified	16.0m2

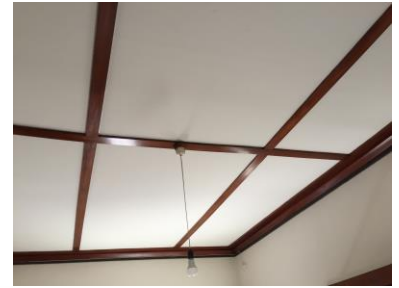
ID: CARD NO:005

Photograph No.	5
Location/Area	Internal: Waiting Room (Ceiling)
Suspected Material Identified	ACM Board
Condition of Material Identified	Good
Categories: (Assessment type). 1: ACM common characteristics or 2: Presumed ACM or 3: Sample collected for analysis	2: Presumed ACM
Sample No.	Sample Not Taken
Laboratory Analysis Findings	Analysis Not Conducted
Quantity of Material Identified	16.0m2

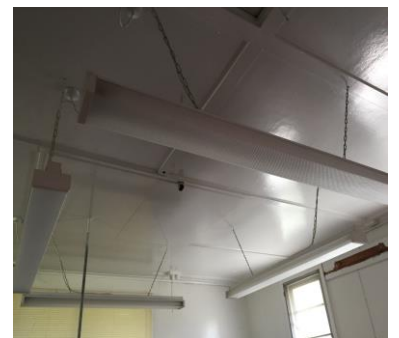
ID: CARD NO:006

Photograph No.	6
Location/Area	Internal: Operating Room (Ceiling)
Suspected Material Identified	ACM Board
Condition of Material Identified	Good
Categories: (Assessment type). 1: ACM common characteristics or 2: Presumed ACM or 3: Sample collected for analysis	2: Presumed ACM
Sample No.	Sample Not Taken
Laboratory Analysis Findings	Analysis Not Conducted
Quantity of Material Identified	18.0m2

006	6	Internal: Operating Room (Ceiling)	2	18.0m2	Ceiling Lining	ACM Board	1	0	0	1	0	0	0	0	0	0	0	Very low risk	Complete a Risk Assessment.
007	7	Internal: Operating Room (Fuse Board)	2	.300m2	Backing Board	ACM Board	1	0	0	1	0	0	0	0	0	0	0	Very low risk	Complete a Risk Assessment.
008	8	Internal: Operating Room (H.W.C)	2	2.0m2	Backing Board	ACM Board	1	0	0	1	0	0	0	0	0	0	0	Very low risk	Complete a Risk Assessment.
009																			
010

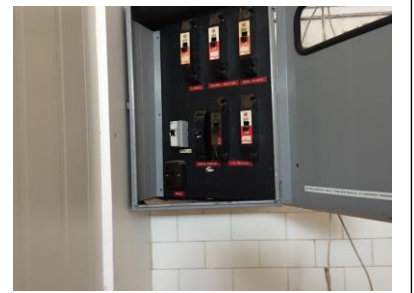
ID: CARD NO:007

Photograph No.	7
Location/Area	Internal Operating Room: Fuse Board
Suspected Material Identified	ACM Board
Condition of Material Identified	Good
Categories: (Assessment type). 1: ACM common characteristics or 2: Presumed ACM or 3: Sample collected for analysis	2: Presumed ACM
Sample No.	Sample Not Taken
Laboratory Analysis Findings	Analysis Not Conducted
Quantity of Material Identified	.300m2

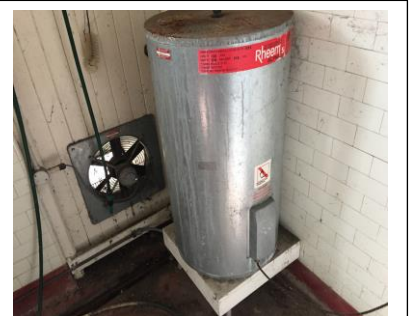
ID: CARD NO:008

Photograph No.	8
Location/Area	Internal: Operating Room (H.W.C)
Suspected Material Identified	ACM Board
Condition of Material Identified	Good
Categories: (Assessment type). 1: ACM common characteristics or 2: Presumed ACM or 3: Sample collected for analysis	2: Presumed ACM
Sample No.	Sample Not Taken
Laboratory Analysis Findings	Analysis Not Conducted
Quantity of Material Identified	2.0m2
