## Asbestos Management Survey Report

### WHANGNAUI HOSPITAL, SPOTLESS WORKSHOP

### **SPOTLESS WORKSHOP-EXTERIOR & INTERNAL**

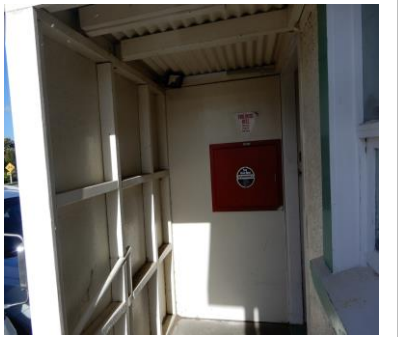
Photograph No.	2

Location/Area	Exterior: Rear Entry	
Suspected Material Identified	ACM Board	
Condition of Material Identified	Good	
<b>Categories: (Assessment type).</b> 1: ACM common characteristics or 2: Presumed ACM or 3: Sample collected for analysis	2: Presumed ACM	
Sample No.	Sample Not Taken	
Laboratory Analysis Findings	Analysis Not Conducted	
Quantity of Material Identified	10.0m2

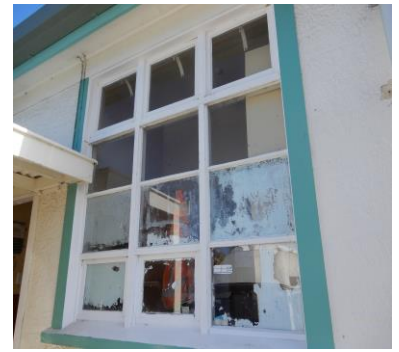
Photograph No.	3
Location/Area	Exterior: Window Frames
Suspected Material Identified	Putty Compound
Condition of Material Identified	Good
<b>Categories: (Assessment type).</b> 1: ACM common characteristics or 2: Presumed ACM or 3: Sample collected for analysis	2: Presumed ACM
Sample No.	Sample Not Taken
Laboratory Analysis Findings	Analysis Not Conducted
Quantity of Material Identified	180.0L/M

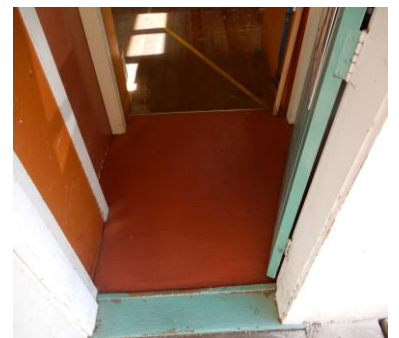
Photograph No.	4
Location/Area	Internal: North Entry
Suspected Material Identified	Vinyl Flooring
Condition of Material Identified	Good
<b>Categories: (Assessment type).</b> 1: ACM common characteristics or 2: Presumed ACM or 3: Sample collected for analysis	2: Presumed ACM
Sample No.	Sample Not Taken
Laboratory Analysis Findings	Analysis Not Conducted
Quantity of Material Identified	1.8m2

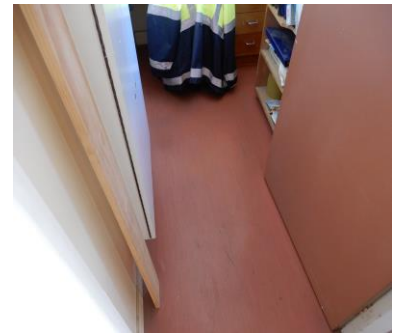
Photograph No.	5
Location/Area	Internal: General Managers Rm
Suspected Material Identified	Vinyl Flooring
Condition of Material Identified	Good
<b>Categories: (Assessment type).</b> 1: ACM common characteristics or 2: Presumed ACM or 3: Sample collected for analysis	2: Presumed ACM
Sample No.	Sample Not Taken
Laboratory Analysis Findings	Analysis Not Conducted
Quantity of Material Identified	3.0m2

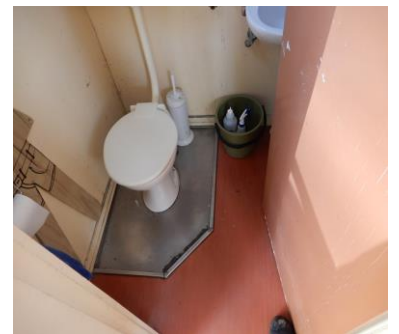
Photograph No.	6
Location/Area	Internal: Staff Toilet
Suspected Material Identified	Vinyl Flooring
Condition of Material Identified	Good
<b>Categories: (Assessment type).</b> 1: ACM common characteristics or 2: Presumed ACM or 3: Sample collected for analysis	2: Presumed ACM
Sample No.	Sample Not Taken
Laboratory Analysis Findings	Analysis Not Conducted
Quantity of Material Identified	1.0m2

006	6	Internal: Staff Toilet	2	1.0m2	Vinyl Flooring	Vinyl/Backing Resin	1	0	0	1	0	0	0	0	0	0	0	Very low risk	Complete a Risk Assessment.
007	7	Internal: Grinder/Welder Room	2	16.0m2	Vinyl Flooring	Vinyl/Backing Resin	1	0	0	1	0	0	0	0	0	0	0	Very low risk	Complete a Risk Assessment.
008	8	Internal: Cable Storage	2	40.0m2	Vinyl Flooring	Vinyl/Backing Resin	1	0	0	1	0	0	0	0	0	0	0	Very low risk	Complete a Risk Assessment.
009	9	Internal: Office 1	2	25.0m2	Vinyl Flooring	Vinyl/Backing Resin	1	0	0	1	0	0	0	0	0	0	0	Very low risk	Complete a Risk Assessment.
010	10	Internal: Entry (West)	2	3.0m2	Vinyl Flooring	Vinyl/Backing Resin	1	0	0	1	0	0	0	0	0	0	0	Very low risk	Complete a Risk Assessment.

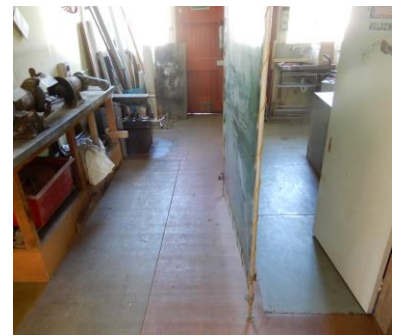
Photograph No.	7
Location/Area	Internal: Grinder/Welding Rm
Suspected Material Identified	Vinyl Flooring
Condition of Material Identified	Good
<b>Categories: (Assessment type).</b> 1: ACM common characteristics or 2: Presumed ACM or 3: Sample collected for analysis	2: Presumed ACM
Sample No.	Sample Not Taken
Laboratory Analysis Findings	Analysis Not Conducted
Quantity of Material Identified	16.0m2

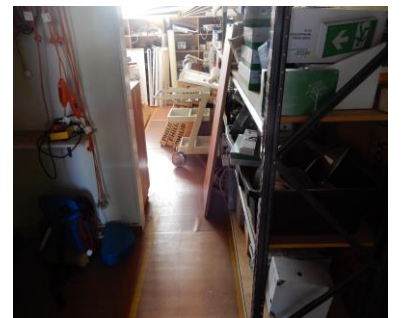
Photograph No.	8
Location/Area	Internal: Cable Store Rm
Suspected Material Identified	Vinyl Flooring
Condition of Material Identified	Good
<b>Categories: (Assessment type).</b> 1: ACM common characteristics or 2: Presumed ACM or 3: Sample collected for analysis	2: Presumed ACM
Sample No.	Sample Not Taken
Laboratory Analysis Findings	Analysis Not Conducted
Quantity of Material Identified	40.0m2

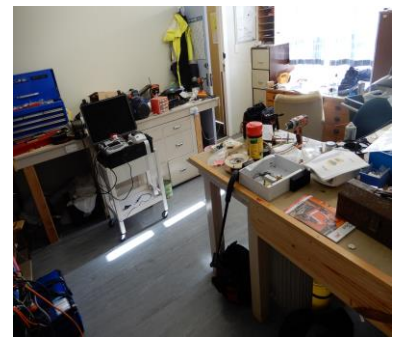
Photograph No.	9
Location/Area	Internal: Office 1
Suspected Material Identified	Vinyl Flooring
Condition of Material Identified	Good
<b>Categories: (Assessment type).</b> 1: ACM common characteristics or 2: Presumed ACM or 3: Sample collected for analysis	2: Presumed ACM
Sample No.	Sample Not Taken
Laboratory Analysis Findings	Analysis Not Conducted
Quantity of Material Identified	25.0m2

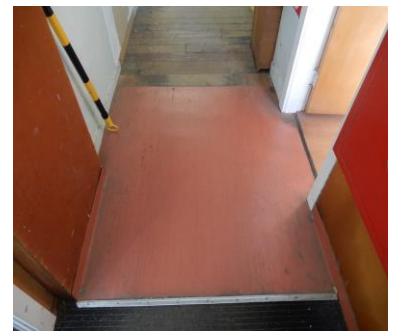
Photograph No.	10
Location/Area	Internal: West Entry
Suspected Material Identified	Vinyl Flooring
Condition of Material Identified	Good
<b>Categories: (Assessment type).</b> 1: ACM common characteristics or 2: Presumed ACM or 3: Sample collected for analysis	2: Presumed ACM
Sample No.	Sample Not Taken
Laboratory Analysis Findings	Analysis Not Conducted
Quantity of Material Identified	3.0m2

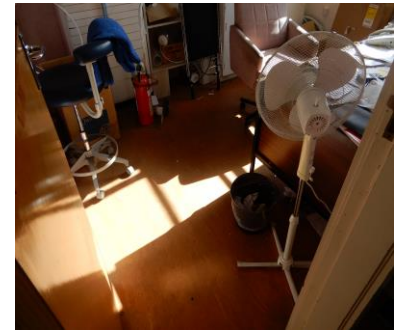
Photograph No.	11
Location/Area	Internal: Office 2
Suspected Material Identified	Vinyl Flooring
Condition of Material Identified	Good
<b>Categories: (Assessment type).</b> 1: ACM common characteristics or 2: Presumed ACM or 3: Sample collected for analysis	2: Presumed ACM
Sample No.	Sample Not Taken
Laboratory Analysis Findings	Analysis Not Conducted
Quantity of Material Identified	13.0m2

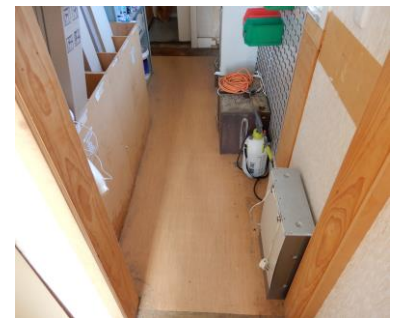
Photograph No.	12
Location/Area	Internal: Office 3-Storage
Suspected Material Identified	Vinyl Flooring
Condition of Material Identified	Good
<b>Categories: (Assessment type).</b> 1: ACM common characteristics or 2: Presumed ACM or 3: Sample collected for analysis	2: Presumed ACM
Sample No.	Sample Not Taken
Laboratory Analysis Findings	Analysis Not Conducted
Quantity of Material Identified	3.6m2

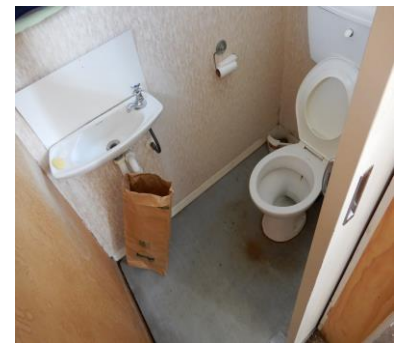
Photograph No.	13
Location/Area	Internal: Office 3-Toilet
Suspected Material Identified	Vinyl Flooring
Condition of Material Identified	Good
<b>Categories: (Assessment type).</b> 1: ACM common characteristics or 2: Presumed ACM or 3: Sample collected for analysis	2: Presumed ACM
Sample No.	Sample Not Taken
Laboratory Analysis Findings	Analysis Not Conducted
Quantity of Material Identified	1.8m2

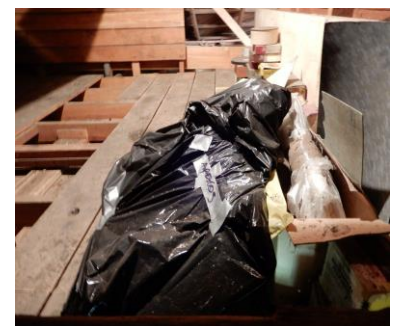
Photograph No.	14
Location/Area	Internal: Ceiling Space
Suspected Material Identified	ACM (Identified) Material
Condition of Material Identified	Good
<b>Categories: (Assessment type).</b> 1: ACM common characteristics or 2: Presumed ACM or 3: Sample collected for analysis	1: ACM common characteristics
Sample No.	Sample Not Taken
Laboratory Analysis Findings	Analysis Not Conducted
Quantity of Material Identified	15.0m2

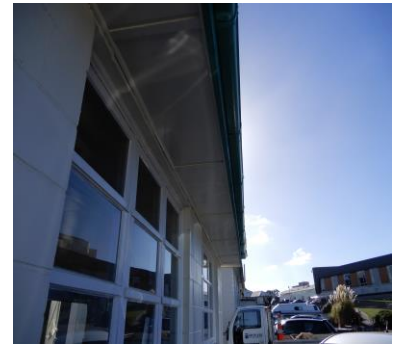
Photograph No.	15
Location/Area	Smoko Room: Soffit
Suspected Material Identified	ACM Board
Condition of Material Identified	Good
<b>Categories: (Assessment type).</b> 1: ACM common characteristics or 2: Presumed ACM or 3: Sample collected for analysis	2: Presumed ACM
Sample No.	Sample Not Taken
Laboratory Analysis Findings	Analysis Not Conducted
Quantity of Material Identified	35.0m2

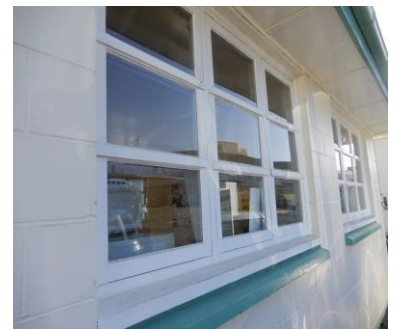
Photograph No.	16
Location/Area	Smoko Room: Window Frame
Suspected Material Identified	Putty Compound
Condition of Material Identified	Good
<b>Categories: (Assessment type).</b> 1: ACM common characteristics or 2: Presumed ACM or 3: Sample collected for analysis	2: Presumed ACM
Sample No.	Sample Not Taken
Laboratory Analysis Findings	Analysis Not Conducted
Quantity of Material Identified	70.0L/M

016	16	Smoko Room: Window	2	70.0L/M	Window Framing	Putty Compound	1	0	0	1	0	0	0	0	0	0	0	Very low risk	Complete a Risk Assessment.
017	17	Smoko Room: Locker Room	2	9.0m2	Vinyl Flooring	Vinyl/Backing Resin	1	0	0	1	0	0	0	0	0	0	0	Very low risk	Complete a Risk Assessment.
018	18	Smoko Room: Fuse Board	2	.300m2	Fuse Board	ACM Board	1	0	0	1	0	0	0	0	0	0	0	Very low risk	Complete a Risk Assessment.
019	19	Smoko Room: Sub-Floor	2	32.0m2	Packing Paper	ACM Material	1	0	0	1	0	0	0	0	0	0	0	Very low risk	Complete a Risk Assessment.
020

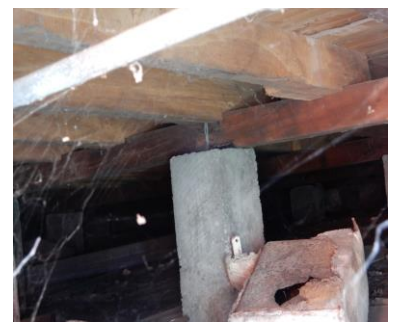
Photograph No.	19
Location/Area	Smoko Room: Sub-Floor
Suspected Material Identified	ACM Packing Paper
Condition of Material Identified	Good
<b>Categories: (Assessment type).</b> 1: ACM common characteristics or 2: Presumed ACM or 3: Sample collected for analysis	2: Presumed ACM
Sample No.	Sample Not Taken
Laboratory Analysis Findings	Analysis Not Conducted
Quantity of Material Identified	32m2
