Asbestos Management Survey Report

WHANGANUI HOSPITAL

STANFORD HOUSE-EXTERNAL & INTERNAL

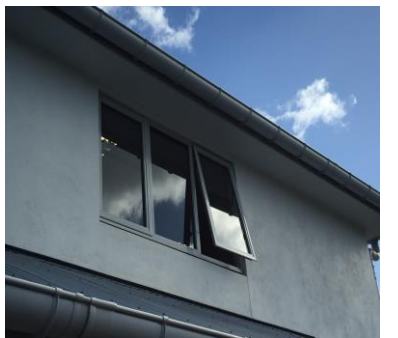
Photograph No.	2

Location/Area	Exterior: Soffits	
Suspected Material Identified	ACM Board	
Condition of Material Identified	Good	
Categories: (Assessment type). 1: ACM common characteristics or 2: Presumed ACM or 3: Sample collected for analysis	2: Presumed ACM	
Sample No.	Sample Not Taken	
Laboratory Analysis Findings	Analysis Not Conducted	
Quantity of Material Identified	20.0m2

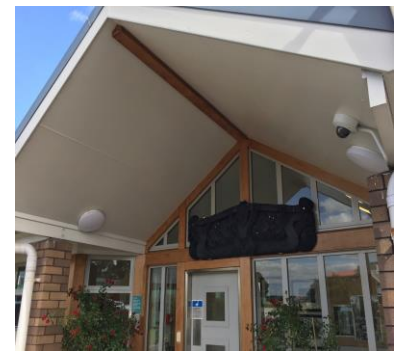
Photograph No.	3
Location/Area	Exterior: Main Entry (Canopy)
Suspected Material Identified	ACM Board
Condition of Material Identified	Good
Categories: (Assessment type). 1: ACM common characteristics or 2: Presumed ACM or 3: Sample collected for analysis	2: Presumed ACM
Sample No.	Sample Not Taken
Laboratory Analysis Findings	Analysis Not Conducted
Quantity of Material Identified	17.5m2

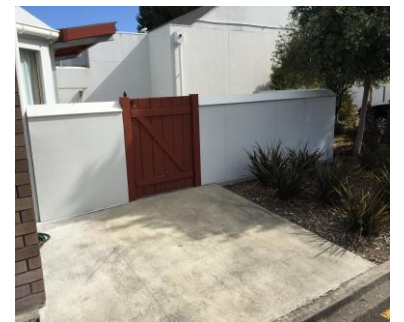
ID: CARD NO:004

Photograph No.	4
Location/Area	Exterior: North Fence line
Suspected Material Identified	ACM Board
Condition of Material Identified	Good
Categories: (Assessment type). 1: ACM common characteristics or 2: Presumed ACM or 3: Sample collected for analysis	2: Presumed ACM
Sample No.	Sample Not Taken
Laboratory Analysis Findings	Analysis Not Conducted
Quantity of Material Identified	18.0m2

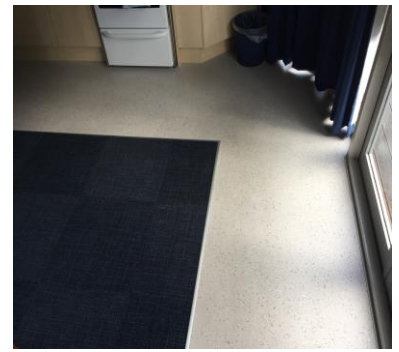
ID: CARD NO:005

Photograph No.	5
Location/Area	Client Flat: Kitchen
Suspected Material Identified	Vinyl Flooring
Condition of Material Identified	Good
Categories: (Assessment type). 1: ACM common characteristics or 2: Presumed ACM or 3: Sample collected for analysis	2: Presumed ACM
Sample No.	Sample Not Taken
Laboratory Analysis Findings	Analysis Not Conducted
Quantity of Material Identified	5.5m ²

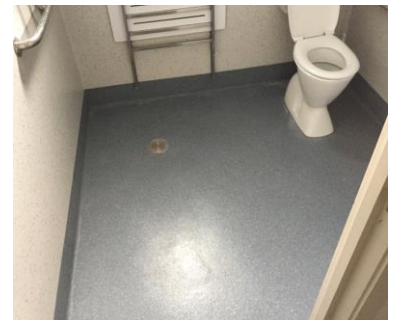
ID: CARD NO:006

Photograph No.	6
Location/Area	Client Flat: Bathroom
Suspected Material Identified	Vinyl Floor/Walls
Condition of Material Identified	Good
Categories: (Assessment type). 1: ACM common characteristics or 2: Presumed ACM or 3: Sample collected for analysis	2: Presumed ACM
Sample No.	Sample Not Taken
Laboratory Analysis Findings	Analysis Not Conducted
Quantity of Material Identified	4.0m ² / 20.0m ²

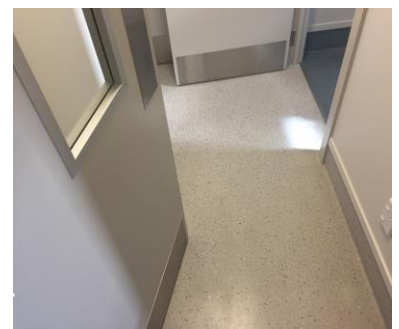
Photograph No.	7
Location/Area	Staff Bathroom: Entry
Suspected Material Identified	Vinyl Flooring
Condition of Material Identified	Good
Categories: (Assessment type). 1: ACM common characteristics or 2: Presumed ACM or 3: Sample collected for analysis	2: Presumed ACM
Sample No.	Sample Not Taken
Laboratory Analysis Findings	Analysis Not Conducted
Quantity of Material Identified	2.6m ²

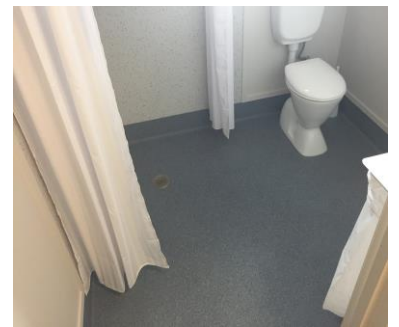
Photograph No.	8
Location/Area	Staff Bathroom: Toilet/Shower
Suspected Material Identified	Vinyl Floor/Walls
Condition of Material Identified	Good
Categories: (Assessment type). 1: ACM common characteristics or 2: Presumed ACM or 3: Sample collected for analysis	2: Presumed ACM
Sample No.	Sample Not Taken
Laboratory Analysis Findings	Analysis Not Conducted
Quantity of Material Identified	3.8m ² / 25.0m ²

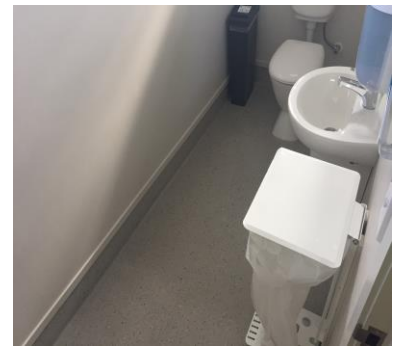
Photograph No.	9
Location/Area	Staff Bathroom: Toilet
Suspected Material Identified	Vinyl Flooring
Condition of Material Identified	Good
Categories: (Assessment type). 1: ACM common characteristics or 2: Presumed ACM or 3: Sample collected for analysis	2: Presumed ACM
Sample No.	Sample Not Taken
Laboratory Analysis Findings	Analysis Not Conducted
Quantity of Material Identified	3.0m2

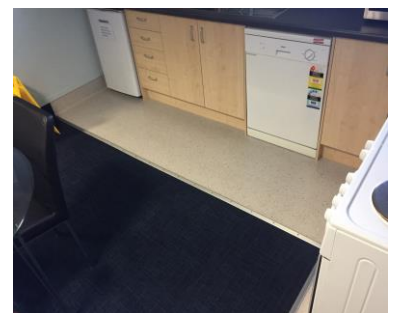
Photograph No.	10
Location/Area	Staff Kitchen
Suspected Material Identified	Vinyl Flooring
Condition of Material Identified	Good
Categories: (Assessment type). 1: ACM common characteristics or 2: Presumed ACM or 3: Sample collected for analysis	2: Presumed ACM
Sample No.	Sample Not Taken
Laboratory Analysis Findings	Analysis Not Conducted
Quantity of Material Identified	3.8m2

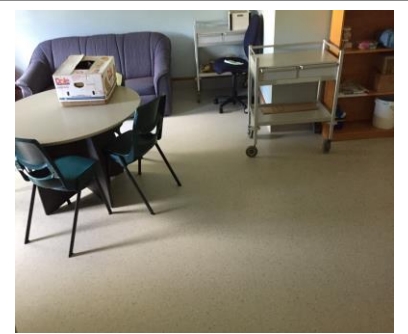
Photograph No.	11
Location/Area	Internal: Whanau Room
Suspected Material Identified	Vinyl Flooring
Condition of Material Identified	Good
Categories: (Assessment type). 1: ACM common characteristics or 2: Presumed ACM or 3: Sample collected for analysis	2: Presumed ACM
Sample No.	Sample Not Taken
Laboratory Analysis Findings	Analysis Not Conducted
Quantity of Material Identified	25.0m2

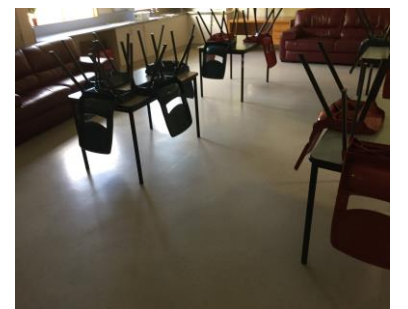
Photograph No.	12
Location/Area	Occupational Therapy: Room
Suspected Material Identified	Vinyl Flooring
Condition of Material Identified	Good
Categories: (Assessment type). 1: ACM common characteristics or 2: Presumed ACM or 3: Sample collected for analysis	2: Presumed ACM
Sample No.	Sample Not Taken
Laboratory Analysis Findings	Analysis Not Conducted
Quantity of Material Identified	35.0m2

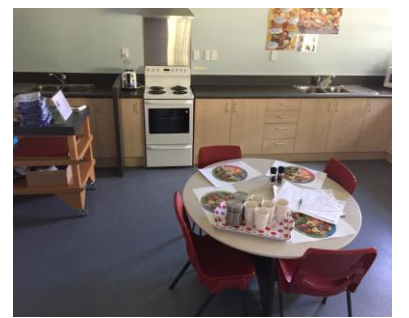
Photograph No.	13
Location/Area	Occupational Therapy: Kitchen
Suspected Material Identified	Vinyl Flooring
Condition of Material Identified	Good
Categories: (Assessment type). 1: ACM common characteristics or 2: Presumed ACM or 3: Sample collected for analysis	2: Presumed ACM
Sample No.	Sample Not Taken
Laboratory Analysis Findings	Analysis Not Conducted
Quantity of Material Identified	26.0m2

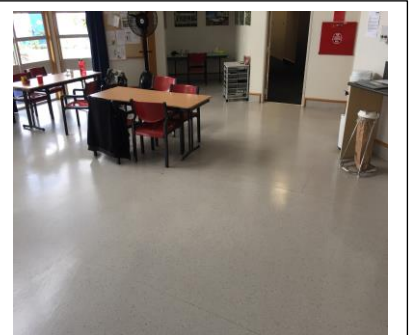
Photograph No.	14
Location/Area	Day Room: Room
Suspected Material Identified	Vinyl Flooring
Condition of Material Identified	Good
Categories: (Assessment type). 1: ACM common characteristics or 2: Presumed ACM or 3: Sample collected for analysis	2: Presumed ACM
Sample No.	Sample Not Taken
Laboratory Analysis Findings	Analysis Not Conducted
Quantity of Material Identified	40.0m2

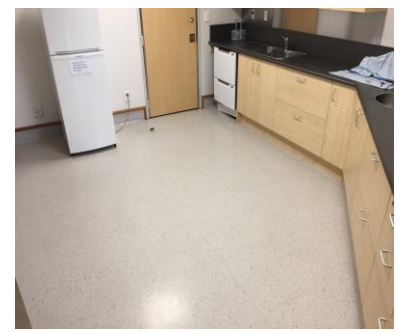
Photograph No.	15
Location/Area	Day Room: Kitchen
Suspected Material Identified	Vinyl Flooring
Condition of Material Identified	Good
Categories: (Assessment type). 1: ACM common characteristics or 2: Presumed ACM or 3: Sample collected for analysis	2: Presumed ACM
Sample No.	Sample Not Taken
Laboratory Analysis Findings	Analysis Not Conducted
Quantity of Material Identified	15.0m2

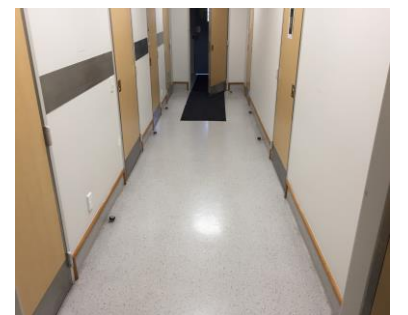
Photograph No.	16
Location/Area	Day Room: Hallway
Suspected Material Identified	Vinyl Flooring
Condition of Material Identified	Good
Categories: (Assessment type). 1: ACM common characteristics or 2: Presumed ACM or 3: Sample collected for analysis	2: Presumed ACM
Sample No.	Sample Not Taken
Laboratory Analysis Findings	Analysis Not Conducted
Quantity of Material Identified	10.5m2

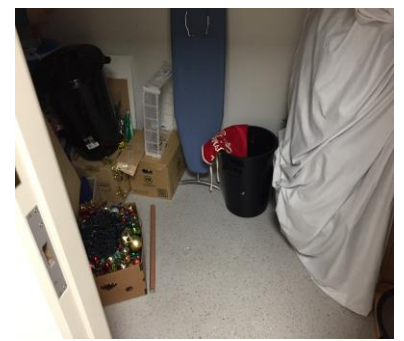
Photograph No.	17
Location/Area	Day Room: Store
Suspected Material Identified	Vinyl Flooring
Condition of Material Identified	Good
Categories: (Assessment type). 1: ACM common characteristics or 2: Presumed ACM or 3: Sample collected for analysis	2: Presumed ACM
Sample No.	Sample Not Taken
Laboratory Analysis Findings	Analysis Not Conducted
Quantity of Material Identified	6.0m2

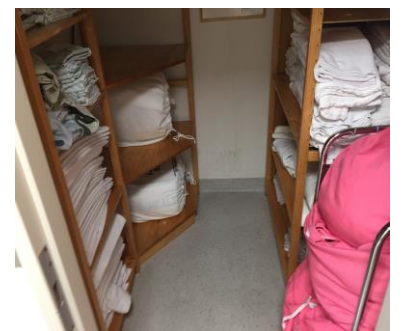
Photograph No.	18
Location/Area	Day Room: Linen
Suspected Material Identified	Vinyl Flooring
Condition of Material Identified	Good
Categories: (Assessment type). 1: ACM common characteristics or 2: Presumed ACM or 3: Sample collected for analysis	2: Presumed ACM
Sample No.	Sample Not Taken
Laboratory Analysis Findings	Analysis Not Conducted
Quantity of Material Identified	4.0m2

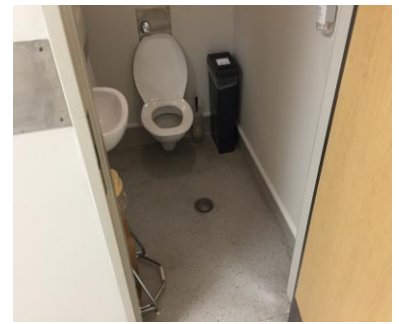
Photograph No.	19
Location/Area	Day Room: Toilet
Suspected Material Identified	Vinyl Flooring
Condition of Material Identified	Good
Categories: (Assessment type). 1: ACM common characteristics or 2: Presumed ACM or 3: Sample collected for analysis	2: Presumed ACM
Sample No.	Sample Not Taken
Laboratory Analysis Findings	Analysis Not Conducted
Quantity of Material Identified	2.5m2

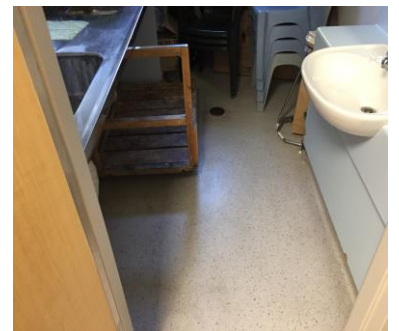
Photograph No.	20
Location/Area	Day Room: Sluice
Suspected Material Identified	Vinyl Flooring
Condition of Material Identified	Good
Categories: (Assessment type). 1: ACM common characteristics or 2: Presumed ACM or 3: Sample collected for analysis	2: Presumed ACM
Sample No.	Sample Not Taken
Laboratory Analysis Findings	Analysis Not Conducted
Quantity of Material Identified	4.0m2

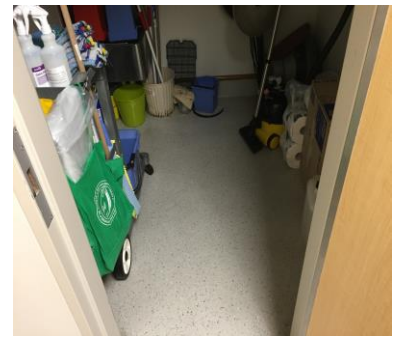
Photograph No.	21
Location/Area	Day Room: Cleaners
Suspected Material Identified	Vinyl Flooring
Condition of Material Identified	Good
Categories: (Assessment type). 1: ACM common characteristics or 2: Presumed ACM or 3: Sample collected for analysis	2: Presumed ACM
Sample No.	Sample Not Taken
Laboratory Analysis Findings	Analysis Not Conducted
Quantity of Material Identified	5.0m2

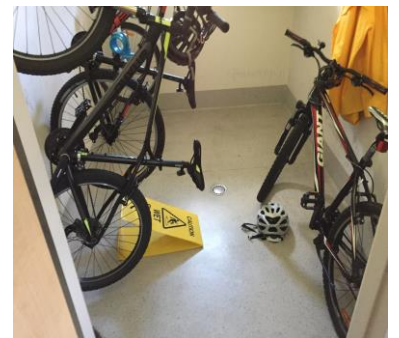
Photograph No.	22
Location/Area	Day Room: Bike/Store
Suspected Material Identified	Vinyl Flooring
Condition of Material Identified	Good
Categories: (Assessment type). 1: ACM common characteristics or 2: Presumed ACM or 3: Sample collected for analysis	2: Presumed ACM
Sample No.	Sample Not Taken
Laboratory Analysis Findings	Analysis Not Conducted
Quantity of Material Identified	6.0m2

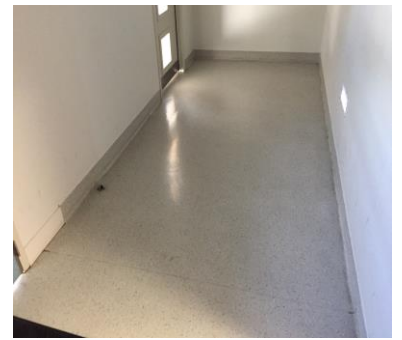
Photograph No.	23
Location/Area	Rear Entry: Floor
Suspected Material Identified	Vinyl Flooring
Condition of Material Identified	Good
Categories: (Assessment type). 1: ACM common characteristics or 2: Presumed ACM or 3: Sample collected for analysis	2: Presumed ACM
Sample No.	Sample Not Taken
Laboratory Analysis Findings	Analysis Not Conducted
Quantity of Material Identified	8.0m2

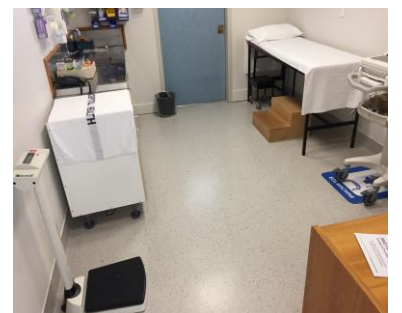
Photograph No.	24
Location/Area	Seclusion: Clinic
Suspected Material Identified	Vinyl Flooring
Condition of Material Identified	Good
Categories: (Assessment type). 1: ACM common characteristics or 2: Presumed ACM or 3: Sample collected for analysis	2: Presumed ACM
Sample No.	Sample Not Taken
Laboratory Analysis Findings	Analysis Not Conducted
Quantity of Material Identified	14.0m2

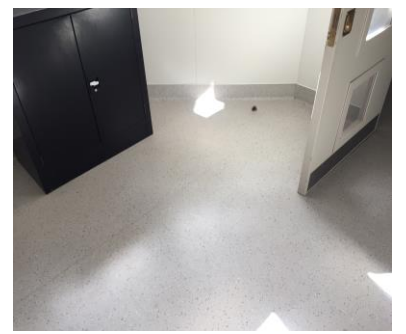
Photograph No.	25
Location/Area	Seclusion: Foyer
Suspected Material Identified	Vinyl Flooring
Condition of Material Identified	Good
Categories: (Assessment type). 1: ACM common characteristics or 2: Presumed ACM or 3: Sample collected for analysis	2: Presumed ACM
Sample No.	Sample Not Taken
Laboratory Analysis Findings	Analysis Not Conducted
Quantity of Material Identified	15.0m2

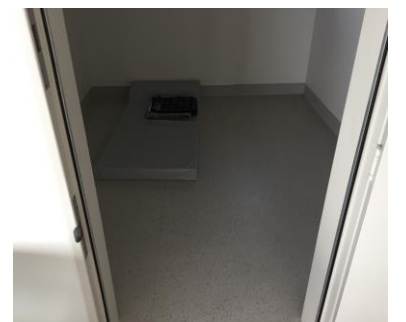
Photograph No.	26
Location/Area	Seclusion: Room 1
Suspected Material Identified	Vinyl Flooring
Condition of Material Identified	Good
Categories: (Assessment type). 1: ACM common characteristics or 2: Presumed ACM or 3: Sample collected for analysis	2: Presumed ACM
Sample No.	Sample Not Taken
Laboratory Analysis Findings	Analysis Not Conducted
Quantity of Material Identified	12.3m2

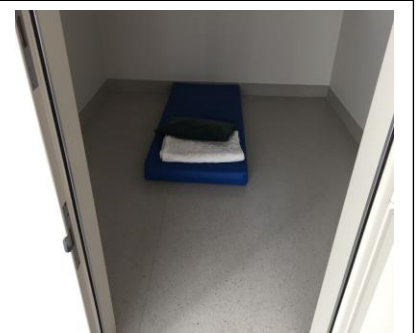
Photograph No.	27
Location/Area	Seclusion: Room 2
Suspected Material Identified	Vinyl Flooring
Condition of Material Identified	Good
Categories: (Assessment type). 1: ACM common characteristics or 2: Presumed ACM or 3: Sample collected for analysis	2: Presumed ACM
Sample No.	Sample Not Taken
Laboratory Analysis Findings	Analysis Not Conducted
Quantity of Material Identified	12.3m2

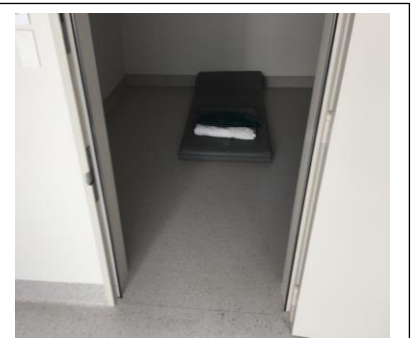
Photograph No.	28
Location/Area	Seclusion: Room 3
Suspected Material Identified	Vinyl Flooring
Condition of Material Identified	Good
Categories: (Assessment type). 1: ACM common characteristics or 2: Presumed ACM or 3: Sample collected for analysis	2: Presumed ACM
Sample No.	Sample Not Taken
Laboratory Analysis Findings	Analysis Not Conducted
Quantity of Material Identified	12.3m2

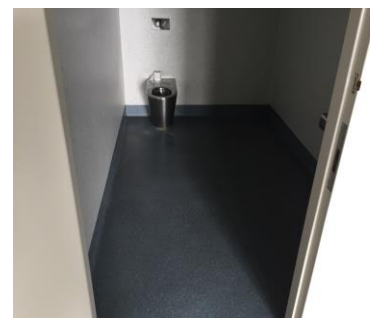
Photograph No.	29
Location/Area	Seclusion: Toilet
Suspected Material Identified	Vinyl Floor/Walls
Condition of Material Identified	Good
Categories: (Assessment type). 1: ACM common characteristics or 2: Presumed ACM or 3: Sample collected for analysis	2: Presumed ACM
Sample No.	Sample Not Taken
Laboratory Analysis Findings	Analysis Not Conducted
Quantity of Material Identified	7.0m ² / 27.8m ²

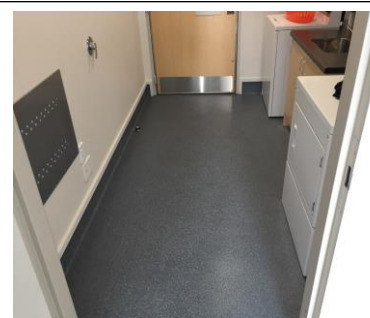
Photograph No.	30
Location/Area	Seclusion: Laundry
Suspected Material Identified	Vinyl Flooring
Condition of Material Identified	Good
Categories: (Assessment type). 1: ACM common characteristics or 2: Presumed ACM or 3: Sample collected for analysis	2: Presumed ACM
Sample No.	Sample Not Taken
Laboratory Analysis Findings	Analysis Not Conducted
Quantity of Material Identified	6.0m ²

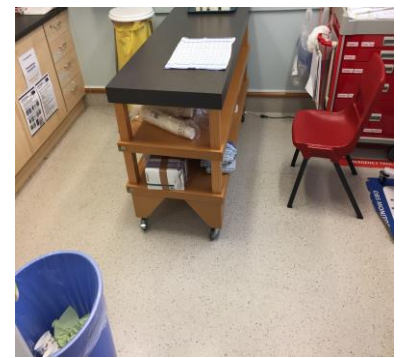
Photograph No.	31
Location/Area	Clinic: Clinic Room
Suspected Material Identified	Vinyl Flooring
Condition of Material Identified	Good
Categories: (Assessment type). 1: ACM common characteristics or 2: Presumed ACM or 3: Sample collected for analysis	2: Presumed ACM
Sample No.	Sample Not Taken
Laboratory Analysis Findings	Analysis Not Conducted
Quantity of Material Identified	8.0

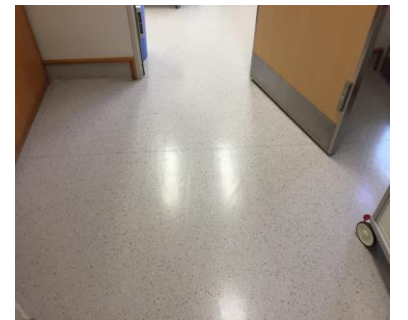
Photograph No.	32
Location/Area	Clinic: Entry
Suspected Material Identified	Vinyl Flooring
Condition of Material Identified	Good
Categories: (Assessment type). 1: ACM common characteristics or 2: Presumed ACM or 3: Sample collected for analysis	2: Presumed ACM
Sample No.	Sample Not Taken
Laboratory Analysis Findings	Analysis Not Conducted
Quantity of Material Identified	5.0m2

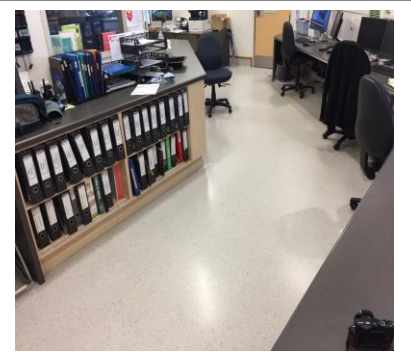
Photograph No.	33
Location/Area	Clinic: Nurses Hub
Suspected Material Identified	Vinyl Flooring
Condition of Material Identified	Good
Categories: (Assessment type). 1: ACM common characteristics or 2: Presumed ACM or 3: Sample collected for analysis	2: Presumed ACM
Sample No.	Sample Not Taken
Laboratory Analysis Findings	Analysis Not Conducted
Quantity of Material Identified	18.0m2

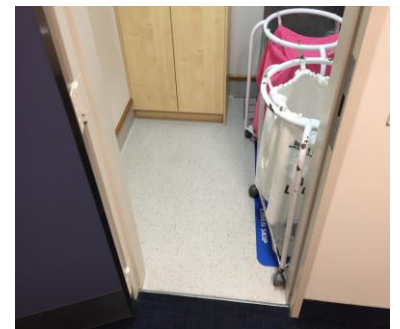
Photograph No.	34
Location/Area	Patient Block: Linen
Suspected Material Identified	Vinyl Flooring
Condition of Material Identified	Good
Categories: (Assessment type). 1: ACM common characteristics or 2: Presumed ACM or 3: Sample collected for analysis	2: Presumed ACM
Sample No.	Sample Not Taken
Laboratory Analysis Findings	Analysis Not Conducted
Quantity of Material Identified	2.5m2

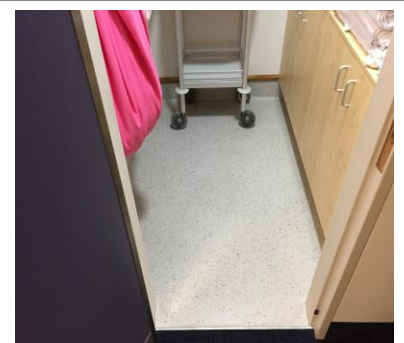
Photograph No.	35
Location/Area	Patient Block: Linen 2
Suspected Material Identified	Vinyl Flooring
Condition of Material Identified	Good
Categories: (Assessment type). 1: ACM common characteristics or 2: Presumed ACM or 3: Sample collected for analysis	2: Presumed ACM
Sample No.	Sample Not Taken
Laboratory Analysis Findings	Analysis Not Conducted
Quantity of Material Identified	1.5m2

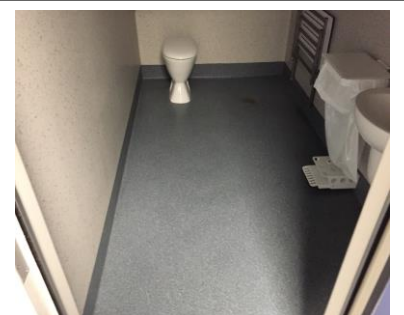
Photograph No.	36
Location/Area	Patient Block: Nurse Toilet 1
Suspected Material Identified	Vinyl Floor/Walls
Condition of Material Identified	Good
Categories: (Assessment type). 1: ACM common characteristics or 2: Presumed ACM or 3: Sample collected for analysis	2: Presumed ACM
Sample No.	Sample Not Taken
Laboratory Analysis Findings	Analysis Not Conducted
Quantity of Material Identified	7.0m2 / 24.5m2

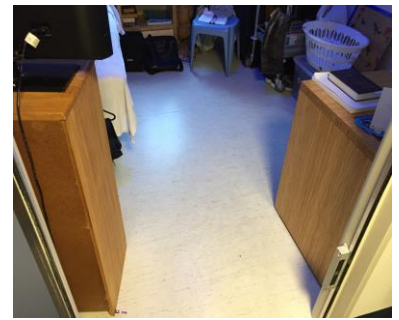
Photograph No.	37
Location/Area	Patient Block: Room 1
Suspected Material Identified	Vinyl Flooring
Condition of Material Identified	Good
Categories: (Assessment type). 1: ACM common characteristics or 2: Presumed ACM or 3: Sample collected for analysis	2: Presumed ACM
Sample No.	Sample Not Taken
Laboratory Analysis Findings	Analysis Not Conducted
Quantity of Material Identified	20.0m2

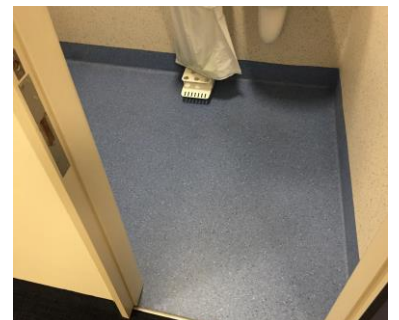
Photograph No.	38
Location/Area	Patient Block: Nurses Toilet 2
Suspected Material Identified	Vinyl Floor/Walls
Condition of Material Identified	Good
Categories: (Assessment type). 1: ACM common characteristics or 2: Presumed ACM or 3: Sample collected for analysis	2: Presumed ACM
Sample No.	Sample Not Taken
Laboratory Analysis Findings	Analysis Not Conducted
Quantity of Material Identified	5.25m2 / 21.5m2

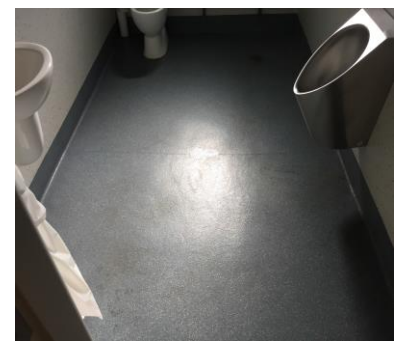
Photograph No.	39
Location/Area	Patient Block: Patient Toilet
Suspected Material Identified	Vinyl Floor/Walls
Condition of Material Identified	Good
Categories: (Assessment type). 1: ACM common characteristics or 2: Presumed ACM or 3: Sample collected for analysis	2: Presumed ACM
Sample No.	Sample Not Taken
Laboratory Analysis Findings	Analysis Not Conducted
Quantity of Material Identified	10.m2 / 30.0m2

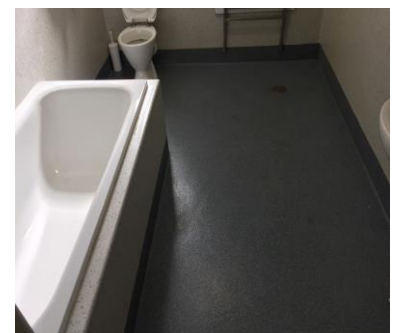
Photograph No.	40
Location/Area	Patient Block: Patient Bathroom
Suspected Material Identified	Vinyl Floor/Walls
Condition of Material Identified	Good
Categories: (Assessment type). 1: ACM common characteristics or 2: Presumed ACM or 3: Sample collected for analysis	2: Presumed ACM
Sample No.	Sample Not Taken
Laboratory Analysis Findings	Analysis Not Conducted
Quantity of Material Identified	10.0m2 / 30.0m2

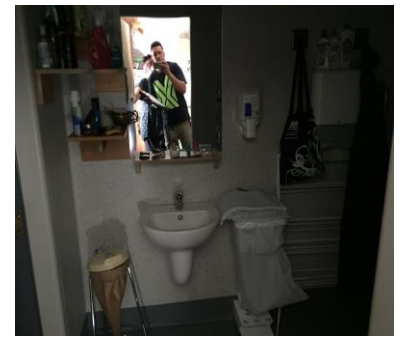
Photograph No.	41
Location/Area	Patient Room: Ensuite
Suspected Material Identified	Vinyl Floor/Walls
Condition of Material Identified	Good
Categories: (Assessment type). 1: ACM common characteristics or 2: Presumed ACM or 3: Sample collected for analysis	2: Presumed ACM
Sample No.	Sample Not Taken
Laboratory Analysis Findings	Analysis Not Conducted
Quantity of Material Identified	6.0m2 / 13.0m2

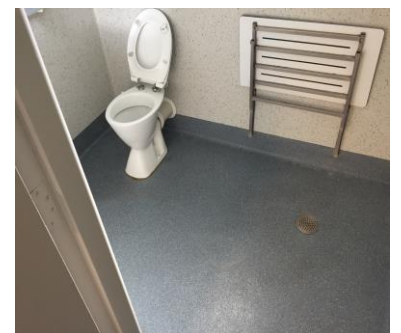
Photograph No.	42
Location/Area	Patient Room: Toilet
Suspected Material Identified	Vinyl Floor/Walls
Condition of Material Identified	Good
Categories: (Assessment type). 1: ACM common characteristics or 2: Presumed ACM or 3: Sample collected for analysis	2: Presumed ACM
Sample No.	Sample Not Taken
Laboratory Analysis Findings	Analysis Not Conducted
Quantity of Material Identified	6.0m2 / 18.0m2
