Asbestos Management Survey Report

WHANGANUI HOSPITAL,
TE PIRINGA

WHANGANUI HOSPITAL - TE PIRINGA

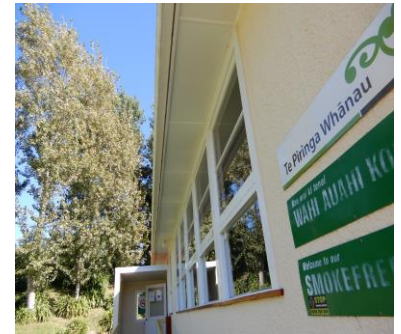
ID: CARD NO:001

Photograph No.	1
Location/Area	Exterior: Soffits
Suspected Material Identified	ACM Board
Condition of Material Identified	Good
Categories: (Assessment type). 1: ACM common characteristics or 2: Presumed ACM or 3: Sample collected for analysis	2: Presumed ACM
Sample No.	Sample Not Taken
Laboratory Analysis Findings	Analysis Not Conducted
Quantity of Material Identified	23.0m2

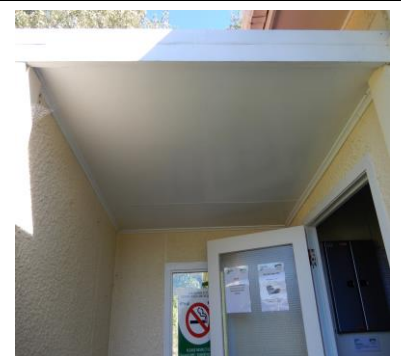
ID: CARD NO:002

Photograph No.	2
Location/Area	Exterior: Entry Canopy
Suspected Material Identified	ACM Board
Condition of Material Identified	Good
Categories: (Assessment type). 1: ACM common characteristics or 2: Presumed ACM or 3: Sample collected for analysis	2: Presumed ACM
Sample No.	Sample Not Taken
Laboratory Analysis Findings	Analysis Not Conducted
Quantity of Material Identified	4.0m2

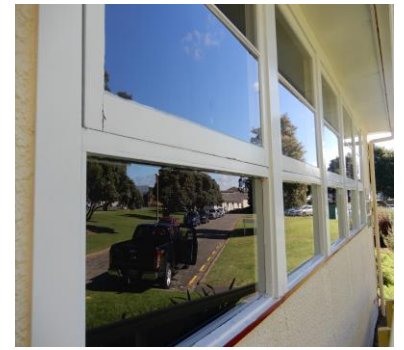
ID: CARD NO:003

Photograph No.	3
Location/Area	Exterior: Window Frame
Suspected Material Identified	Putty Compound
Condition of Material Identified	Good
Categories: (Assessment type). 1: ACM common characteristics or 2: Presumed ACM or 3: Sample collected for analysis	2: Presumed ACM
Sample No.	Sample Not Taken
Laboratory Analysis Findings	Analysis Not Conducted
Quantity of Material Identified	112.0L/M

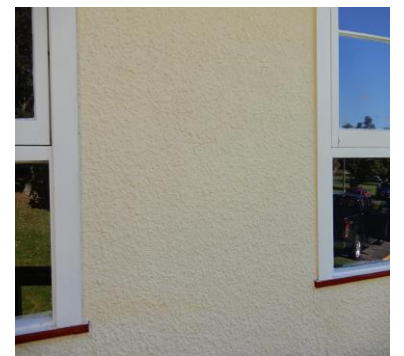
ID: CARD NO:004

Photograph No.	4
Location/Area	Exterior: Walls
Suspected Material Identified	Stucco
Condition of Material Identified	Good
Categories: (Assessment type). 1: ACM common characteristics or 2: Presumed ACM or 3: Sample collected for analysis	2: Presumed ACM
Sample No.	Sample Not Taken
Laboratory Analysis Findings	Analysis Not Conducted
Quantity of Material Identified	190.0m2

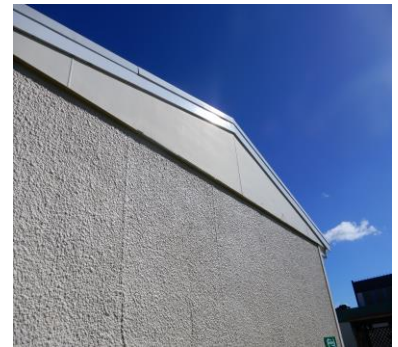
ID: CARD NO:005

Photograph No.	5
Location/Area	Exterior: Gable Ends
Suspected Material Identified	ACM Board
Condition of Material Identified	Good
Categories: (Assessment type).	2: Presumed ACM
1: ACM common characteristics or	
2: Presumed ACM or	
3: Sample collected for analysis	
Sample No.	Sample Not Taken
Laboratory Analysis Findings	Analysis Not Conducted
Quantity of Material Identified	12.0m2

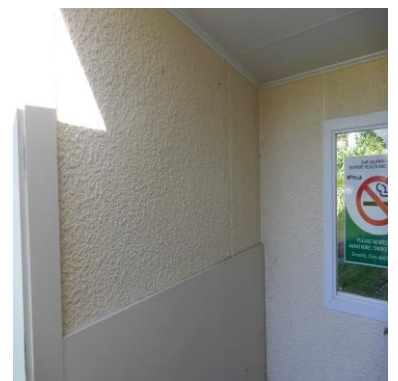
ID: CARD NO:006

Photograph No.	6
Location/Area	Exterior: Entry Walls
Suspected Material Identified	Stucco
Condition of Material Identified	Good
Categories: (Assessment type).	2: Presumed ACM
1: ACM common characteristics or	
2: Presumed ACM or	
3: Sample collected for analysis	
Sample No.	Sample Not Taken
Laboratory Analysis Findings	Analysis Not Conducted
Quantity of Material Identified	8.0m2

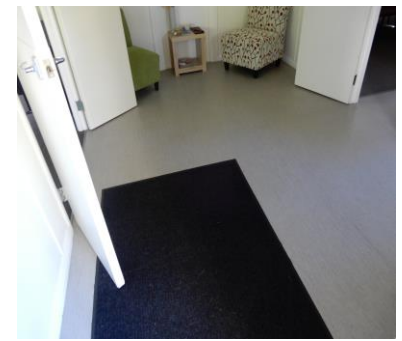
ID: CARD NO:007

Photograph No.	7
Location/Area	Internal: Foyer
Suspected Material Identified	Vinyl Flooring
Condition of Material Identified	Good
Categories: (Assessment type). 1: ACM common characteristics or 2: Presumed ACM or 3: Sample collected for analysis	2: Presumed ACM
Sample No.	Sample Not Taken
Laboratory Analysis Findings	Analysis Not Conducted
Quantity of Material Identified	12.0m2

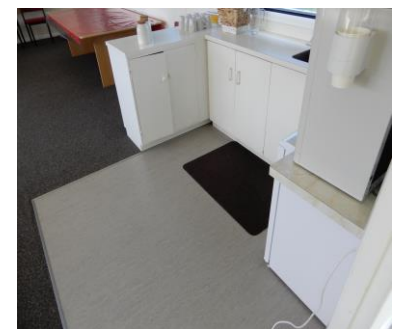
ID: CARD NO:008

Photograph No.	8
Location/Area	Internal: Kitchen
Suspected Material Identified	Vinyl Flooring
Condition of Material Identified	Good
Categories: (Assessment type). 1: ACM common characteristics or 2: Presumed ACM or 3: Sample collected for analysis	2: Presumed ACM
Sample No.	Sample Not Taken
Laboratory Analysis Findings	Analysis Not Conducted
Quantity of Material Identified	4.0m2

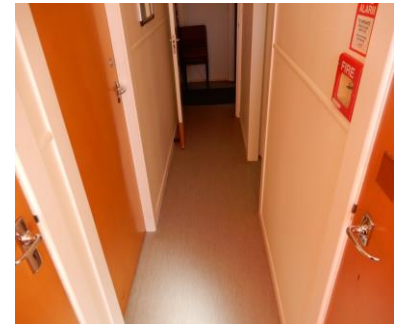
ID: CARD NO:009

Photograph No.	9
Location/Area	Internal: Hallway
Suspected Material Identified	Vinyl Flooring
Condition of Material Identified	Good
Categories: (Assessment type). 1: ACM common characteristics or 2: Presumed ACM or 3: Sample collected for analysis	2: Presumed ACM
Sample No.	Sample Not Taken
Laboratory Analysis Findings	Analysis Not Conducted
Quantity of Material Identified	9.0m2

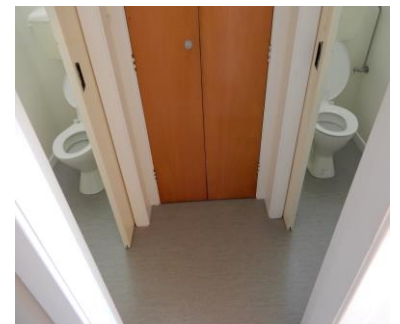
ID: CARD NO:010

Photograph No.	10
Location/Area	Internal: Toilets
Suspected Material Identified	Vinyl Flooring
Condition of Material Identified	Good
Categories: (Assessment type). 1: ACM common characteristics or 2: Presumed ACM or 3: Sample collected for analysis	2: Presumed ACM
Sample No.	Sample Not Taken
Laboratory Analysis Findings	Analysis Not Conducted
Quantity of Material Identified	5.0m2

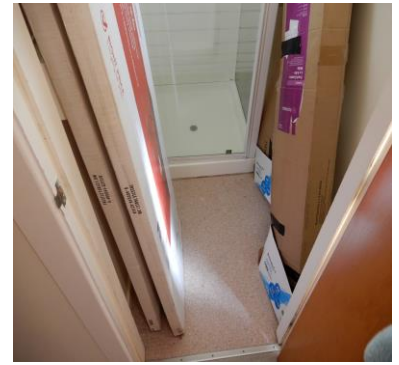
ID: CARD NO:011

Photograph No.	11
Location/Area	Internal: Shower
Suspected Material Identified	Vinyl Flooring
Condition of Material Identified	Good
Categories: (Assessment type). 1: ACM common characteristics or 2: Presumed ACM or 3: Sample collected for analysis	2: Presumed ACM
Sample No.	Sample Not Taken
Laboratory Analysis Findings	Analysis Not Conducted
Quantity of Material Identified	1.7m2
