Asbestos Management Survey Report

***WHANGANUI HOSPITAL
OLD THEATRE
ASBESTOS MANAGEMENT SURVEY***

WHANGANUI HOSPITAL – OLD THEATRE

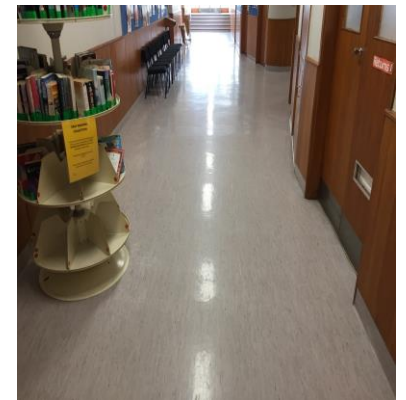
ID: CARD NO:001

Photograph No.	001
Location/Area	Ground Floor-Lobby
Suspected Material Identified	Vinyl Floor
Condition of Material Identified	Good
Categories: (Assessment type). 1: ACM common characteristics or 2: Presumed ACM or 3: Sample collected for analysis	Presumed ACM
Sample No.	N/A
Laboratory Analysis Findings	N/A
Quantity of Material Identified	103m ²

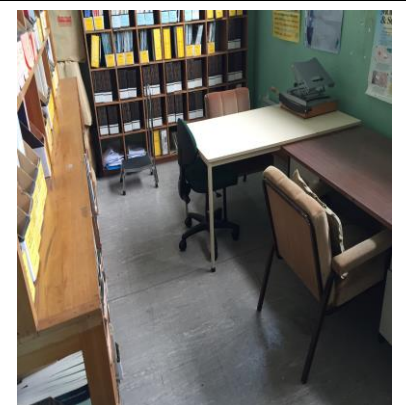
ID: CARD NO:002

Photograph No.	002
Location/Area	Ground Floor-Study Room
Suspected Material Identified	Vinyl Floor
Condition of Material Identified	Good
Categories: (Assessment type). 1: ACM common characteristics or 2: Presumed ACM or 3: Sample collected for analysis	Presumed ACM
Sample No.	N/A
Laboratory Analysis Findings	N/A
Quantity of Material Identified	20.8m ²

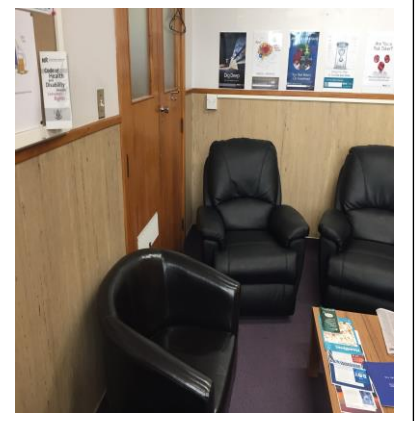
ID: CARD NO:003

Photograph No.	003
Location/Area	Ground Floor-Reading Room
Suspected Material Identified	Vinyl Floor
Condition of Material Identified	Good
Categories: (Assessment type). 1: ACM common characteristics or 2: Presumed ACM or 3: Sample collected for analysis	Presumed ACM
Sample No.	N/A
Laboratory Analysis Findings	N/A
Quantity of Material Identified	19m ²

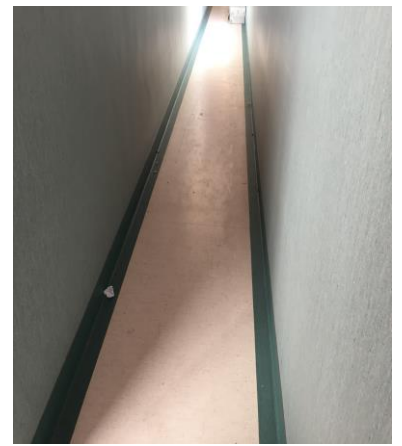
ID: CARD NO:005

Photograph No.	005
Location/Area	1 st Floor-Access Corridor 1
Suspected Material Identified	Vinyl Floor/Wall
Condition of Material Identified	Good
Categories: (Assessment type). 1: ACM common characteristics or 2: Presumed ACM or 3: Sample collected for analysis	Presumed ACM
Sample No.	N/A
Laboratory Analysis Findings	N/A
Quantity of Material Identified	26m ² /78m ²

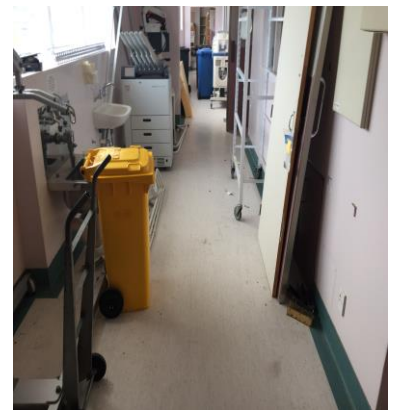
ID: CARD NO:006

Photograph No.	006
Location/Area	1 st Floor-Access Corridor 2
Suspected Material Identified	Vinyl Floor
Condition of Material Identified	Good
Categories: (Assessment type). 1: ACM common characteristics or 2: Presumed ACM or 3: Sample collected for analysis	Presumed ACM
Sample No.	N/A
Laboratory Analysis Findings	N/A
Quantity of Material Identified	75m ²

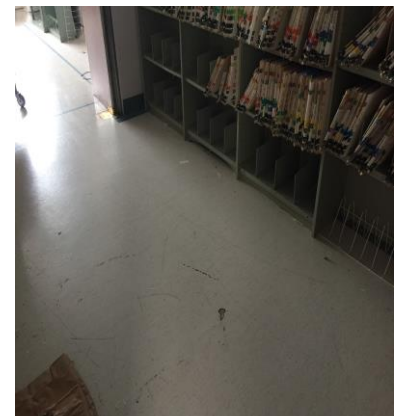
ID: CARD NO:007

Photograph No.	007
Location/Area	1 st Floor-Operating/Scrub Room 1
Suspected Material Identified	Vinyl Floor
Condition of Material Identified	Good
Categories: (Assessment type). 1: ACM common characteristics or 2: Presumed ACM or 3: Sample collected for analysis	Presumed ACM
Sample No.	N/A
Laboratory Analysis Findings	N/A
Quantity of Material Identified	46m ²

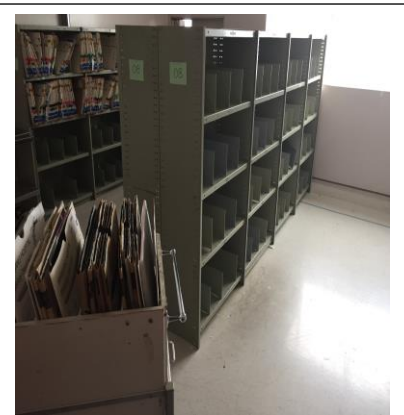
ID: CARD NO:008

Photograph No.	008
Location/Area	1 st Floor-Anaesthetic Room 1
Suspected Material Identified	Vinyl Floor
Condition of Material Identified	Good
Categories: (Assessment type). 1: ACM common characteristics or 2: Presumed ACM or 3: Sample collected for analysis	Presumed ACM
Sample No.	N/A
Laboratory Analysis Findings	N/A
Quantity of Material Identified	19.5m ²

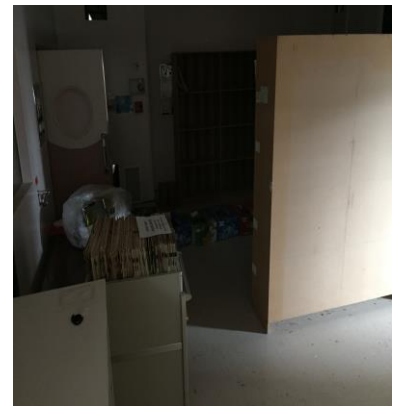
ID: CARD NO:009

Photograph No.	009
Location/Area	1 st Floor-Setup Room 1
Suspected Material Identified	Vinyl Floor
Condition of Material Identified	Good
Categories: (Assessment type). 1: ACM common characteristics or 2: Presumed ACM or 3: Sample collected for analysis	Presumed ACM
Sample No.	N/A
Laboratory Analysis Findings	N/A
Quantity of Material Identified	20m ²

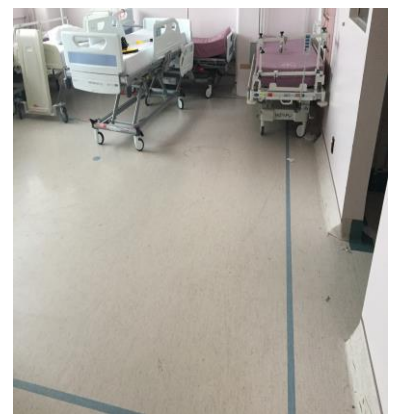
ID: CARD NO:010

Photograph No.	010
Location/Area	1 st Floor-Operating/Scrub Room 2
Suspected Material Identified	Vinyl Floor
Condition of Material Identified	Good
Categories: (Assessment type). 1: ACM common characteristics or 2: Presumed ACM or 3: Sample collected for analysis	Presumed ACM
Sample No.	N/A
Laboratory Analysis Findings	N/A
Quantity of Material Identified	46m ²

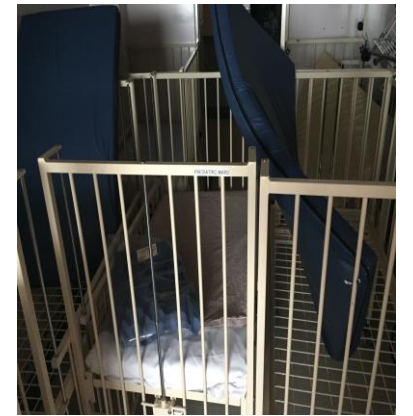
ID: CARD NO:011

Photograph No.	011
Location/Area	1 st Floor-Anaesthetic Room 2
Suspected Material Identified	Vinyl Floor
Condition of Material Identified	Good
Categories: (Assessment type). 1: ACM common characteristics or 2: Presumed ACM or 3: Sample collected for analysis	Presumed ACM
Sample No.	N/A
Laboratory Analysis Findings	N/A
Quantity of Material Identified	14m ²

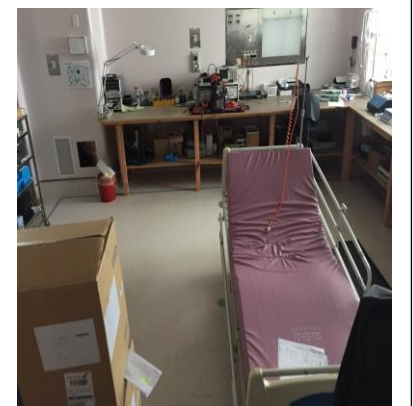
ID: CARD NO:012

Photograph No.	012
Location/Area	1 st Floor-Operating/Scrub Room 3
Suspected Material Identified	Vinyl Floor
Condition of Material Identified	Good
Categories: (Assessment type). 1: ACM common characteristics or 2: Presumed ACM or 3: Sample collected for analysis	Presumed ACM
Sample No.	N/A
Laboratory Analysis Findings	N/A
Quantity of Material Identified	46m ²

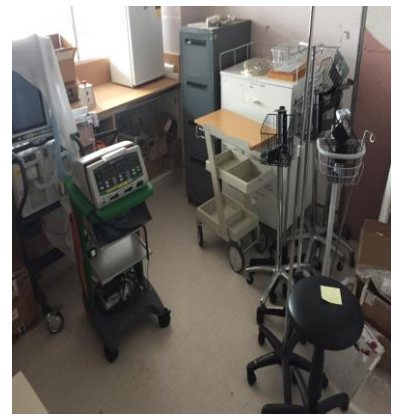
ID: CARD NO:013

Photograph No.	013
Location/Area	1 st Floor-Anaesthetic Room 3
Suspected Material Identified	Vinyl Floor
Condition of Material Identified	Good
Categories: (Assessment type). 1: ACM common characteristics or 2: Presumed ACM or 3: Sample collected for analysis	Presumed ACM
Sample No.	N/A
Laboratory Analysis Findings	N/A
Quantity of Material Identified	14m ²

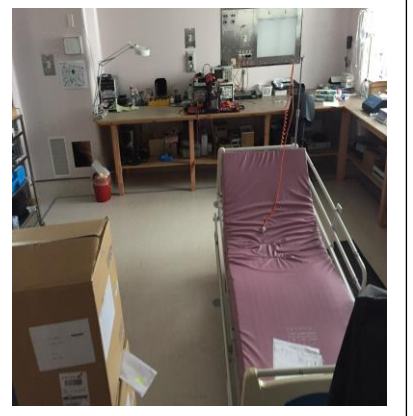
ID: CARD NO:014

Photograph No.	014
Location/Area	1 st Floor-Operating/Scrub Room 4
Suspected Material Identified	Vinyl Floor
Condition of Material Identified	Good
Categories: (Assessment type). 1: ACM common characteristics or 2: Presumed ACM or 3: Sample collected for analysis	Presumed ACM
Sample No.	N/A
Laboratory Analysis Findings	N/A
Quantity of Material Identified	46m ²

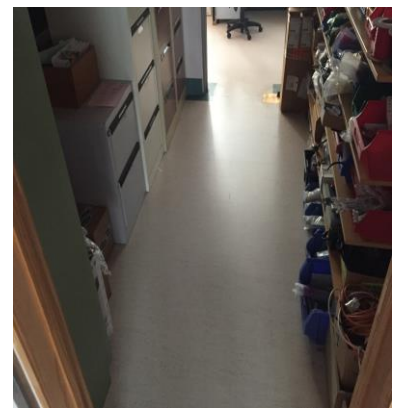
ID: CARD NO:015

Photograph No.	015
Location/Area	1 st Floor-Anaesthetic Room 4
Suspected Material Identified	Vinyl Floor
Condition of Material Identified	Good
Categories: (Assessment type). 1: ACM common characteristics or 2: Presumed ACM or 3: Sample collected for analysis	Presumed ACM
Sample No.	N/A
Laboratory Analysis Findings	N/A
Quantity of Material Identified	14m ²

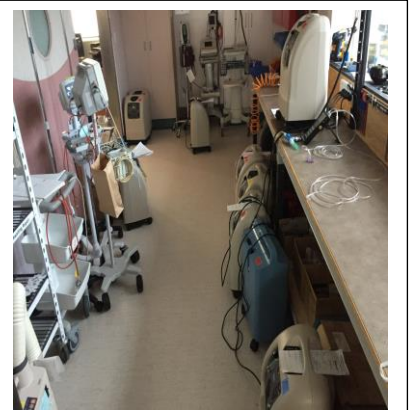
ID: CARD NO:016

Photograph No.	016
Location/Area	1 st Floor-Setup Room 2
Suspected Material Identified	Vinyl Floor
Condition of Material Identified	Good
Categories: (Assessment type). 1: ACM common characteristics or 2: Presumed ACM or 3: Sample collected for analysis	Presumed ACM
Sample No.	N/A
Laboratory Analysis Findings	N/A
Quantity of Material Identified	20m ²

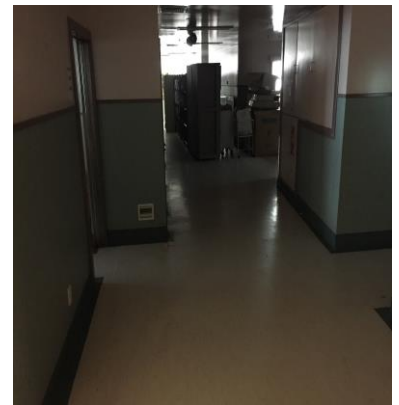
ID: CARD NO:017

Photograph No.	017
Location/Area	1 st Floor-Main Lobby
Suspected Material Identified	Vinyl Floor/Wall
Condition of Material Identified	Good
Categories: (Assessment type). 1: ACM common characteristics or 2: Presumed ACM or 3: Sample collected for analysis	Presumed ACM
Sample No.	N/A
Laboratory Analysis Findings	N/A
Quantity of Material Identified	175m ² /130m ²

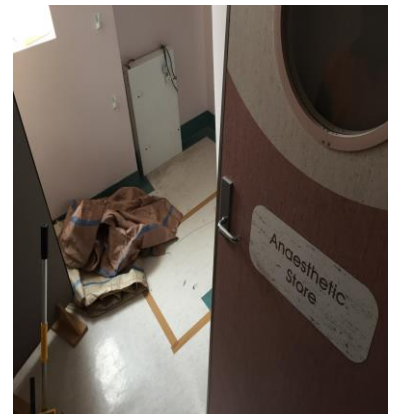
ID: CARD NO:018

Photograph No.	018
Location/Area	1 st Floor-Anaesthetic Store
Suspected Material Identified	Vinyl Floor
Condition of Material Identified	Good
Categories: (Assessment type). 1: ACM common characteristics or 2: Presumed ACM or 3: Sample collected for analysis	Presumed ACM
Sample No.	N/A
Laboratory Analysis Findings	N/A
Quantity of Material Identified	16m ²

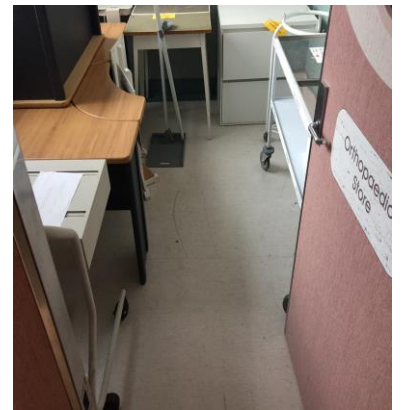
ID: CARD NO:019

Photograph No.	019
Location/Area	1 st Floor-Orthopaedic Store
Suspected Material Identified	Vinyl Floor/Wall
Condition of Material Identified	Good
Categories: (Assessment type). 1: ACM common characteristics or 2: Presumed ACM or 3: Sample collected for analysis	Presumed ACM
Sample No.	N/A
Laboratory Analysis Findings	N/A
Quantity of Material Identified	12.6m ² /21.9m ²

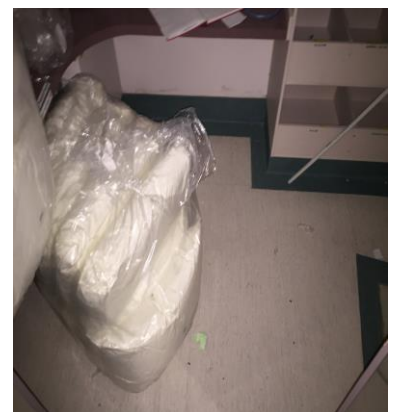
ID: CARD NO:020

Photograph No.	020
Location/Area	1 st Floor-Pharmacy Store
Suspected Material Identified	Vinyl Floor
Condition of Material Identified	Good
Categories: (Assessment type). 1: ACM common characteristics or 2: Presumed ACM or 3: Sample collected for analysis	Presumed ACM
Sample No.	N/A
Laboratory Analysis Findings	N/A
Quantity of Material Identified	5.2m ²

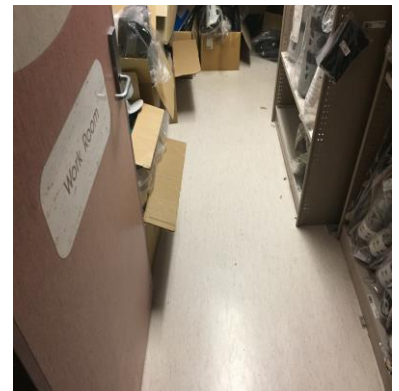
ID: CARD NO:021

Photograph No.	021
Location/Area	1 st Floor-Work Room
Suspected Material Identified	Vinyl Floor
Condition of Material Identified	Good
Categories: (Assessment type). 1: ACM common characteristics or 2: Presumed ACM or 3: Sample collected for analysis	Presumed ACM
Sample No.	N/A
Laboratory Analysis Findings	N/A
Quantity of Material Identified	8m ²

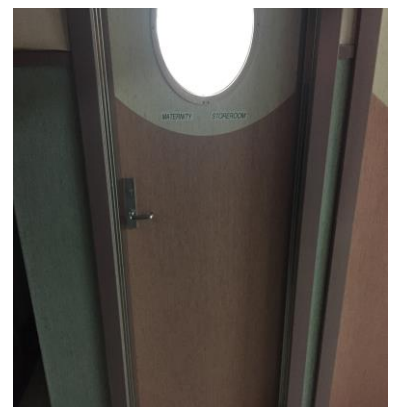
ID: CARD NO:022

Photograph No.	022
Location/Area	1 st Floor-Paediatric Room
Suspected Material Identified	Vinyl Floor
Condition of Material Identified	Good
Categories: (Assessment type). 1: ACM common characteristics or 2: Presumed ACM or 3: Sample collected for analysis	Presumed ACM
Sample No.	N/A
Laboratory Analysis Findings	N/A
Quantity of Material Identified	20m ²

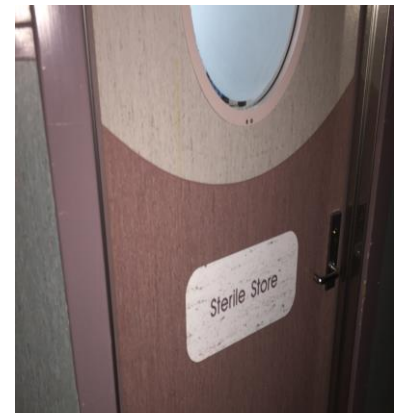
ID: CARD NO:023

Photograph No.	023
Location/Area	1 st Floor-Sterile Room
Suspected Material Identified	Vinyl Floor
Condition of Material Identified	Good
Categories: (Assessment type). 1: ACM common characteristics or 2: Presumed ACM or 3: Sample collected for analysis	Presumed ACM
Sample No.	N/A
Laboratory Analysis Findings	N/A
Quantity of Material Identified	15.5m ²

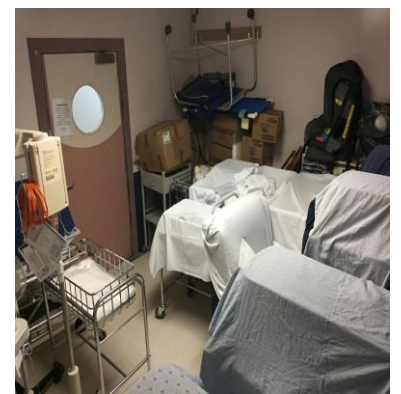
ID: CARD NO:024

Photograph No.	024
Location/Area	1 st Floor-Maternity Storeroom
Suspected Material Identified	Vinyl Floor
Condition of Material Identified	Good
Categories: (Assessment type). 1: ACM common characteristics or 2: Presumed ACM or 3: Sample collected for analysis	Presumed ACM
Sample No.	N/A
Laboratory Analysis Findings	N/A
Quantity of Material Identified	20m ²

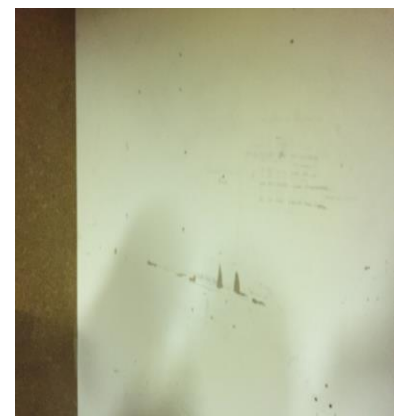
ID: CARD NO:025

Photograph No.	025
Location/Area	1 st Floor-Ceiling (all rooms)
Suspected Material Identified	Lath & Plaster
Condition of Material Identified	Good
Categories: (Assessment type). 1: ACM common characteristics or 2: Presumed ACM or 3: Sample collected for analysis	Presumed ACM
Sample No.	N/A
Laboratory Analysis Findings	N/A
Quantity of Material Identified	805m ²

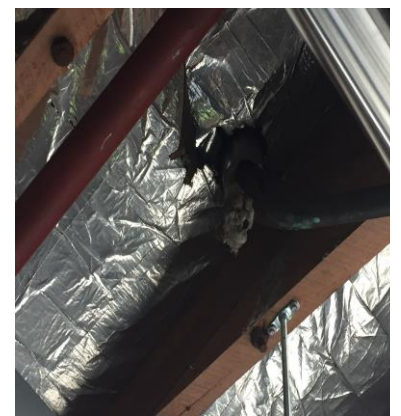
ID: CARD NO:026

Photograph No.	026
Location/Area	Top Floor-Plant Room
Suspected Material Identified	Rope Lagging
Condition of Material Identified	Damaged
Categories: (Assessment type). 1: ACM common characteristics or 2: Presumed ACM or 3: Sample collected for analysis	Presumed ACM
Sample No.	N/A
Laboratory Analysis Findings	N/A
Quantity of Material Identified	.300 L/M

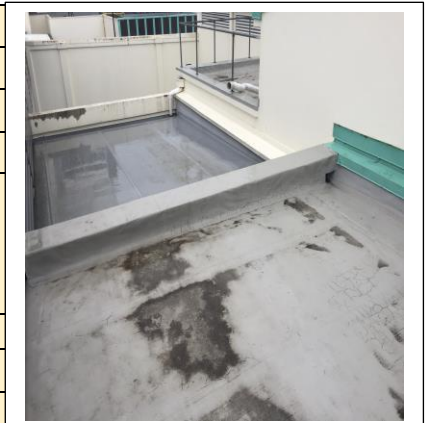
ID: CARD NO:027

Photograph No.	027
Location/Area	Roof Top
Suspected Material Identified	Waterproofing
Condition of Material Identified	Good
Categories: (Assessment type). 1: ACM common characteristics or 2: Presumed ACM or 3: Sample collected for analysis	Presumed ACM
Sample No.	N/A
Laboratory Analysis Findings	N/A
Quantity of Material Identified	80m ²
