## **Asbestos Management Survey Report**

### **Whanganui Hospital (Community Mental Health)**

### **Community Mental Health**

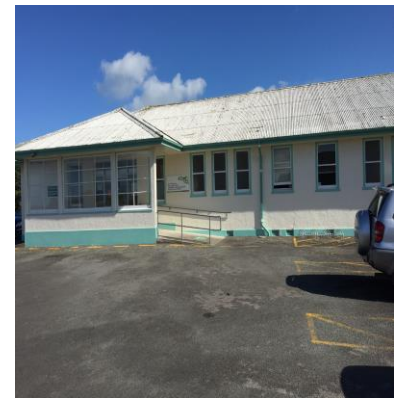
**ID: CARD NO:001**

Photograph No.	
Location/Area	External: Roof
Suspected Material Identified	ACM Sheeting
Condition of Material Identified	Good
<b>Categories: (Assessment type).</b> 1: ACM common characteristics or 2: Presumed ACM or 3: Sample collected for analysis	1: ACM common characteristics
Sample No.	Sample not collected
Laboratory Analysis Findings	Analysis not conducted
Quantity of Material Identified	1390.0m2

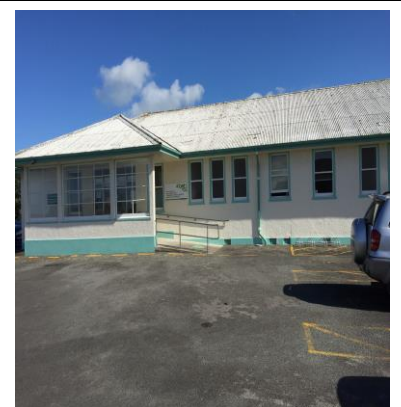
**ID: CARD NO:002**

Photograph No.	
Location/Area	External: Roof Flashings
Suspected Material Identified	ACM Sheeting
Condition of Material Identified	Good
<b>Categories: (Assessment type).</b> 1: ACM common characteristics or 2: Presumed ACM or 3: Sample collected for analysis	1: ACM common characteristics
Sample No.	Sample not collected
Laboratory Analysis Findings	Analysis not conducted
Quantity of Material Identified	120.0m2

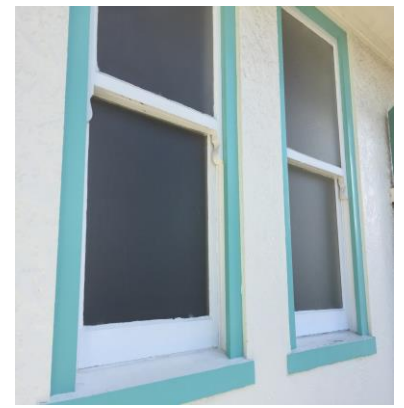
**ID: CARD NO:003**

Photograph No.	
Location/Area	External: Window frame
Suspected Material Identified	Putty compound
Condition of Material Identified	Good
<b>Categories: (Assessment type).</b> 1: ACM common characteristics or 2: Presumed ACM or 3: Sample collected for analysis	2: Presumed ACM
Sample No.	Sample not collected
Laboratory Analysis Findings	Analysis not conducted
Quantity of Material Identified	850.0L/M

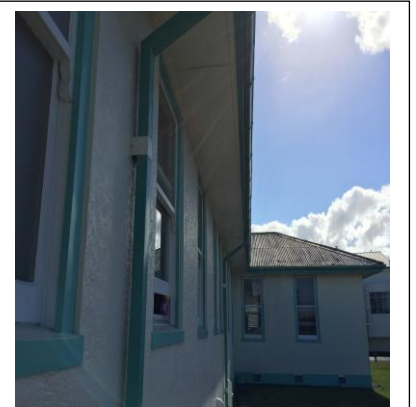
**ID: CARD NO:004**

Photograph No.	
Location/Area	External: Soffits
Suspected Material Identified	ACM board
Condition of Material Identified	Good
<b>Categories: (Assessment type).</b> 1: ACM common characteristics or 2: Presumed ACM or 3: Sample collected for analysis	2: Presumed ACM
Sample No.	Sample not collected
Laboratory Analysis Findings	Analysis not conducted
Quantity of Material Identified	180.0m2

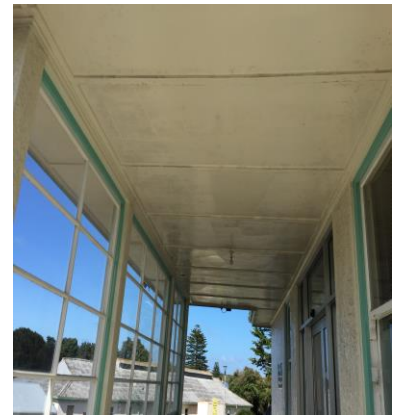
**ID: CARD NO:005**

Photograph No.	
Location/Area	External: Main Entry (Canopy)
Suspected Material Identified	ACM board
Condition of Material Identified	Good
<b>Categories: (Assessment type).</b> 1: ACM common characteristics or 2: Presumed ACM or 3: Sample collected for analysis	2: Presumed ACM
Sample No.	Sample not collected
Laboratory Analysis Findings	Analysis not conducted
Quantity of Material Identified	24.0m2

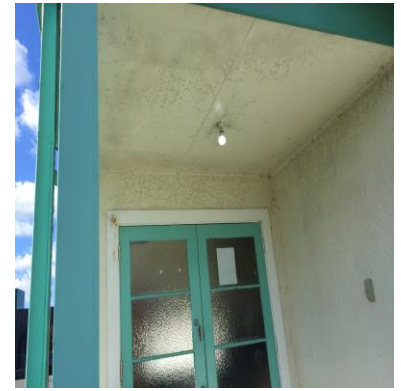
**ID: CARD NO:007**

Photograph No.	
Location/Area	External: South/West Entry (Canopy)
Suspected Material Identified	ACM board
Condition of Material Identified	Good
<b>Categories: (Assessment type).</b> 1: ACM common characteristics or 2: Presumed ACM or 3: Sample collected for analysis	2: Presumed ACM
Sample No.	Sample not collected
Laboratory Analysis Findings	Analysis not conducted
Quantity of Material Identified	4.0m2

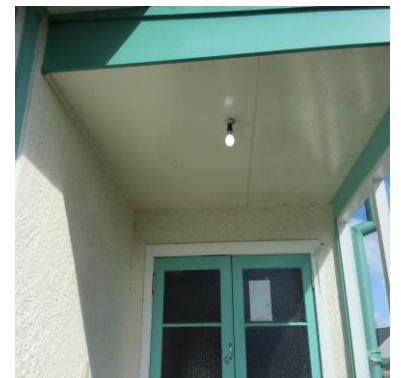
**ID: CARD NO:008**

Photograph No.	
Location/Area	External: North/West Entry (Canopy)
Suspected Material Identified	ACM board
Condition of Material Identified	Good
<b>Categories: (Assessment type).</b> 1: ACM common characteristics or 2: Presumed ACM or 3: Sample collected for analysis	2: Presumed ACM
Sample No.	Sample not collected
Laboratory Analysis Findings	Analysis not conducted
Quantity of Material Identified	4.0m2

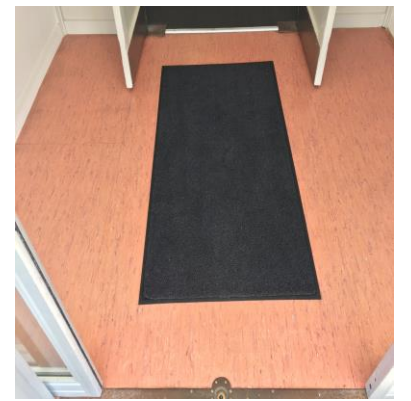
**ID: CARD NO:009**

Photograph No.	
Location/Area	Internal: Entry
Suspected Material Identified	Vinyl Flooring (Pink)
Condition of Material Identified	Good
<b>Categories: (Assessment type).</b> 1: ACM common characteristics or 2: Presumed ACM or 3: Sample collected for analysis	2: Presumed ACM
Sample No.	Sample not collected
Laboratory Analysis Findings	Analysis not conducted
Quantity of Material Identified	7.0m2

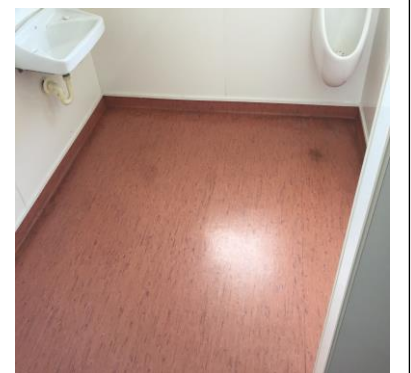
**ID: CARD NO:010**

Photograph No.	
Location/Area	Reception: Male toilet
Suspected Material Identified	Vinyl Flooring (Pink)
Condition of Material Identified	Good
<b>Categories: (Assessment type).</b> 1: ACM common characteristics or 2: Presumed ACM or 3: Sample collected for analysis	2: Presumed ACM
Sample No.	Sample not collected
Laboratory Analysis Findings	Analysis not conducted
Quantity of Material Identified	8.75m2

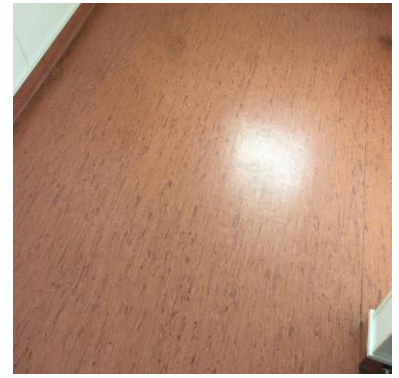
**ID: CARD NO:011**

Photograph No.	
Location/Area	Reception: Female toilet
Suspected Material Identified	Vinyl Flooring (Pink)
Condition of Material Identified	Good
<b>Categories: (Assessment type).</b> 1: ACM common characteristics or 2: Presumed ACM or 3: Sample collected for analysis	2: Presumed ACM
Sample No.	Sample not collected
Laboratory Analysis Findings	Analysis not conducted
Quantity of Material Identified	8.75m2

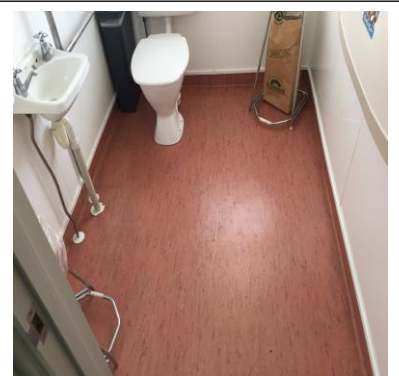
**ID: CARD NO:012**

Photograph No.	
Location/Area	Reception: Accessible toilet
Suspected Material Identified	Vinyl Flooring (Pink)
Condition of Material Identified	Good
<b>Categories: (Assessment type).</b> 1: ACM common characteristics or 2: Presumed ACM or 3: Sample collected for analysis	2: Presumed ACM
Sample No.	Sample not collected
Laboratory Analysis Findings	Analysis not conducted
Quantity of Material Identified	3.5m2

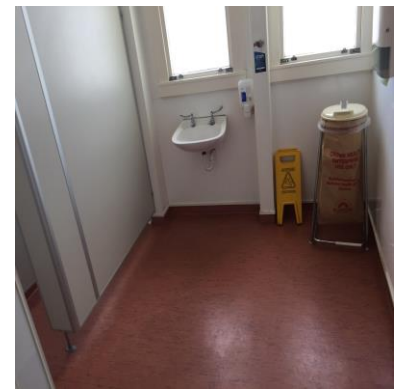
**ID: CARD NO:013**

Photograph No.	
Location/Area	Rata Block: Staff toilet
Suspected Material Identified	Vinyl Flooring (Pink)
Condition of Material Identified	Good
<b>Categories: (Assessment type).</b> 1: ACM common characteristics or 2: Presumed ACM or 3: Sample collected for analysis	2: Presumed ACM
Sample No.	Sample not collected
Laboratory Analysis Findings	Analysis not conducted
Quantity of Material Identified	12.0m2

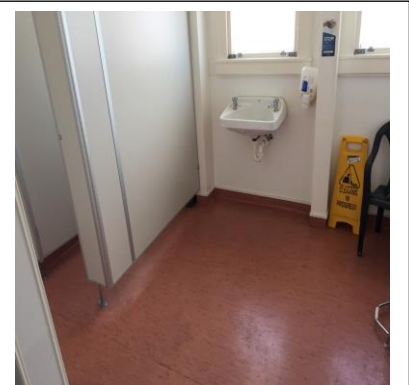
**ID: CARD NO:014**

Photograph No.	
Location/Area	Rata Block: Female toilet
Suspected Material Identified	Vinyl Flooring (Pink)
Condition of Material Identified	Good
<b>Categories: (Assessment type).</b> 1: ACM common characteristics or 2: Presumed ACM or 3: Sample collected for analysis	2: Presumed ACM
Sample No.	Sample not collected
Laboratory Analysis Findings	Analysis not conducted
Quantity of Material Identified	12.0m2

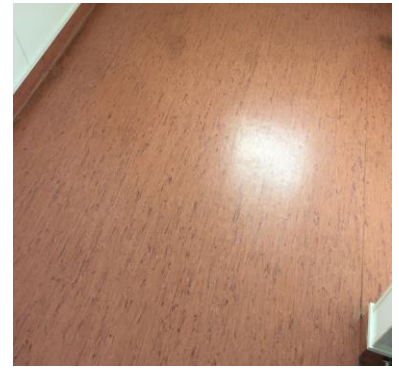
**ID: CARD NO:015**

Photograph No.	
Location/Area	Kauri Block: Kitchen
Suspected Material Identified	Vinyl Flooring (Pink)
Condition of Material Identified	Good
<b>Categories: (Assessment type).</b> 1: ACM common characteristics or 2: Presumed ACM or 3: Sample collected for analysis	2: Presumed ACM
Sample No.	Sample not collected
Laboratory Analysis Findings	Analysis not conducted
Quantity of Material Identified	5.0m2

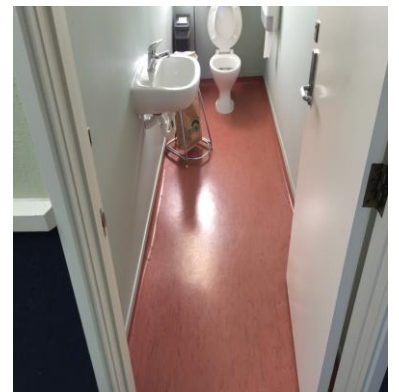
**ID: CARD NO:016**

Photograph No.	
Location/Area	Kauri Block: Toilet
Suspected Material Identified	Vinyl Flooring (Pink)
Condition of Material Identified	Good
<b>Categories: (Assessment type).</b> 1: ACM common characteristics or 2: Presumed ACM or 3: Sample collected for analysis	2: Presumed ACM
Sample No.	Sample not collected
Laboratory Analysis Findings	Analysis not conducted
Quantity of Material Identified	3.2m2

016		Kauri Block: Toilet	2	3.2m2	Vinyl covering (Pink)	Backing Glue	1	0	0	1	0	0	0	0	0	0	0	Very low risk	Complete a Risk Assessment.
017		Kauri Block: Clinic Room	2	12.0m2	Vinyl covering (Blue)	Backing Glue	1	0	0	1	0	0	0	0	0	0	0	Very low risk	Complete a Risk Assessment.
018		Kauri Block: Gents Toilet	2	12.0m2	Vinyl covering (Pink)	Backing Glue	1	0	0	1	0	0	0	0	0	0	0	Very low risk	Complete a Risk Assessment.
019		Kauri Block: Female Toilet	2	12.0m2	Vinyl covering (Pink)	Backing Glue	1	0	0	1	0	0	0	0	0	0	0	Very low risk	Complete a Risk Assessment.
020		Internal: Ceiling Space	2	14.5m2	Wall Lining	Lath & Plaster	1	0	0	1	0	0	0	0	0	0	0	Very low risk	Complete a Risk Assessment.

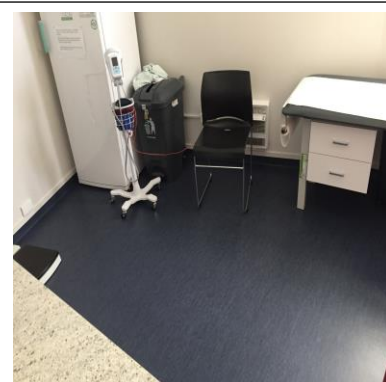
**ID: CARD NO:017**

Photograph No.	
Location/Area	Kauri Block: Clinic Room
Suspected Material Identified	Vinyl Flooring (Blue)
Condition of Material Identified	Good
<b>Categories: (Assessment type).</b> 1: ACM common characteristics or 2: Presumed ACM or 3: Sample collected for analysis	2: Presumed ACM
Sample No.	Sample not collected
Laboratory Analysis Findings	Analysis not conducted
Quantity of Material Identified	12.0m2

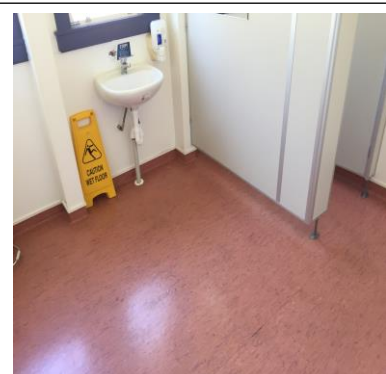
**ID: CARD NO:018**

Photograph No.	
Location/Area	Kauri Block: Gent toilets
Suspected Material Identified	Vinyl Flooring (Pink)
Condition of Material Identified	Good
<b>Categories: (Assessment type).</b> 1: ACM common characteristics or 2: Presumed ACM or 3: Sample collected for analysis	2: Presumed ACM
Sample No.	Sample not collected
Laboratory Analysis Findings	Analysis not conducted
Quantity of Material Identified	12.0m2

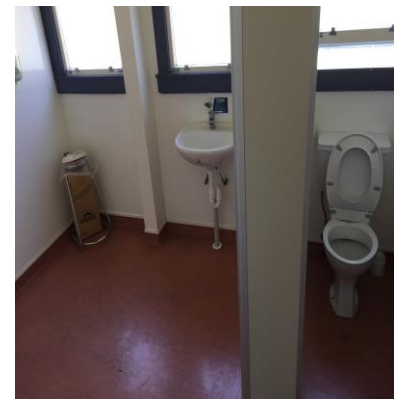
**ID: CARD NO:019**

Photograph No.	
Location/Area	Kauri Block: Female toilets
Suspected Material Identified	Vinyl Flooring (Pink)
Condition of Material Identified	Good
<b>Categories: (Assessment type).</b> 1: ACM common characteristics or 2: Presumed ACM or 3: Sample collected for analysis	2: Presumed ACM
Sample No.	Sample not collected
Laboratory Analysis Findings	Analysis not conducted
Quantity of Material Identified	12.0m2

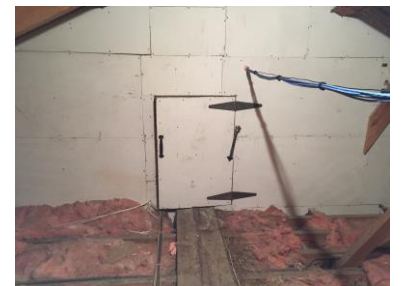
**ID: CARD NO:020**

Photograph No.	020
Location/Area	Internal: Ceiling Space
Suspected Material Identified	Lath & Plaster
Condition of Material Identified	Good
<b>Categories: (Assessment type).</b> 1: ACM common characteristics or 2: Presumed ACM or 3: Sample collected for analysis	1: ACM common characteristics
Sample No.	Sample not collected
Laboratory Analysis Findings	Analysis not conducted
Quantity of Material Identified	14.5m2
