## **Asbestos Management Survey Report**

***MATERNITY WARD  
WHANGANUI HOSPITAL  
ASBESTOS MANAGEMENT SURVEY***

### **WHANGANUI HOSPITAL – CHILDRENS WARD**

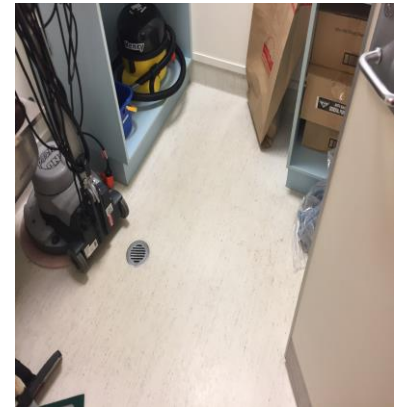
**ID: CARD NO:001**

Photograph No.	00
Location/Area	Cleaners/Flowers Room
Suspected Material Identified	Vinyl Floor
Condition of Material Identified	Good
<b>Categories: (Assessment type).</b> 1: ACM common characteristics or 2: Presumed ACM or 3: Sample collected for analysis	Presumed ACM
Sample No.	N/A
Laboratory Analysis Findings	N/A
Quantity of Material Identified	5m <sup>2</sup>

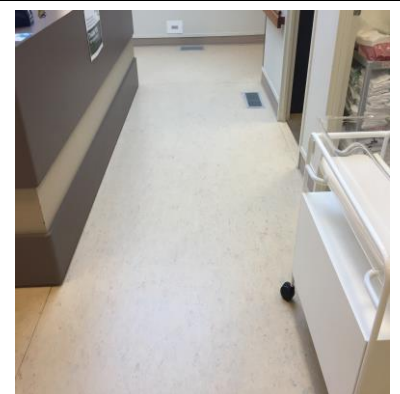
**ID: CARD NO:002**

Photograph No.	002
Location/Area	Corridors
Suspected Material Identified	Vinyl Floor
Condition of Material Identified	Good
<b>Categories: (Assessment type).</b> 1: ACM common characteristics or 2: Presumed ACM or 3: Sample collected for analysis	Presumed ACM
Sample No.	N/A
Laboratory Analysis Findings	N/A
Quantity of Material Identified	136m <sup>2</sup>

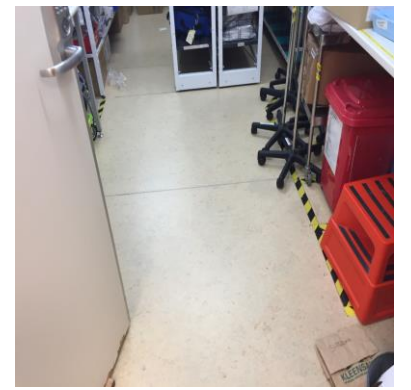
**ID: CARD NO:003**

Photograph No.	003
Location/Area	Store Room
Suspected Material Identified	Vinyl Floor
Condition of Material Identified	Good
<b>Categories: (Assessment type).</b> 1: ACM common characteristics or 2: Presumed ACM or 3: Sample collected for analysis	Presumed ACM
Sample No.	N/A
Laboratory Analysis Findings	N/A
Quantity of Material Identified	15m <sup>2</sup>

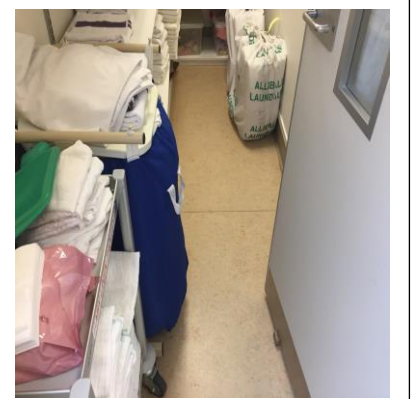
**ID: CARD NO:004**

Photograph No.	004
Location/Area	Linen Room
Suspected Material Identified	Vinyl Floor
Condition of Material Identified	Good
<b>Categories: (Assessment type).</b> 1: ACM common characteristics or 2: Presumed ACM or 3: Sample collected for analysis	Presumed ACM
Sample No.	N/A
Laboratory Analysis Findings	N/A
Quantity of Material Identified	3m <sup>2</sup>

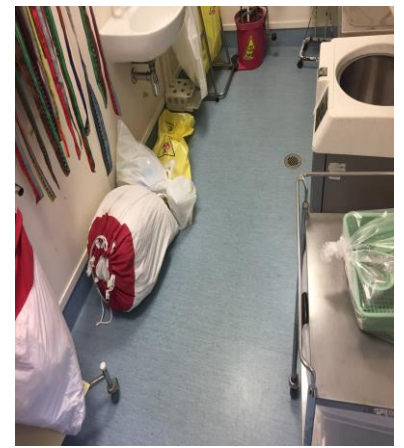
**ID: CARD NO:005**

Photograph No.	005
Location/Area	Utility Room
Suspected Material Identified	Vinyl Floor
Condition of Material Identified	Good
<b>Categories: (Assessment type).</b> 1: ACM common characteristics or 2: Presumed ACM or 3: Sample collected for analysis	Presumed ACM
Sample No.	N/A
Laboratory Analysis Findings	N/A
Quantity of Material Identified	10m <sup>2</sup>

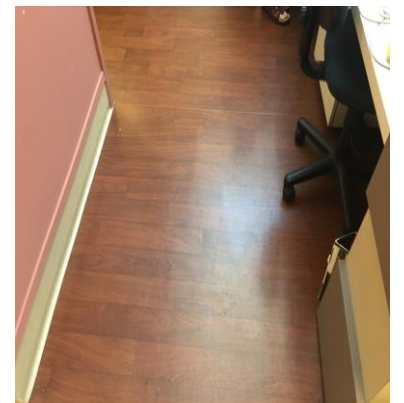
**ID: CARD NO:006**

Photograph No.	006
Location/Area	Reception/Office
Suspected Material Identified	Vinyl Floor
Condition of Material Identified	Good
<b>Categories: (Assessment type).</b> 1: ACM common characteristics or 2: Presumed ACM or 3: Sample collected for analysis	Presumed ACM
Sample No.	N/A
Laboratory Analysis Findings	N/A
Quantity of Material Identified	23m <sup>2</sup>

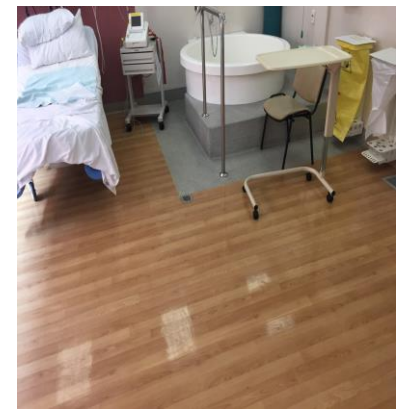
**ID: CARD NO:007**

Photograph No.	007
Location/Area	Room 1
Suspected Material Identified	Vinyl Floor/Walls
Condition of Material Identified	Good
<b>Categories: (Assessment type).</b> 1: ACM common characteristics or 2: Presumed ACM or 3: Sample collected for analysis	Presumed ACM
Sample No.	N/A
Laboratory Analysis Findings	N/A
Quantity of Material Identified	33m <sup>2</sup> /14m <sup>2</sup>

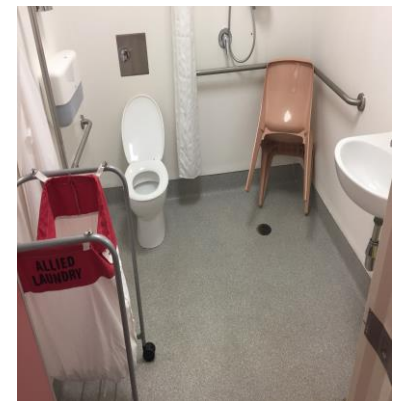
**ID: CARD NO:008**

Photograph No.	008
Location/Area	Room 1 Shower Room
Suspected Material Identified	Vinyl Floor/Walls
Condition of Material Identified	Good
<b>Categories: (Assessment type).</b> 1: ACM common characteristics or 2: Presumed ACM or 3: Sample collected for analysis	Presumed ACM
Sample No.	N/A
Laboratory Analysis Findings	N/A
Quantity of Material Identified	5.8m <sup>2</sup> /21m <sup>2</sup>

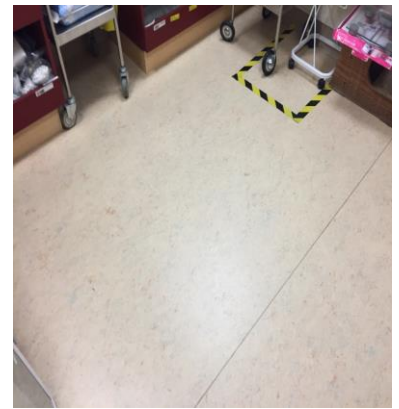
**ID: CARD NO:009**

Photograph No.	009
Location/Area	Clean Utility Room
Suspected Material Identified	Vinyl Floor
Condition of Material Identified	Good
<b>Categories: (Assessment type).</b> 1: ACM common characteristics or 2: Presumed ACM or 3: Sample collected for analysis	Presumed ACM
Sample No.	N/A
Laboratory Analysis Findings	N/A
Quantity of Material Identified	12.6m <sup>2</sup>

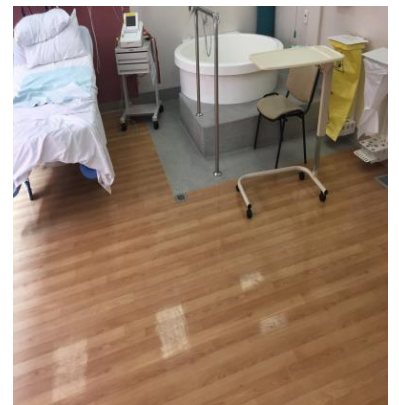
**ID: CARD NO:010**

Photograph No.	010
Location/Area	Room 2
Suspected Material Identified	Vinyl Floor/Walls
Condition of Material Identified	Good
<b>Categories: (Assessment type).</b> 1: ACM common characteristics or 2: Presumed ACM or 3: Sample collected for analysis	Presumed ACM
Sample No.	N/A
Laboratory Analysis Findings	N/A
Quantity of Material Identified	33m <sup>2</sup> /14m <sup>2</sup>

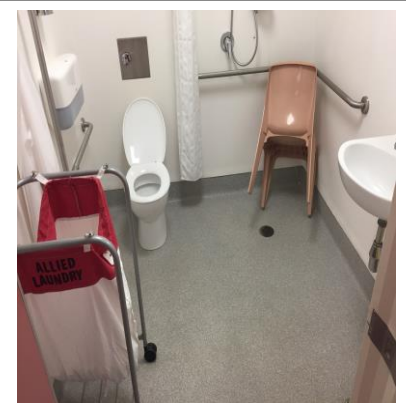
**ID: CARD NO:011**

Photograph No.	011
Location/Area	Room 2 Shower Room
Suspected Material Identified	Vinyl Floor/Walls
Condition of Material Identified	Good
<b>Categories: (Assessment type).</b> 1: ACM common characteristics or 2: Presumed ACM or 3: Sample collected for analysis	Presumed ACM
Sample No.	N/A
Laboratory Analysis Findings	N/A
Quantity of Material Identified	5.8m <sup>2</sup> /21m <sup>2</sup>

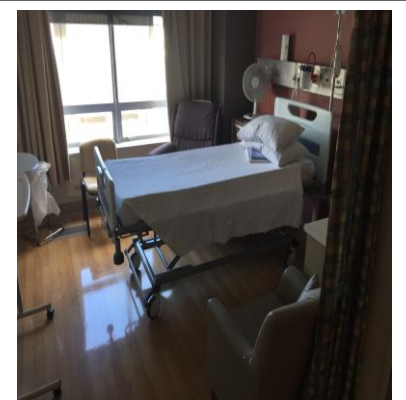
**ID: CARD NO:012**

Photograph No.	012
Location/Area	Room 10
Suspected Material Identified	Vinyl Floor/Walls
Condition of Material Identified	Good
<b>Categories: (Assessment type).</b> 1: ACM common characteristics or 2: Presumed ACM or 3: Sample collected for analysis	Presumed ACM
Sample No.	N/A
Laboratory Analysis Findings	N/A
Quantity of Material Identified	14.5m <sup>2</sup> /4m <sup>2</sup>

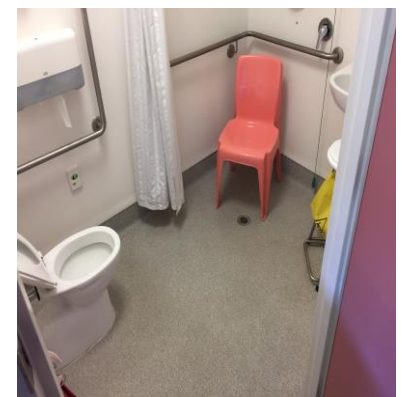
**ID: CARD NO:013**

Photograph No.	013
Location/Area	Room 10 Shower/Room
Suspected Material Identified	Vinyl Floor/Walls
Condition of Material Identified	Good
<b>Categories: (Assessment type).</b> 1: ACM common characteristics or 2: Presumed ACM or 3: Sample collected for analysis	Presumed ACM
Sample No.	N/A
Laboratory Analysis Findings	N/A
Quantity of Material Identified	5m <sup>2</sup> /19.8m <sup>2</sup>

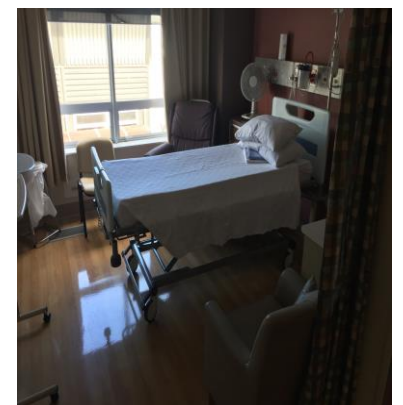
**ID: CARD NO:014**

Photograph No.	014
Location/Area	Room 9
Suspected Material Identified	Vinyl Floor/Walls
Condition of Material Identified	Good
<b>Categories: (Assessment type).</b> 1: ACM common characteristics or 2: Presumed ACM or 3: Sample collected for analysis	Presumed ACM
Sample No.	N/A
Laboratory Analysis Findings	N/A
Quantity of Material Identified	14.5m <sup>2</sup> /4m <sup>2</sup>

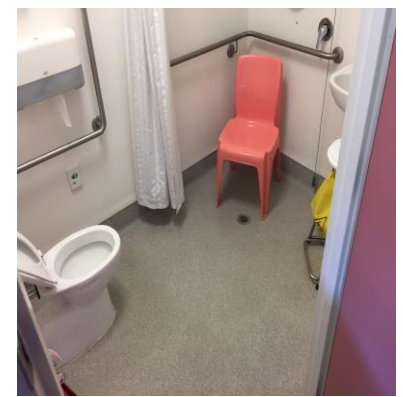
**ID: CARD NO:015**

Photograph No.	015
Location/Area	Room 9 Shower/Room
Suspected Material Identified	Vinyl Floor/Walls
Condition of Material Identified	Good
<b>Categories: (Assessment type).</b> 1: ACM common characteristics or 2: Presumed ACM or 3: Sample collected for analysis	Presumed ACM
Sample No.	N/A
Laboratory Analysis Findings	N/A
Quantity of Material Identified	5m <sup>2</sup> /19.8m <sup>2</sup>

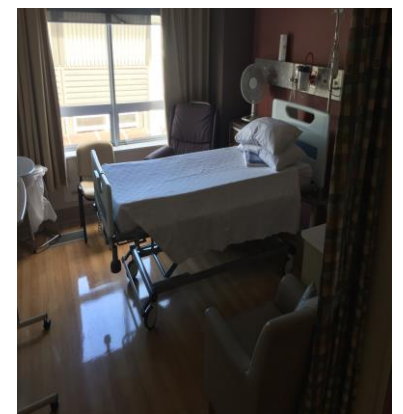
**ID: CARD NO:016**

Photograph No.	016
Location/Area	Room 8
Suspected Material Identified	Vinyl Floor/Walls
Condition of Material Identified	Good
<b>Categories: (Assessment type).</b> 1: ACM common characteristics or 2: Presumed ACM or 3: Sample collected for analysis	Presumed ACM
Sample No.	N/A
Laboratory Analysis Findings	N/A
Quantity of Material Identified	14.5m <sup>2</sup> /4m <sup>2</sup>

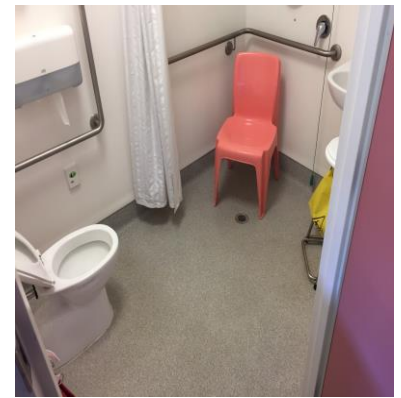
**ID: CARD NO:017**

Photograph No.	017
Location/Area	Room 8 Shower/Room
Suspected Material Identified	Vinyl Floor/Walls
Condition of Material Identified	Good
<b>Categories: (Assessment type).</b> 1: ACM common characteristics or 2: Presumed ACM or 3: Sample collected for analysis	Presumed ACM
Sample No.	N/A
Laboratory Analysis Findings	N/A
Quantity of Material Identified	5m <sup>2</sup> /19.8m <sup>2</sup>

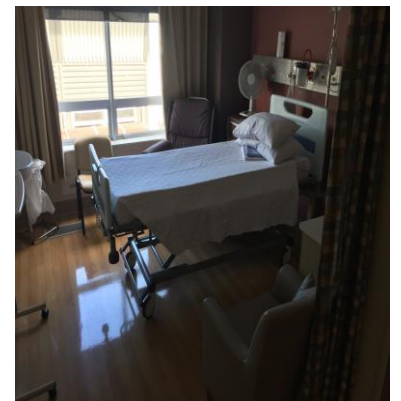
**ID: CARD NO:018**

Photograph No.	018
Location/Area	Room 7
Suspected Material Identified	Vinyl Floor/Walls
Condition of Material Identified	Good
<b>Categories: (Assessment type).</b> 1: ACM common characteristics or 2: Presumed ACM or 3: Sample collected for analysis	Presumed ACM
Sample No.	N/A
Laboratory Analysis Findings	N/A
Quantity of Material Identified	14.5m <sup>2</sup> /4m <sup>2</sup>

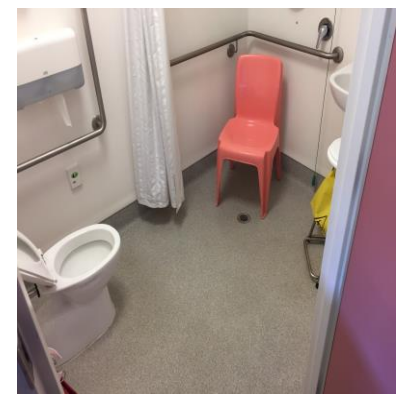
**ID: CARD NO:019**

Photograph No.	019
Location/Area	Room 7 Shower/Room
Suspected Material Identified	Vinyl Floor/Walls
Condition of Material Identified	Good
<b>Categories: (Assessment type).</b> 1: ACM common characteristics or 2: Presumed ACM or 3: Sample collected for analysis	Presumed ACM
Sample No.	N/A
Laboratory Analysis Findings	N/A
Quantity of Material Identified	5m <sup>2</sup> /19.8m <sup>2</sup>

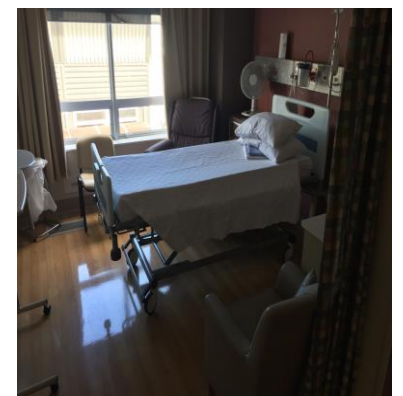
**ID: CARD NO:020**

Photograph No.	020
Location/Area	Room 6
Suspected Material Identified	Vinyl Floor/Walls
Condition of Material Identified	Good
<b>Categories: (Assessment type).</b> 1: ACM common characteristics or 2: Presumed ACM or 3: Sample collected for analysis	Presumed ACM
Sample No.	N/A
Laboratory Analysis Findings	N/A
Quantity of Material Identified	14.5m <sup>2</sup> /4m <sup>2</sup>

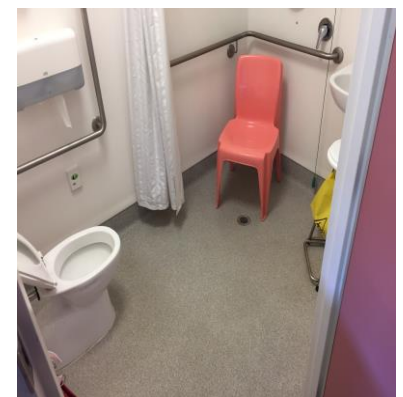
**ID: CARD NO:021**

Photograph No.	021
Location/Area	Room 6 Shower/Room
Suspected Material Identified	Vinyl Floor/Walls
Condition of Material Identified	Good
<b>Categories: (Assessment type).</b> 1: ACM common characteristics or 2: Presumed ACM or 3: Sample collected for analysis	Presumed ACM
Sample No.	N/A
Laboratory Analysis Findings	N/A
Quantity of Material Identified	5m <sup>2</sup> /19.8m <sup>2</sup>

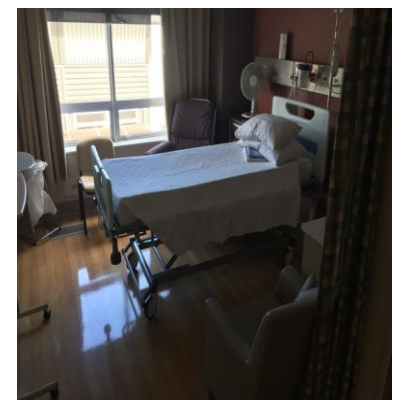
**ID: CARD NO:022**

Photograph No.	022
Location/Area	Room 5
Suspected Material Identified	Vinyl Floor/Walls
Condition of Material Identified	Good
<b>Categories: (Assessment type).</b> 1: ACM common characteristics or 2: Presumed ACM or 3: Sample collected for analysis	Presumed ACM
Sample No.	N/A
Laboratory Analysis Findings	N/A
Quantity of Material Identified	14.5m <sup>2</sup> /4m <sup>2</sup>

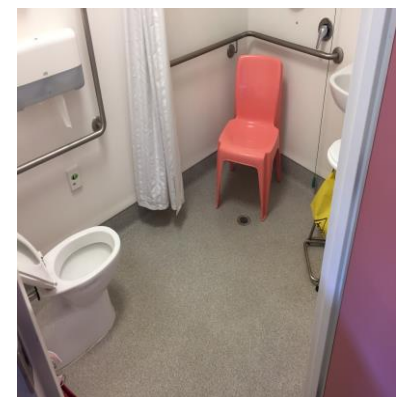
**ID: CARD NO:023**

Photograph No.	023
Location/Area	Room 5 Shower/Room
Suspected Material Identified	Vinyl Floor/Walls
Condition of Material Identified	Good
<b>Categories: (Assessment type).</b> 1: ACM common characteristics or 2: Presumed ACM or 3: Sample collected for analysis	Presumed ACM
Sample No.	N/A
Laboratory Analysis Findings	N/A
Quantity of Material Identified	5m <sup>2</sup> /19.8m <sup>2</sup>

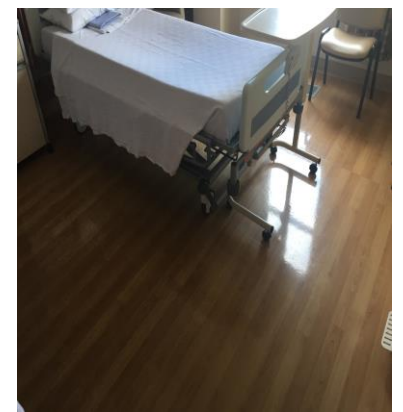
**ID: CARD NO:024**

Photograph No.	024
Location/Area	Room 4
Suspected Material Identified	Vinyl Floor/Walls
Condition of Material Identified	Good
<b>Categories: (Assessment type).</b> 1: ACM common characteristics or 2: Presumed ACM or 3: Sample collected for analysis	Presumed ACM
Sample No.	N/A
Laboratory Analysis Findings	N/A
Quantity of Material Identified	20m <sup>2</sup> /4m <sup>2</sup>

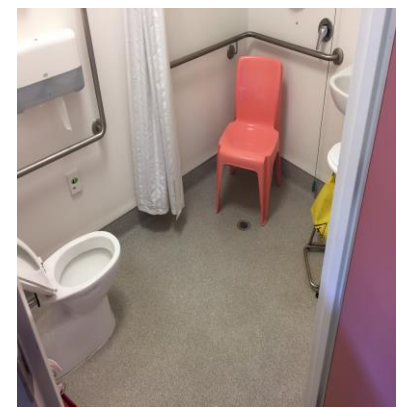
**ID: CARD NO:025**

Photograph No.	025
Location/Area	Room 4 Shower/Room
Suspected Material Identified	Vinyl Floor/Walls
Condition of Material Identified	Good
<b>Categories: (Assessment type).</b> 1: ACM common characteristics or 2: Presumed ACM or 3: Sample collected for analysis	Presumed ACM
Sample No.	N/A
Laboratory Analysis Findings	N/A
Quantity of Material Identified	5m <sup>2</sup> /19.8m <sup>2</sup>

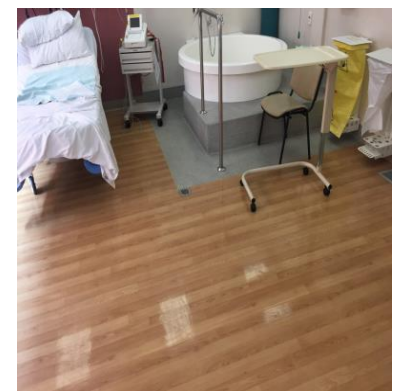
**ID: CARD NO:026**

Photograph No.	026
Location/Area	Room 3
Suspected Material Identified	Vinyl Floor/Walls
Condition of Material Identified	Good
<b>Categories: (Assessment type).</b> 1: ACM common characteristics or 2: Presumed ACM or 3: Sample collected for analysis	Presumed ACM
Sample No.	N/A
Laboratory Analysis Findings	N/A
Quantity of Material Identified	33m <sup>2</sup> /14m <sup>2</sup>

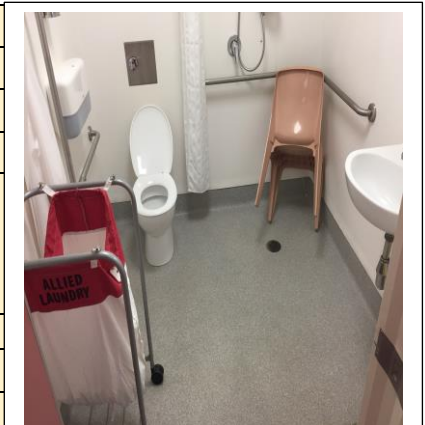
**ID: CARD NO:027**

Photograph No.	027
Location/Area	Room 3 Shower Room
Suspected Material Identified	Vinyl Floor/Walls
Condition of Material Identified	Good
<b>Categories: (Assessment type).</b> 1: ACM common characteristics or 2: Presumed ACM or 3: Sample collected for analysis	Presumed ACM
Sample No.	N/A
Laboratory Analysis Findings	N/A
Quantity of Material Identified	5.8m <sup>2</sup> /21m <sup>2</sup>

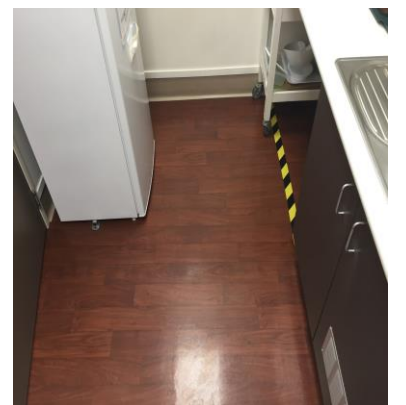
**ID: CARD NO:032**

Photograph No.	032
Location/Area	Staff Kitchen
Suspected Material Identified	Vinyl Floor
Condition of Material Identified	Good
<b>Categories: (Assessment type).</b> 1: ACM common characteristics or 2: Presumed ACM or 3: Sample collected for analysis	Presumed ACM
Sample No.	N/A
Laboratory Analysis Findings	N/A
Quantity of Material Identified	5.8m <sup>2</sup>
