## Asbestos Management Survey Report

### *WHANGANUI HOSPITAL ACCIDENT & MEDICAL ASBESTOS MANAGEMENT SURVEY*

### **WHANGANUI HOSPITAL – ACCIDENT & MEDICAL**

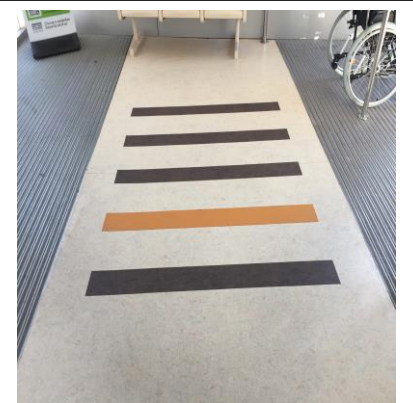
**ID: CARD NO:001**

Photograph No.	001
Location/Area	Main Entry
Suspected Material Identified	Vinyl Floor
Condition of Material Identified	Good
<b>Categories: (Assessment type).</b> 1: ACM common characteristics or 2: Presumed ACM or 3: Sample collected for analysis	Presumed ACM
Sample No.	N/A
Laboratory Analysis Findings	N/A
Quantity of Material Identified	9m <sup>2</sup>

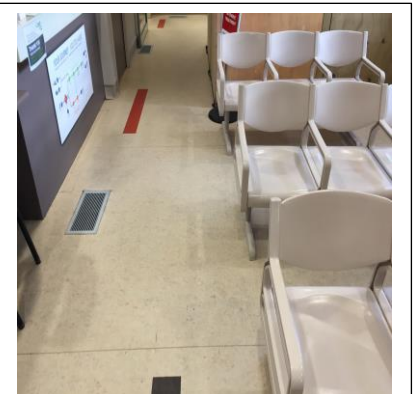
**ID: CARD NO:002**

Photograph No.	002
Location/Area	Reception Area
Suspected Material Identified	Vinyl Floor
Condition of Material Identified	Good
<b>Categories: (Assessment type).</b> 1: ACM common characteristics or 2: Presumed ACM or 3: Sample collected for analysis	Presumed ACM
Sample No.	N/A
Laboratory Analysis Findings	N/A
Quantity of Material Identified	110m <sup>2</sup>

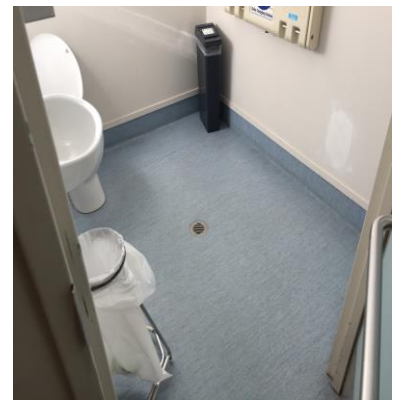
**ID: CARD NO:003**

Photograph No.	003
Location/Area	Unisex Toilet
Suspected Material Identified	Vinyl Floor
Condition of Material Identified	Good
<b>Categories: (Assessment type).</b> 1: ACM common characteristics or 2: Presumed ACM or 3: Sample collected for analysis	Presumed ACM
Sample No.	N/A
Laboratory Analysis Findings	N/A
Quantity of Material Identified	5m <sup>2</sup>

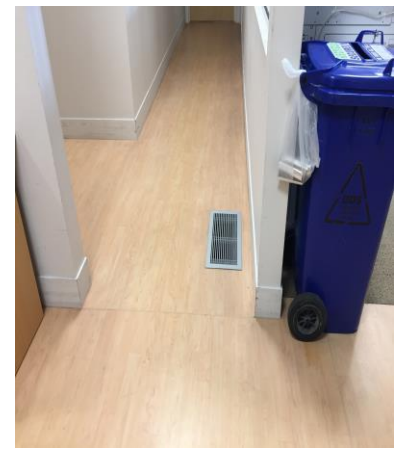
**ID: CARD NO:005**

Photograph No.	005
Location/Area	Reception Office
Suspected Material Identified	Vinyl Floor
Condition of Material Identified	Good
<b>Categories: (Assessment type).</b> 1: ACM common characteristics or 2: Presumed ACM or 3: Sample collected for analysis	Presumed ACM
Sample No.	N/A
Laboratory Analysis Findings	N/A
Quantity of Material Identified	19m <sup>2</sup>

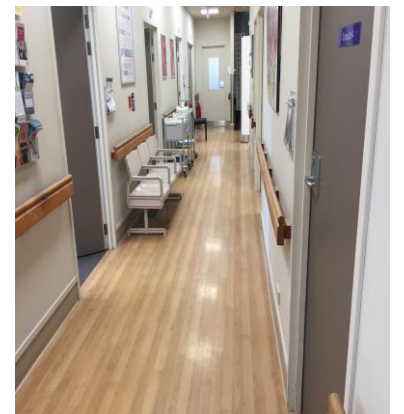
**ID: CARD NO:006**

Photograph No.	006
Location/Area	Corridor
Suspected Material Identified	Vinyl Floor
Condition of Material Identified	Good
<b>Categories: (Assessment type).</b> 1: ACM common characteristics or 2: Presumed ACM or 3: Sample collected for analysis	Presumed ACM
Sample No.	N/A
Laboratory Analysis Findings	N/A
Quantity of Material Identified	30m <sup>2</sup>

006	006	Corridor	2	30m <sup>2</sup>	Vinyl floor	Suspect ACM	1	0	0	0	0	0	0	0	0	0	0	Very low risk	Complete a Risk Assessment.
007	007	Eye Room	2	12.5m <sup>2</sup>	Vinyl floor	Suspect ACM	1	0	0	0	0	0	0	0	0	0	0	Very low risk	Complete a Risk Assessment.
008	008	Nurse Consult	2	12m <sup>2</sup>	Vinyl floor	Suspect ACM	1	0	0	0	0	0	0	0	0	0	0	Very low risk	Complete a Risk Assessment.
009	009	Consult 1	2	12m <sup>2</sup>	Vinyl floor	Suspect ACM	1	0	0	0	0	0	0	0	0	0	0	Very low risk	Complete a Risk Assessment.
010	010	Treatment Room	2	12m <sup>2</sup>	Vinyl floor	Suspect ACM	1	0	0	0	0	0	0	0	0	0	0	Very low risk	Complete a Risk Assessment.

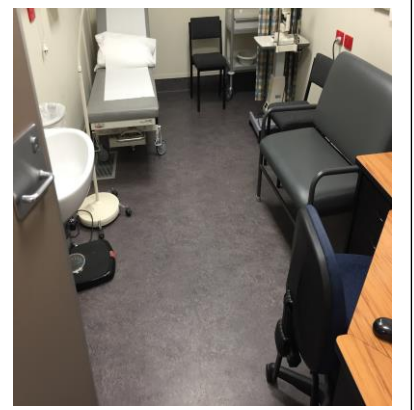
**ID: CARD NO:007**

Photograph No.	007
Location/Area	Eye Room
Suspected Material Identified	Vinyl Floor
Condition of Material Identified	Good
<b>Categories: (Assessment type).</b> 1: ACM common characteristics or 2: Presumed ACM or 3: Sample collected for analysis	Presumed ACM
Sample No.	N/A
Laboratory Analysis Findings	N/A
Quantity of Material Identified	12.5m <sup>2</sup>

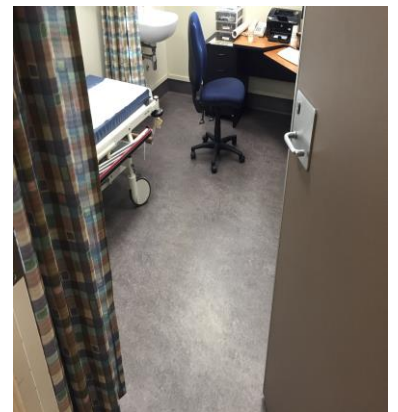
**ID: CARD NO:008**

Photograph No.	008
Location/Area	Nurse Consult
Suspected Material Identified	Vinyl Floor
Condition of Material Identified	Good
<b>Categories: (Assessment type).</b> 1: ACM common characteristics or 2: Presumed ACM or 3: Sample collected for analysis	Presumed ACM
Sample No.	N/A
Laboratory Analysis Findings	N/A
Quantity of Material Identified	12m <sup>2</sup>

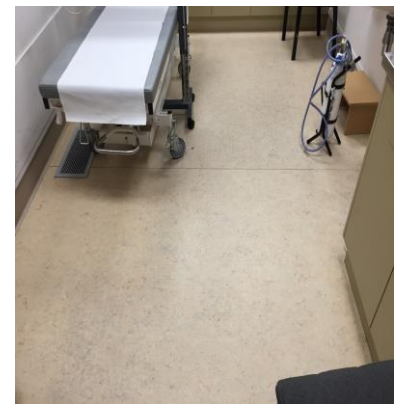
**ID: CARD NO:009**

Photograph No.	009
Location/Area	Consult 1
Suspected Material Identified	Vinyl Floor
Condition of Material Identified	Good
<b>Categories: (Assessment type).</b> 1: ACM common characteristics or 2: Presumed ACM or 3: Sample collected for analysis	Presumed ACM
Sample No.	N/A
Laboratory Analysis Findings	N/A
Quantity of Material Identified	12m <sup>2</sup>

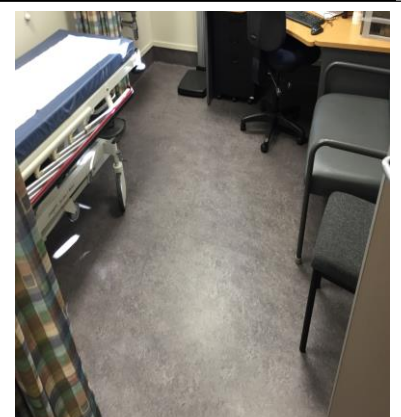
**ID: CARD NO:010**

Photograph No.	010
Location/Area	Treatment Room
Suspected Material Identified	Vinyl Floor
Condition of Material Identified	Good
<b>Categories: (Assessment type).</b> 1: ACM common characteristics or 2: Presumed ACM or 3: Sample collected for analysis	Presumed ACM
Sample No.	N/A
Laboratory Analysis Findings	N/A
Quantity of Material Identified	12m <sup>2</sup>

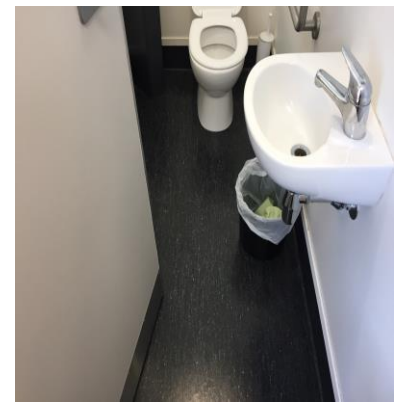
**ID: CARD NO:013**

Photograph No.	013
Location/Area	Unisex Toilet
Suspected Material Identified	Vinyl Floor
Condition of Material Identified	Good
<b>Categories: (Assessment type).</b> 1: ACM common characteristics or 2: Presumed ACM or 3: Sample collected for analysis	Presumed ACM
Sample No.	N/A
Laboratory Analysis Findings	N/A
Quantity of Material Identified	5m <sup>2</sup>

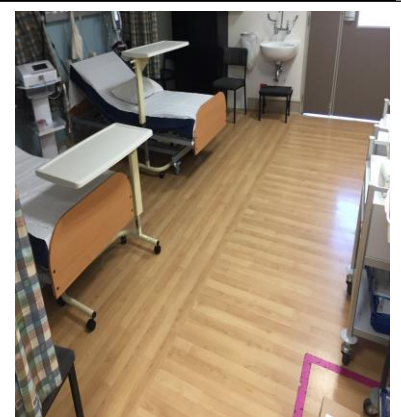
**ID: CARD NO:014**

Photograph No.	014
Location/Area	Observation Room
Suspected Material Identified	Vinyl Floor
Condition of Material Identified	Good
<b>Categories: (Assessment type).</b> 1: ACM common characteristics or 2: Presumed ACM or 3: Sample collected for analysis	Presumed ACM
Sample No.	N/A
Laboratory Analysis Findings	N/A
Quantity of Material Identified	22m <sup>2</sup>

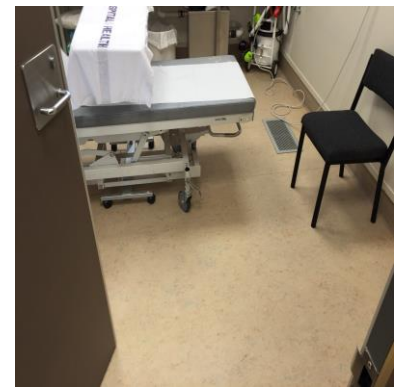
**ID: CARD NO:015**

Photograph No.	015
Location/Area	Plaster Room
Suspected Material Identified	Vinyl Floor
Condition of Material Identified	Good
<b>Categories: (Assessment type).</b> 1: ACM common characteristics or 2: Presumed ACM or 3: Sample collected for analysis	Presumed ACM
Sample No.	N/A
Laboratory Analysis Findings	N/A
Quantity of Material Identified	12m <sup>2</sup>

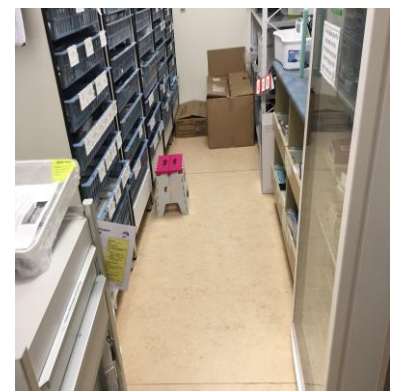
**ID: CARD NO:016**

Photograph No.	016
Location/Area	Medical Supply Room
Suspected Material Identified	Vinyl Floor
Condition of Material Identified	Good
<b>Categories: (Assessment type).</b> 1: ACM common characteristics or 2: Presumed ACM or 3: Sample collected for analysis	Presumed ACM
Sample No.	N/A
Laboratory Analysis Findings	N/A
Quantity of Material Identified	8m <sup>2</sup>

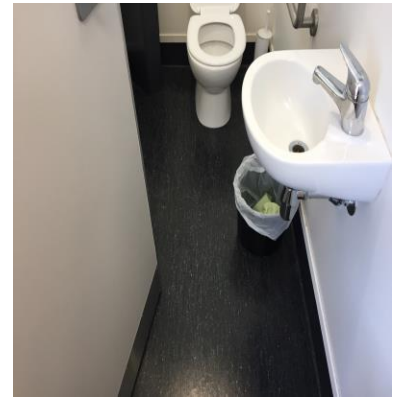
**ID: CARD NO:017**

Photograph No.	017
Location/Area	Staff Toilet
Suspected Material Identified	Vinyl Floor
Condition of Material Identified	Good
<b>Categories: (Assessment type).</b> 1: ACM common characteristics or 2: Presumed ACM or 3: Sample collected for analysis	Presumed ACM
Sample No.	N/A
Laboratory Analysis Findings	N/A
Quantity of Material Identified	2.4m <sup>2</sup>

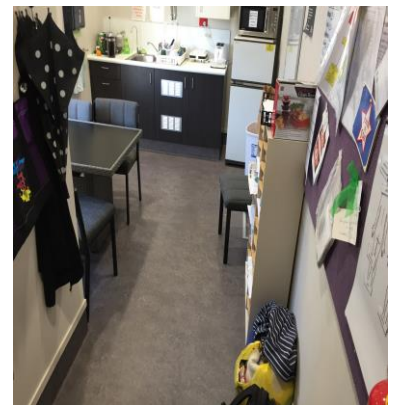
**ID: CARD NO:018**

Photograph No.	018
Location/Area	Staff Kitchen
Suspected Material Identified	Vinyl Floor
Condition of Material Identified	Good
<b>Categories: (Assessment type).</b> 1: ACM common characteristics or 2: Presumed ACM or 3: Sample collected for analysis	Presumed ACM
Sample No.	N/A
Laboratory Analysis Findings	N/A
Quantity of Material Identified	9m <sup>2</sup>

018	018	Staff Kitchen	2	9m <sup>2</sup>	Vinyl floor	Suspect ACM	1	0	0	0	0	0	0	0	0	0	0	0	Very low risk	Complete a Risk Assessment.
019	019	Laundry Store Room	2	6m <sup>2</sup>	Vinyl floor	Suspect ACM	1	0	0	0	0	0	0	0	0	0	0	0	Very low risk	Complete a Risk Assessment.
020	020	Emergency Dept Corridor	2	117.5m <sup>2</sup>	Vinyl floor	Suspect ACM	1	0	0	0	0	0	0	0	0	0	0	0	Very low risk	Complete a Risk Assessment.

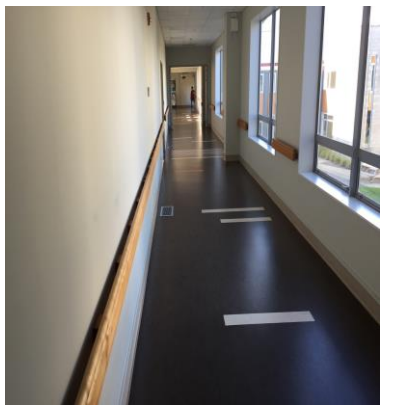
Photograph No.	020

Location/Area	Emergency Dept Corridor	
Suspected Material Identified	Vinyl Floor	
Condition of Material Identified	Good	
<b>Categories: (Assessment type).</b> 1: ACM common characteristics or 2: Presumed ACM or 3: Sample collected for analysis	Presumed ACM	
Sample No.	N/A	
Laboratory Analysis Findings	N/A	
Quantity of Material Identified	117.5m <sup>2</sup>

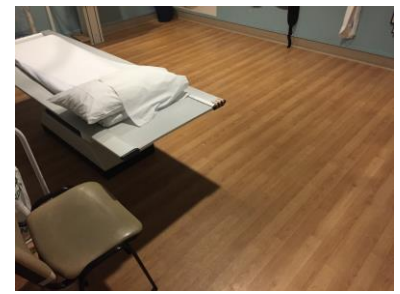
**ID: CARD NO:021**

Photograph No.	021
Location/Area	X-Ray Room
Suspected Material Identified	Vinyl Floor
Condition of Material Identified	Good
<b>Categories: (Assessment type).</b> 1: ACM common characteristics or 2: Presumed ACM or 3: Sample collected for analysis	Presumed ACM
Sample No.	N/A
Laboratory Analysis Findings	N/A
Quantity of Material Identified	28m <sup>2</sup>

021	021	X-Ray Room	2	28m <sup>2</sup>	Vinyl floor	Suspect ACM	1	0	0	0	0	0	0	0	0	0	0	0	Very low risk	Complete a Risk Assessment.
022	022	Changing Room	2	4m <sup>2</sup>	Vinyl floor	Suspect ACM	1	0	0	0	0	0	0	0	0	0	0	0	Very low risk	Complete a Risk Assessment.
023

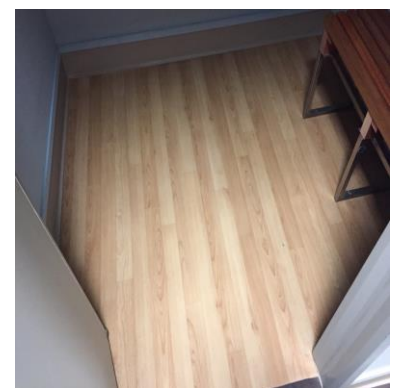
**ID: CARD NO:022**

Photograph No.	022
Location/Area	Changing Room
Suspected Material Identified	Vinyl Floor
Condition of Material Identified	Good
<b>Categories: (Assessment type).</b> 1: ACM common characteristics or 2: Presumed ACM or 3: Sample collected for analysis	Presumed ACM
Sample No.	N/A
Laboratory Analysis Findings	N/A
Quantity of Material Identified	4m <sup>2</sup>
