Asbestos Management Survey Report

***WHANGANUI HOSPITAL
A.T & REHABILITATION – 1st FLOOR
ASBESTOS MANAGEMENT SURVEY***

WHANGANUI HOSPITAL – AT & R WARD 1st FLOOR

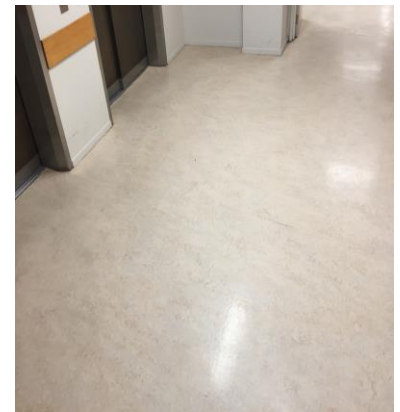
Photograph No	001
Location/Area	Elevator Lobby
Suspected Material Identified	Vinyl Floor
Condition of Material Identified	Good
Categories: (Assessment type) 1: ACM common characteristics or 2: Presumed ACM or 3: Sample collected for analysis	Presumed ACM
Sample No	N/A
Laboratory Analysis Findings	N/A
Quantity of Material Identified	16m ²

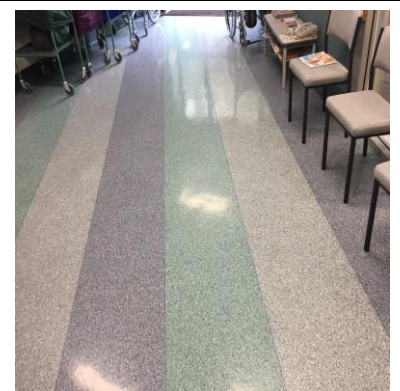
ID: CARD NO:002

Photograph No	002
Location/Area	Main Corridor Area
Suspected Material Identified	Vinyl Floor
Condition of Material Identified	Good
Categories: (Assessment type) 1: ACM common characteristics or 2: Presumed ACM or 3: Sample collected for analysis	Presumed ACM
Sample No	N/A
Laboratory Analysis Findings	N/A
Quantity of Material Identified	178m ²

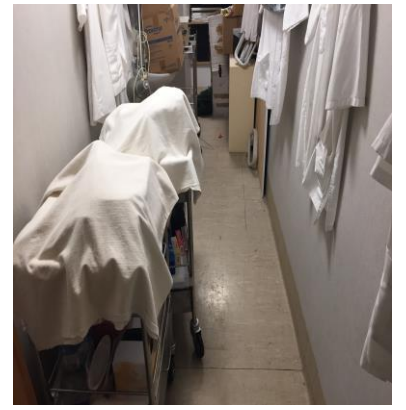
ID: CARD NO:003

Photograph No	003
Location/Area	Elevator Lobby (change room)
Suspected Material Identified	Vinyl Floor
Condition of Material Identified	Good
Categories: (Assessment type) 1: ACM common characteristics or 2: Presumed ACM or 3: Sample collected for analysis	Presumed ACM
Sample No	N/A
Laboratory Analysis Findings	N/A
Quantity of Material Identified	8.3m ²

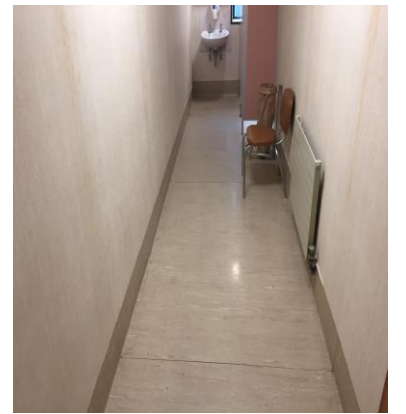
ID: CARD NO:004

Photograph No	004
Location/Area	Elevator Lobby (women toilet)
Suspected Material Identified	Vinyl Floor
Condition of Material Identified	Good
Categories: (Assessment type) 1: ACM common characteristics or 2: Presumed ACM or 3: Sample collected for analysis	Presumed ACM
Sample No	N/A
Laboratory Analysis Findings	N/A
Quantity of Material Identified	8.3m ²

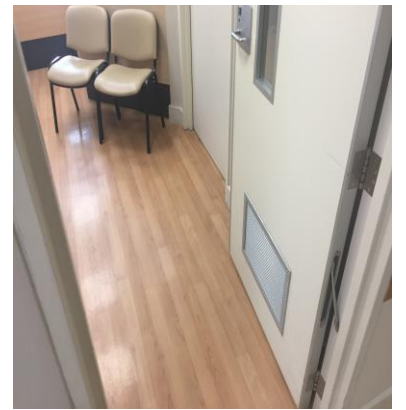
ID: CARD NO:005

Photograph No	005
Location/Area	Dental Unit (waiting/reception)
Suspected Material Identified	Vinyl Floor
Condition of Material Identified	Good
Categories: (Assessment type) 1: ACM common characteristics or 2: Presumed ACM or 3: Sample collected for analysis	Presumed ACM
Sample No	N/A
Laboratory Analysis Findings	N/A
Quantity of Material Identified	30m ²

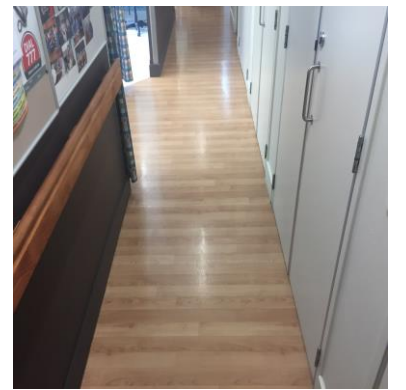
ID: CARD NO:006

Photograph No	006
Location/Area	Dental Unit Corridor
Suspected Material Identified	Vinyl Floor
Condition of Material Identified	Good
Categories: (Assessment type) 1: ACM common characteristics or 2: Presumed ACM or 3: Sample collected for analysis	Presumed ACM
Sample No	N/A
Laboratory Analysis Findings	N/A
Quantity of Material Identified	14m ²

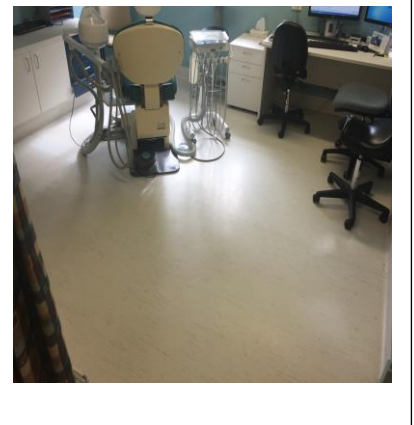
ID: CARD NO:007

Photograph No	007
Location/Area	Dental Unit (operating 1)
Suspected Material Identified	Vinyl Floor
Condition of Material Identified	Good
Categories: (Assessment type) 1: ACM common characteristics or 2: Presumed ACM or 3: Sample collected for analysis	Presumed ACM
Sample No	N/A
Laboratory Analysis Findings	N/A
Quantity of Material Identified	16m ²

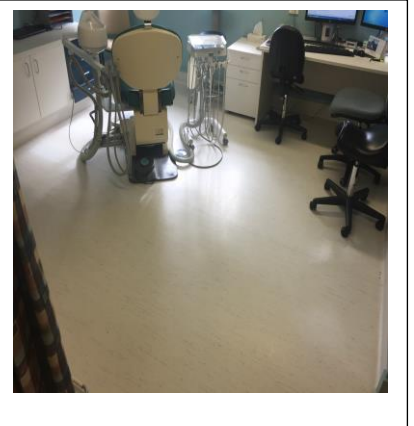
ID: CARD NO:008

Photograph No	008
Location/Area	Dental Unit (operating 2)
Suspected Material Identified	Vinyl Floor
Condition of Material Identified	Good
Categories: (Assessment type) 1: ACM common characteristics or 2: Presumed ACM or 3: Sample collected for analysis	Presumed ACM
Sample No	N/A
Laboratory Analysis Findings	N/A
Quantity of Material Identified	16m ²

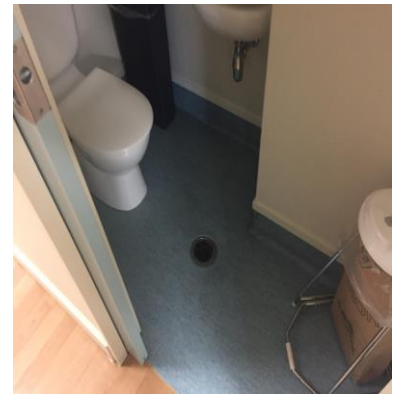
ID: CARD NO:009

Photograph No	009
Location/Area	Dental Unit (toilet)
Suspected Material Identified	Vinyl Floor
Condition of Material Identified	Good
Categories: (Assessment type) 1: ACM common characteristics or 2: Presumed ACM or 3: Sample collected for analysis	Presumed ACM
Sample No	N/A
Laboratory Analysis Findings	N/A
Quantity of Material Identified	2m ²

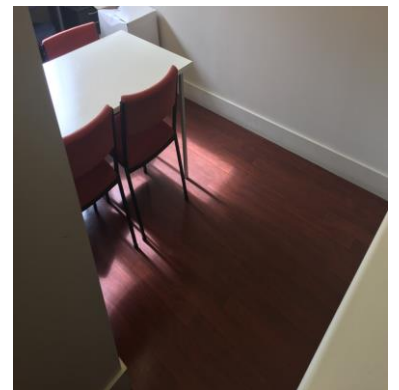
Photograph No	010
Location/Area	Dental Unit (kitchen)
Suspected Material Identified	Vinyl Floor
Condition of Material Identified	Good
Categories: (Assessment type) 1: ACM common characteristics or 2: Presumed ACM or 3: Sample collected for analysis	Presumed ACM
Sample No	N/A
Laboratory Analysis Findings	N/A
Quantity of Material Identified	11m ²

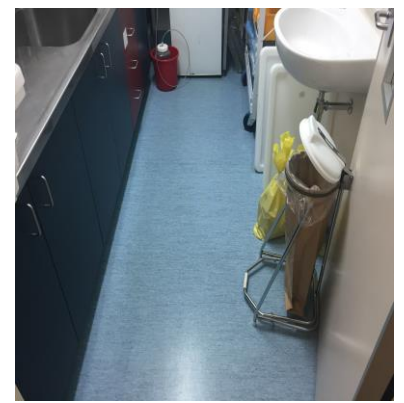
Photograph No	011
Location/Area	Dental Unit (store rm)
Suspected Material Identified	Vinyl Floor
Condition of Material Identified	Good
Categories: (Assessment type) 1: ACM common characteristics or 2: Presumed ACM or 3: Sample collected for analysis	Presumed ACM
Sample No	N/A
Laboratory Analysis Findings	N/A
Quantity of Material Identified	6m ²

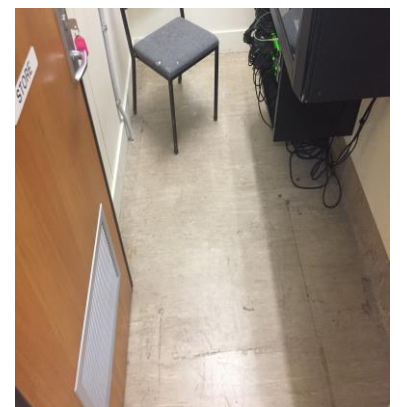
Photograph No	012
Location/Area	Main Corridor (store room)
Suspected Material Identified	Vinyl Floor
Condition of Material Identified	Good
Categories: (Assessment type) 1: ACM common characteristics or 2: Presumed ACM or 3: Sample collected for analysis	Presumed ACM
Sample No	N/A
Laboratory Analysis Findings	N/A
Quantity of Material Identified	2.8m ²

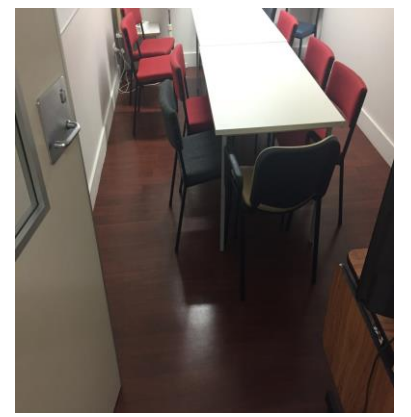
Photograph No	013
Location/Area	Main Corridor (meeting room)
Suspected Material Identified	Vinyl Floor
Condition of Material Identified	Good
Categories: (Assessment type) 1: ACM common characteristics or 2: Presumed ACM or 3: Sample collected for analysis	Presumed ACM
Sample No	N/A
Laboratory Analysis Findings	N/A
Quantity of Material Identified	12m ²

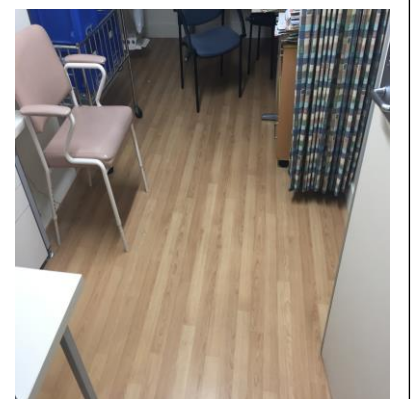
Photograph No	014
Location/Area	Medical Staff
Suspected Material Identified	Vinyl Floor
Condition of Material Identified	Good
Categories: (Assessment type) 1: ACM common characteristics or 2: Presumed ACM or 3: Sample collected for analysis	Presumed ACM
Sample No	N/A
Laboratory Analysis Findings	N/A
Quantity of Material Identified	11.5m ²

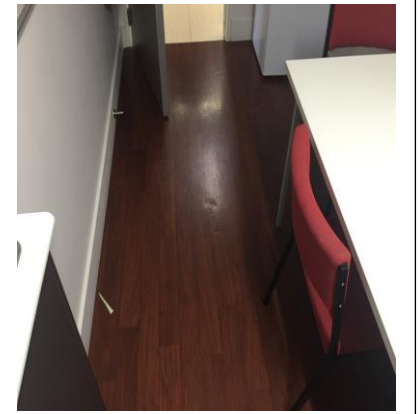
Photograph No	015
Location/Area	Staff Room
Suspected Material Identified	Vinyl Floor
Condition of Material Identified	Good
Categories: (Assessment type) 1: ACM common characteristics or 2: Presumed ACM or 3: Sample collected for analysis	Presumed ACM
Sample No	N/A
Laboratory Analysis Findings	N/A
Quantity of Material Identified	8m ²

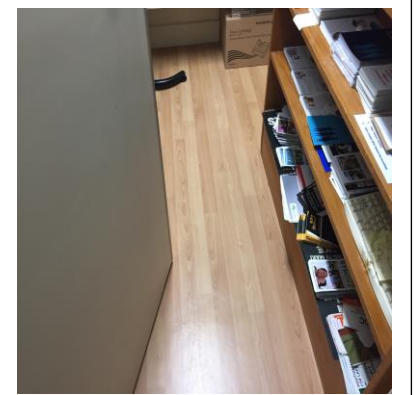
Photograph No	016
Location/Area	supplies
Suspected Material Identified	Vinyl Floor
Condition of Material Identified	Good
Categories: (Assessment type) 1: ACM common characteristics or 2: Presumed ACM or 3: Sample collected for analysis	Presumed ACM
Sample No	N/A
Laboratory Analysis Findings	N/A
Quantity of Material Identified	4m ²

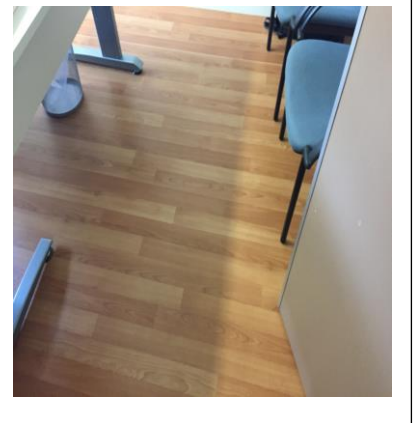
Photograph No	017
Location/Area	Clinical Nurse Manager
Suspected Material Identified	Vinyl Floor
Condition of Material Identified	Good
Categories: (Assessment type) 1: ACM common characteristics or 2: Presumed ACM or 3: Sample collected for analysis	Presumed ACM
Sample No	N/A
Laboratory Analysis Findings	N/A
Quantity of Material Identified	8.5m ²

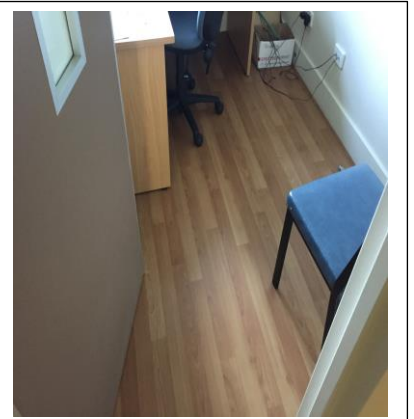
Photograph No	018
Location/Area	Therapy
Suspected Material Identified	Vinyl Floor
Condition of Material Identified	Good
Categories: (Assessment type) 1: ACM common characteristics or 2: Presumed ACM or 3: Sample collected for analysis	Presumed ACM
Sample No	N/A
Laboratory Analysis Findings	N/A
Quantity of Material Identified	6m ²

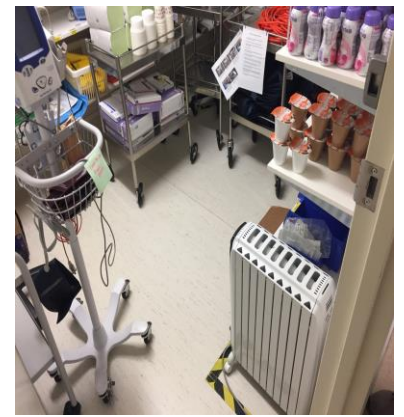
Photograph No	019
Location/Area	Equipment Store
Suspected Material Identified	Vinyl Floor
Condition of Material Identified	Good
Categories: (Assessment type) 1: ACM common characteristics or 2: Presumed ACM or 3: Sample collected for analysis	Presumed ACM
Sample No	N/A
Laboratory Analysis Findings	N/A
Quantity of Material Identified	11.2m ²

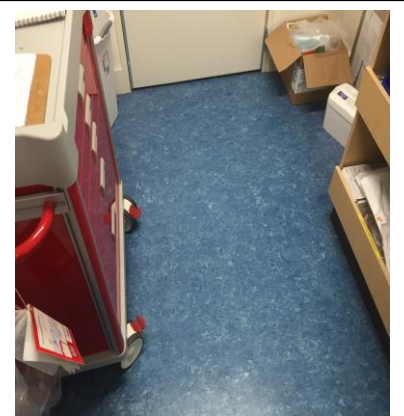
Photograph No	020
Location/Area	Clean Utility
Suspected Material Identified	Vinyl Floor
Condition of Material Identified	Good
Categories: (Assessment type) 1: ACM common characteristics or 2: Presumed ACM or 3: Sample collected for analysis	Presumed ACM
Sample No	N/A
Laboratory Analysis Findings	N/A
Quantity of Material Identified	10m ²

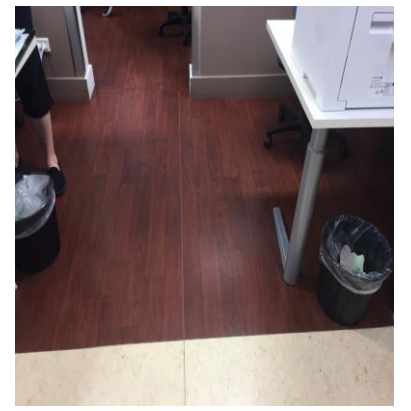
Photograph No	021
Location/Area	Reception/Office
Suspected Material Identified	Vinyl Floor
Condition of Material Identified	Good
Categories: (Assessment type) 1: ACM common characteristics or 2: Presumed ACM or 3: Sample collected for analysis	Presumed ACM
Sample No	N/A
Laboratory Analysis Findings	N/A
Quantity of Material Identified	25m ²

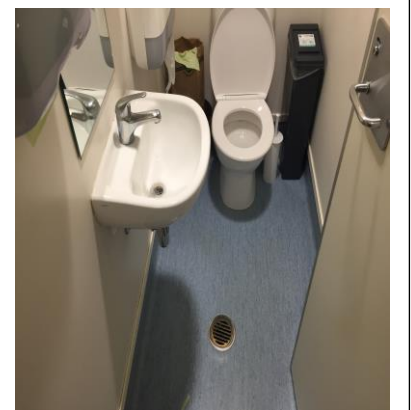
Photograph No	022
Location/Area	Staff Toilet
Suspected Material Identified	Vinyl Floor
Condition of Material Identified	Good
Categories: (Assessment type) 1: ACM common characteristics or 2: Presumed ACM or 3: Sample collected for analysis	Presumed ACM
Sample No	N/A
Laboratory Analysis Findings	N/A
Quantity of Material Identified	2m ²

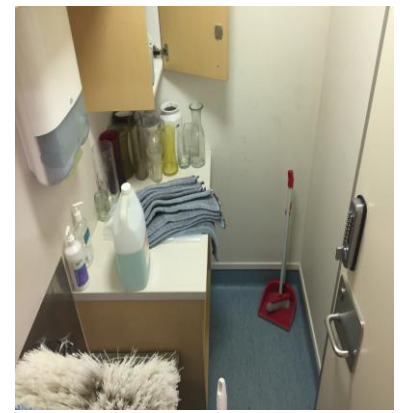
Photograph No	023
Location/Area	Flowers/Cleaners
Suspected Material Identified	Vinyl Floor
Condition of Material Identified	Good
Categories: (Assessment type)	Presumed ACM
1: ACM common characteristics or	
2: Presumed ACM or	
3: Sample collected for analysis	
Sample No	N/A
Laboratory Analysis Findings	N/A
Quantity of Material Identified	3m ²

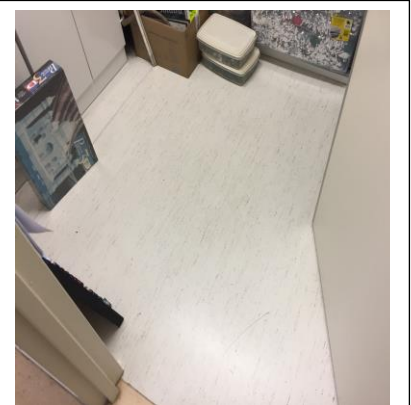
Photograph No	024
Location/Area	Therapy Storage
Suspected Material Identified	Vinyl Floor
Condition of Material Identified	Good
Categories: (Assessment type)	Presumed ACM
1: ACM common characteristics or	
2: Presumed ACM or	
3: Sample collected for analysis	
Sample No	N/A
Laboratory Analysis Findings	N/A
Quantity of Material Identified	4.5m ²

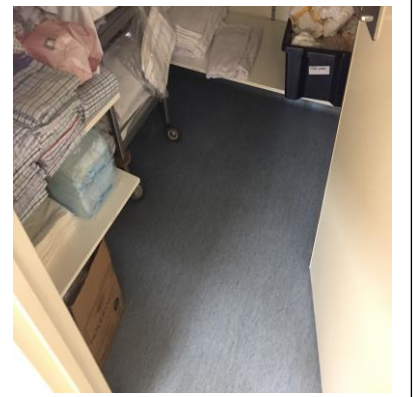
Photograph No	025
Location/Area	Linen Room
Suspected Material Identified	Vinyl Floor
Condition of Material Identified	Good
Categories: (Assessment type) 1: ACM common characteristics or 2: Presumed ACM or 3: Sample collected for analysis	Presumed ACM
Sample No	N/A
Laboratory Analysis Findings	N/A
Quantity of Material Identified	5.2m ²

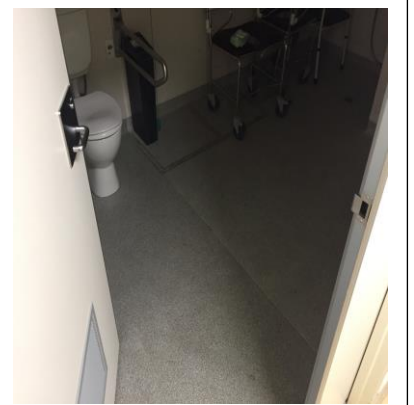
Photograph No	026
Location/Area	Unisex Toilet/Shower
Suspected Material Identified	Vinyl Floor
Condition of Material Identified	Good
Categories: (Assessment type) 1: ACM common characteristics or 2: Presumed ACM or 3: Sample collected for analysis	Presumed ACM
Sample No	N/A
Laboratory Analysis Findings	N/A
Quantity of Material Identified	9m ²

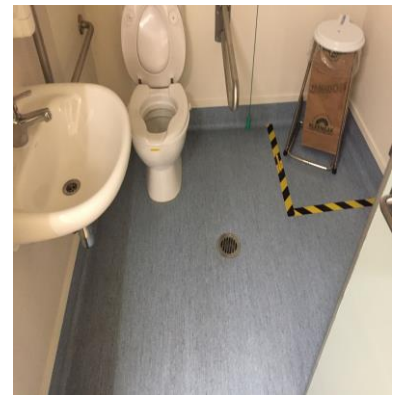
Photograph No	027
Location/Area	Unisex Toilet
Suspected Material Identified	Vinyl Floor
Condition of Material Identified	Good
Categories: (Assessment type) 1: ACM common characteristics or 2: Presumed ACM or 3: Sample collected for analysis	Presumed ACM
Sample No	N/A
Laboratory Analysis Findings	N/A
Quantity of Material Identified	4m ²

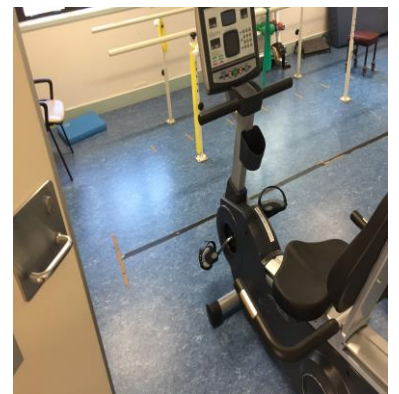
Photograph No	028
Location/Area	Gymnasium
Suspected Material Identified	Vinyl Floor
Condition of Material Identified	Good
Categories: (Assessment type) 1: ACM common characteristics or 2: Presumed ACM or 3: Sample collected for analysis	Presumed ACM
Sample No	N/A
Laboratory Analysis Findings	N/A
Quantity of Material Identified	45m ²

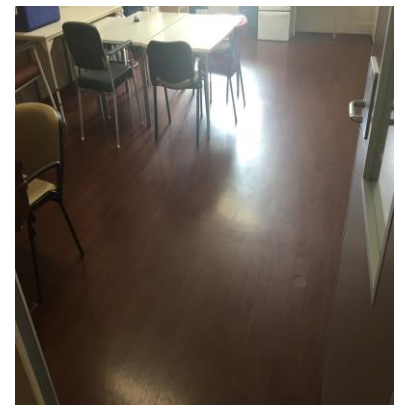
Photograph No	029
Location/Area	Dining Room
Suspected Material Identified	Vinyl Floor
Condition of Material Identified	Good
Categories: (Assessment type) 1: ACM common characteristics or 2: Presumed ACM or 3: Sample collected for analysis	Presumed ACM
Sample No	N/A
Laboratory Analysis Findings	N/A
Quantity of Material Identified	24m ²

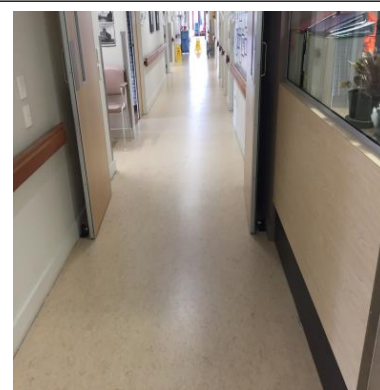
Photograph No	032
Location/Area	Room 4
Suspected Material Identified	Vinyl Floor
Condition of Material Identified	Good
Categories: (Assessment type) 1: ACM common characteristics or 2: Presumed ACM or 3: Sample collected for analysis	Presumed ACM
Sample No	N/A
Laboratory Analysis Findings	N/A
Quantity of Material Identified	45m ²

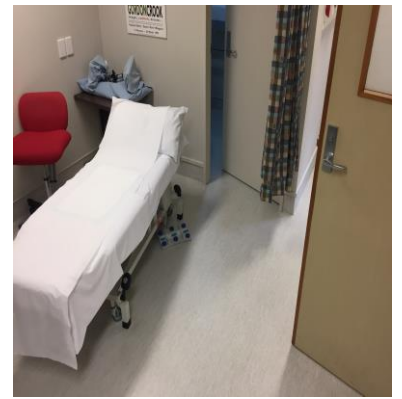
Photograph No	033
Location/Area	Room 3
Suspected Material Identified	Vinyl Floor
Condition of Material Identified	Good
Categories: (Assessment type) 1: ACM common characteristics or 2: Presumed ACM or 3: Sample collected for analysis	Presumed ACM
Sample No	N/A
Laboratory Analysis Findings	N/A
Quantity of Material Identified	23m ²

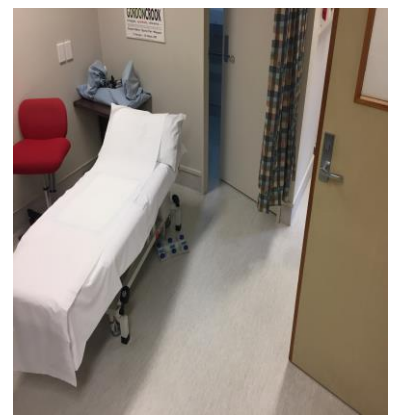
Photograph No	034
Location/Area	Room 2
Suspected Material Identified	Vinyl Floor
Condition of Material Identified	Good
Categories: (Assessment type) 1: ACM common characteristics or 2: Presumed ACM or 3: Sample collected for analysis	Presumed ACM
Sample No	N/A
Laboratory Analysis Findings	N/A
Quantity of Material Identified	23m ²

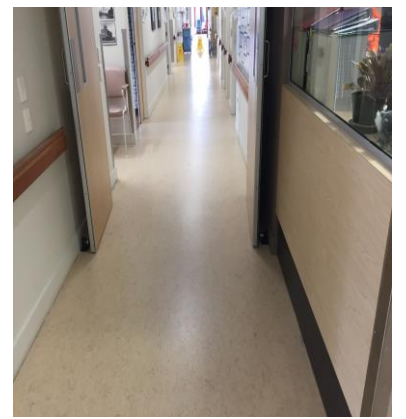
Photograph No	035
Location/Area	Room 1
Suspected Material Identified	Vinyl Floor
Condition of Material Identified	Good
Categories: (Assessment type) 1: ACM common characteristics or 2: Presumed ACM or 3: Sample collected for analysis	Presumed ACM
Sample No	N/A
Laboratory Analysis Findings	N/A
Quantity of Material Identified	45m ²

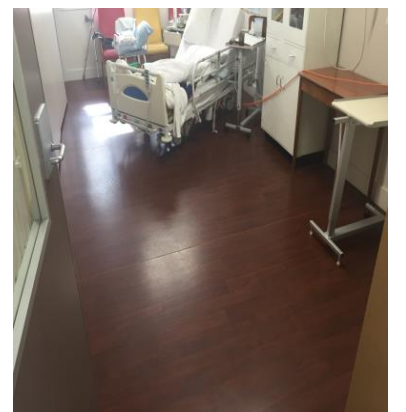
Photograph No	036
Location/Area	Room 8
Suspected Material Identified	Vinyl Floor
Condition of Material Identified	Good
Categories: (Assessment type) 1: ACM common characteristics or 2: Presumed ACM or 3: Sample collected for analysis	Presumed ACM
Sample No	N/A
Laboratory Analysis Findings	N/A
Quantity of Material Identified	15m ²

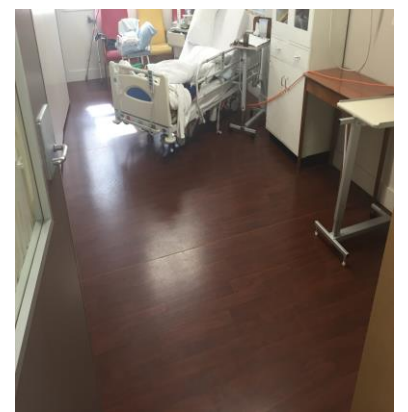
Photograph No	037
Location/Area	Room 7
Suspected Material Identified	Vinyl Floor
Condition of Material Identified	Good
Categories: (Assessment type) 1: ACM common characteristics or 2: Presumed ACM or 3: Sample collected for analysis	Presumed ACM
Sample No	N/A
Laboratory Analysis Findings	N/A
Quantity of Material Identified	15m ²

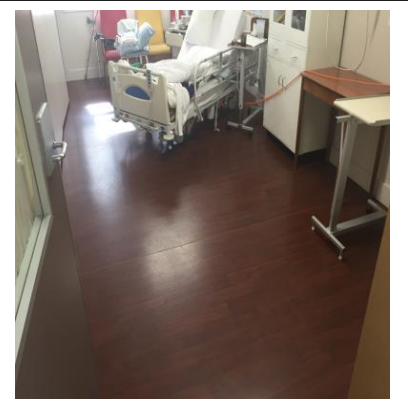
Photograph No	038
Location/Area	Room 6
Suspected Material Identified	Vinyl Floor
Condition of Material Identified	Good
Categories: (Assessment type) 1: ACM common characteristics or 2: Presumed ACM or 3: Sample collected for analysis	Presumed ACM
Sample No	N/A
Laboratory Analysis Findings	N/A
Quantity of Material Identified	15m ²

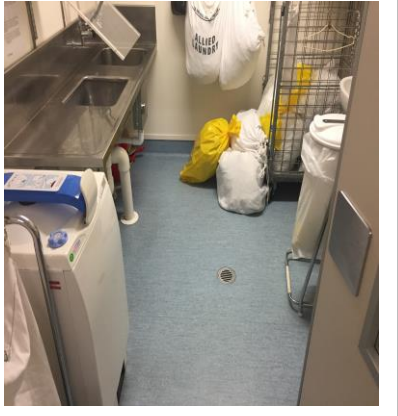
Photograph No	040

Location/Area	Dirty Utility Room	
Suspected Material Identified	Vinyl Floor	
Condition of Material Identified	Good	
Categories: (Assessment type) 1: ACM common characteristics or 2: Presumed ACM or 3: Sample collected for analysis	Presumed ACM	
Sample No	N/A	
Laboratory Analysis Findings	N/A	
Quantity of Material Identified	8m ²
