Asbestos Management Survey Report

***WHANGANUI HOSPITAL
SURGICAL WARD – 2nd FLOOR
ASBESTOS MANAGEMENT SURVEY***

WHANGANUI HOSPITAL – SURGICAL WARD 2nd FLOOR

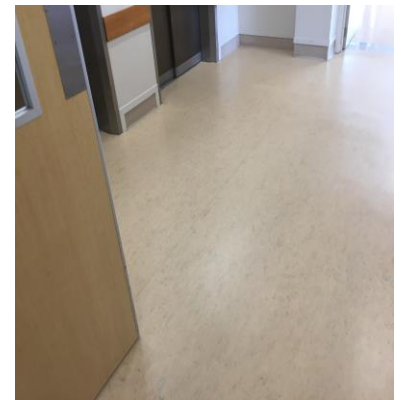
Photograph No.	001
Location/Area	Reception/Elevator Lobby
Suspected Material Identified	Vinyl Floor
Condition of Material Identified	Good
Categories: (Assessment type). 1: ACM common characteristics or 2: Presumed ACM or 3: Sample collected for analysis	Presumed ACM
Sample No.	N/A
Laboratory Analysis Findings	N/A
Quantity of Material Identified	16m ²

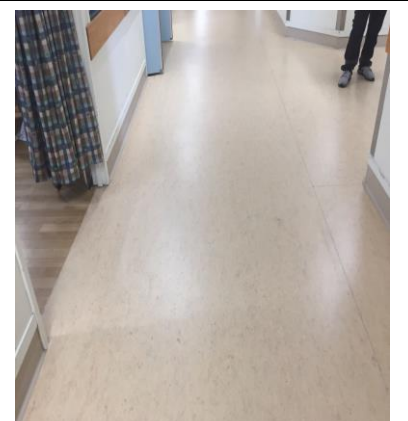
ID: CARD NO:002

Photograph No.	002
Location/Area	Main Corridor Area
Suspected Material Identified	Vinyl Floor
Condition of Material Identified	Good
Categories: (Assessment type). 1: ACM common characteristics or 2: Presumed ACM or 3: Sample collected for analysis	Presumed ACM
Sample No.	N/A
Laboratory Analysis Findings	N/A
Quantity of Material Identified	194m ²

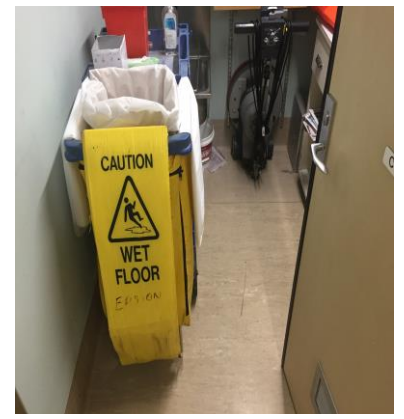
Photograph No.	003
Location/Area	Cleaners Room
Suspected Material Identified	Vinyl Floor
Condition of Material Identified	Good
Categories: (Assessment type). 1: ACM common characteristics or 2: Presumed ACM or 3: Sample collected for analysis	Presumed ACM
Sample No.	N/A
Laboratory Analysis Findings	N/A
Quantity of Material Identified	4m ²

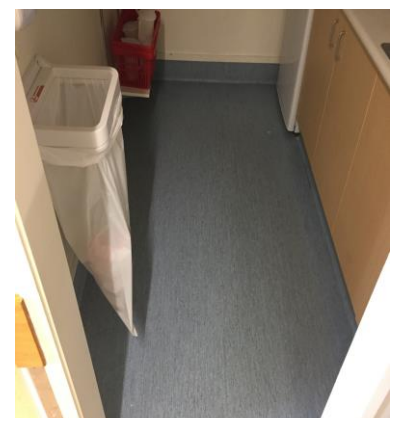
Photograph No.	004
Location/Area	Family Kitchen
Suspected Material Identified	Vinyl Floor
Condition of Material Identified	Good
Categories: (Assessment type). 1: ACM common characteristics or 2: Presumed ACM or 3: Sample collected for analysis	Presumed ACM
Sample No.	N/A
Laboratory Analysis Findings	N/A
Quantity of Material Identified	4m ²

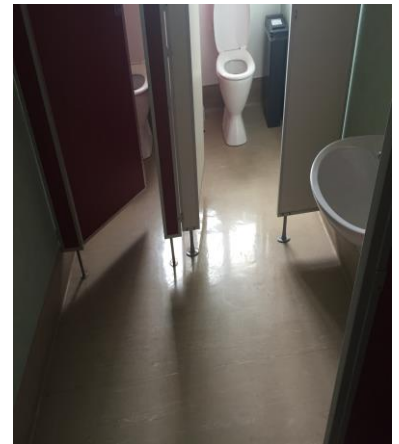
Photograph No.	005
Location/Area	Staff Toilet
Suspected Material Identified	Vinyl Floor
Condition of Material Identified	Good
Categories: (Assessment type). 1: ACM common characteristics or 2: Presumed ACM or 3: Sample collected for analysis	Presumed ACM
Sample No.	N/A
Laboratory Analysis Findings	N/A
Quantity of Material Identified	8m ²

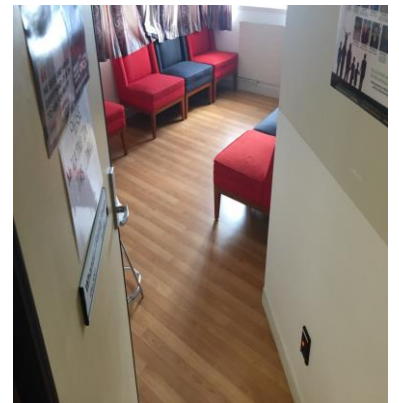
Photograph No.	006
Location/Area	Family Room
Suspected Material Identified	Vinyl Floor
Condition of Material Identified	Good
Categories: (Assessment type). 1: ACM common characteristics or 2: Presumed ACM or 3: Sample collected for analysis	Presumed ACM
Sample No.	N/A
Laboratory Analysis Findings	N/A
Quantity of Material Identified	13m ²

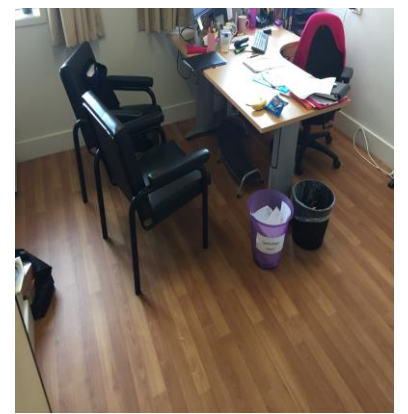
Photograph No.	007
Location/Area	Clinical Nurse Manager
Suspected Material Identified	Vinyl Floor
Condition of Material Identified	Good
Categories: (Assessment type). 1: ACM common characteristics or 2: Presumed ACM or 3: Sample collected for analysis	Presumed ACM
Sample No.	N/A
Laboratory Analysis Findings	N/A
Quantity of Material Identified	7m ²

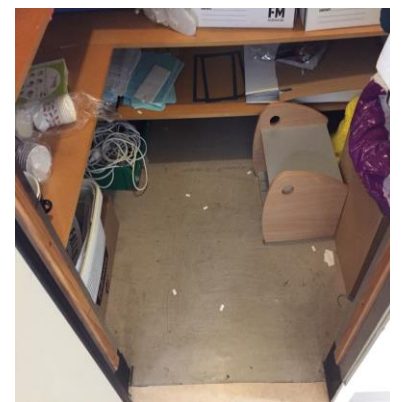
Photograph No.	008
Location/Area	Store Room N° 10
Suspected Material Identified	Vinyl Floor
Condition of Material Identified	Good
Categories: (Assessment type). 1: ACM common characteristics or 2: Presumed ACM or 3: Sample collected for analysis	Presumed ACM
Sample No.	N/A
Laboratory Analysis Findings	N/A
Quantity of Material Identified	3m ²

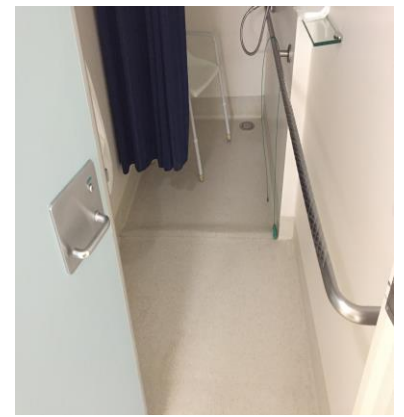
Photograph No.	009
Location/Area	Shower Room 1
Suspected Material Identified	Vinyl Floor
Condition of Material Identified	Good
Categories: (Assessment type). 1: ACM common characteristics or 2: Presumed ACM or 3: Sample collected for analysis	Presumed ACM
Sample No.	N/A
Laboratory Analysis Findings	N/A
Quantity of Material Identified	4m ²

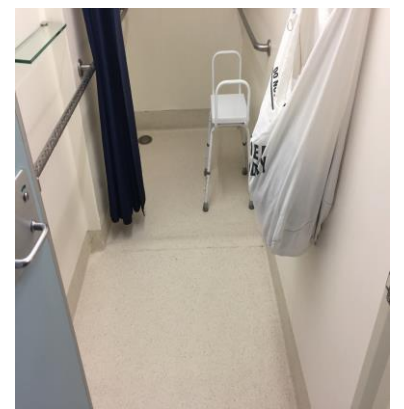
Photograph No.	010
Location/Area	Shower Room 2
Suspected Material Identified	Vinyl Floor
Condition of Material Identified	Good
Categories: (Assessment type). 1: ACM common characteristics or 2: Presumed ACM or 3: Sample collected for analysis	Presumed ACM
Sample No.	N/A
Laboratory Analysis Findings	N/A
Quantity of Material Identified	4m ²

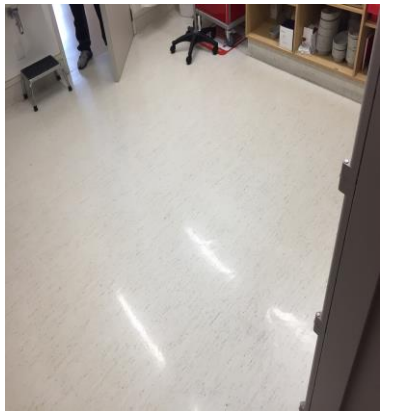
Photograph No.	012

Location/Area	Drug Room	
Suspected Material Identified	Vinyl Floor	
Condition of Material Identified	Good	
Categories: (Assessment type). 1: ACM common characteristics or 2: Presumed ACM or 3: Sample collected for analysis	Presumed ACM	
Sample No.	N/A	
Laboratory Analysis Findings	N/A	
Quantity of Material Identified	20m ²

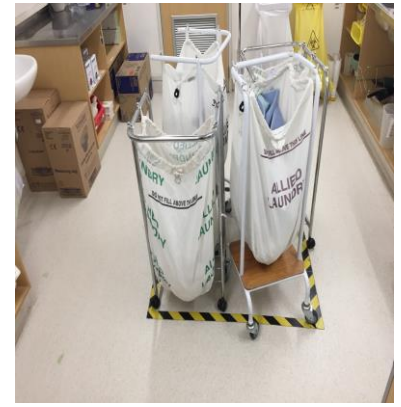
Photograph No.	013
Location/Area	Laundry Room
Suspected Material Identified	Vinyl Floor
Condition of Material Identified	Good
Categories: (Assessment type). 1: ACM common characteristics or 2: Presumed ACM or 3: Sample collected for analysis	Presumed ACM
Sample No.	N/A
Laboratory Analysis Findings	N/A
Quantity of Material Identified	18m ²

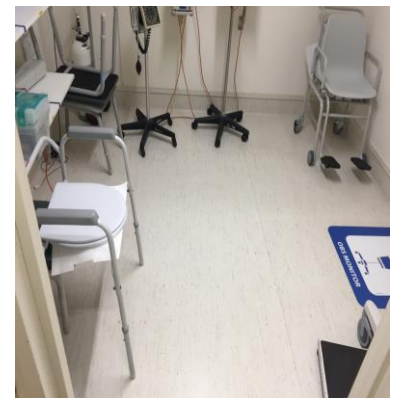
Photograph No.	014
Location/Area	Monitor Room
Suspected Material Identified	Vinyl Floor
Condition of Material Identified	Good
Categories: (Assessment type). 1: ACM common characteristics or 2: Presumed ACM or 3: Sample collected for analysis	Presumed ACM
Sample No.	N/A
Laboratory Analysis Findings	N/A
Quantity of Material Identified	9m ²

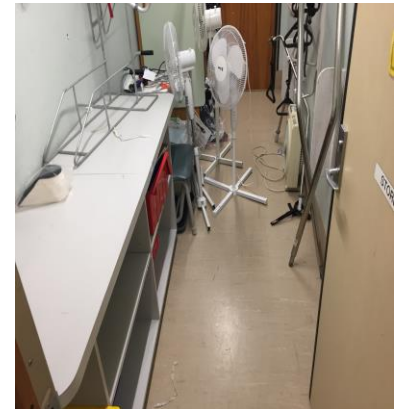
Photograph No.	015
Location/Area	Store Room N° 65
Suspected Material Identified	Vinyl Floor
Condition of Material Identified	Good
Categories: (Assessment type). 1: ACM common characteristics or 2: Presumed ACM or 3: Sample collected for analysis	Presumed ACM
Sample No.	N/A
Laboratory Analysis Findings	N/A
Quantity of Material Identified	8m ²

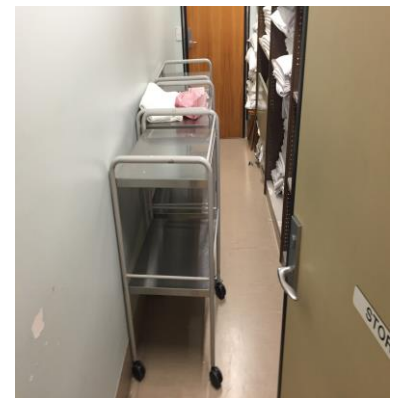
Photograph No.	016
Location/Area	Store Room N° 40
Suspected Material Identified	Vinyl Floor
Condition of Material Identified	Good
Categories: (Assessment type). 1: ACM common characteristics or 2: Presumed ACM or 3: Sample collected for analysis	Presumed ACM
Sample No.	N/A
Laboratory Analysis Findings	N/A
Quantity of Material Identified	8m ²

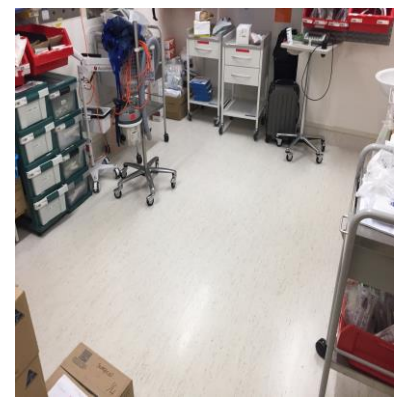
Photograph No.	017
Location/Area	Treatment Room
Suspected Material Identified	Vinyl Floor
Condition of Material Identified	Good
Categories: (Assessment type). 1: ACM common characteristics or 2: Presumed ACM or 3: Sample collected for analysis	Presumed ACM
Sample No.	N/A
Laboratory Analysis Findings	N/A
Quantity of Material Identified	12m ²

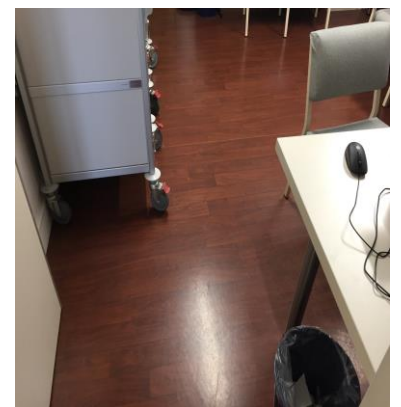
Photograph No.	018
Location/Area	Staff Station
Suspected Material Identified	Vinyl Floor
Condition of Material Identified	Good
Categories: (Assessment type). 1: ACM common characteristics or 2: Presumed ACM or 3: Sample collected for analysis	Presumed ACM
Sample No.	N/A
Laboratory Analysis Findings	N/A
Quantity of Material Identified	20m ²

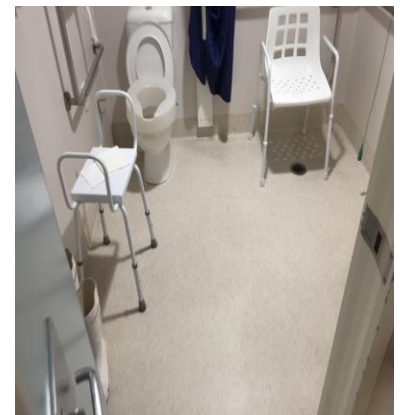
Photograph No.	019
Location/Area	Patient Toilet 1
Suspected Material Identified	Vinyl Floor/Walls
Condition of Material Identified	Good
Categories: (Assessment type). 1: ACM common characteristics or 2: Presumed ACM or 3: Sample collected for analysis	Presumed ACM
Sample No.	N/A
Laboratory Analysis Findings	N/A
Quantity of Material Identified	4.5m ² /19m ²

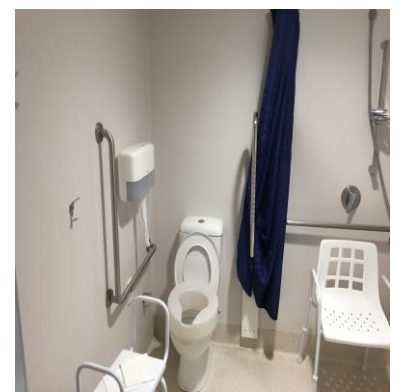
Photograph No.	020
Location/Area	Patient Toilet 2
Suspected Material Identified	Vinyl Floor/Walls
Condition of Material Identified	Good
Categories: (Assessment type). 1: ACM common characteristics or 2: Presumed ACM or 3: Sample collected for analysis	Presumed ACM
Sample No.	N/A
Laboratory Analysis Findings	N/A
Quantity of Material Identified	4.5m ² /19m ²

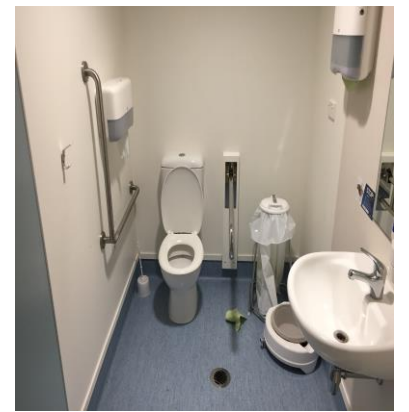
Photograph No.	021
Location/Area	Patient Toilet 3
Suspected Material Identified	Vinyl Floor
Condition of Material Identified	Good
Categories: (Assessment type). 1: ACM common characteristics or 2: Presumed ACM or 3: Sample collected for analysis	Presumed ACM
Sample No.	N/A
Laboratory Analysis Findings	N/A
Quantity of Material Identified	4.5m ²

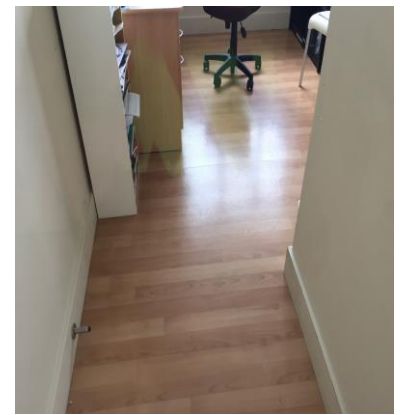
Photograph No.	023
Location/Area	Clinic Coach Room
Suspected Material Identified	Vinyl Floor
Condition of Material Identified	Good
Categories: (Assessment type). 1: ACM common characteristics or 2: Presumed ACM or 3: Sample collected for analysis	Presumed ACM
Sample No.	N/A
Laboratory Analysis Findings	N/A
Quantity of Material Identified	7m ²

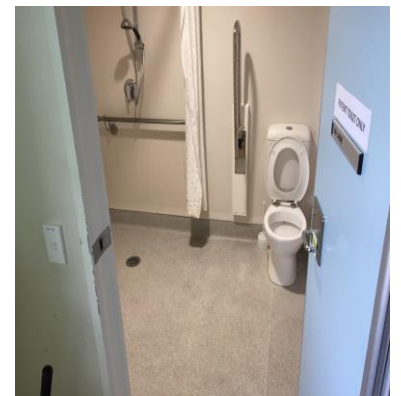
Photograph No.	024
Location/Area	Room 8 Shower/Toilet
Suspected Material Identified	Vinyl Floor/Walls
Condition of Material Identified	Good
Categories: (Assessment type). 1: ACM common characteristics or 2: Presumed ACM or 3: Sample collected for analysis	Presumed ACM
Sample No.	N/A
Laboratory Analysis Findings	N/A
Quantity of Material Identified	5m ² /15m ²

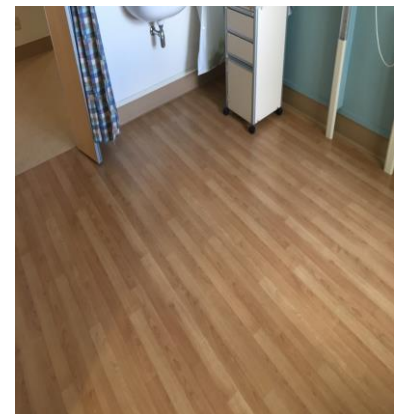
Photograph No.	025
Location/Area	Room 7
Suspected Material Identified	Vinyl Floor
Condition of Material Identified	Good
Categories: (Assessment type). 1: ACM common characteristics or 2: Presumed ACM or 3: Sample collected for analysis	Presumed ACM
Sample No.	N/A
Laboratory Analysis Findings	N/A
Quantity of Material Identified	45m ²

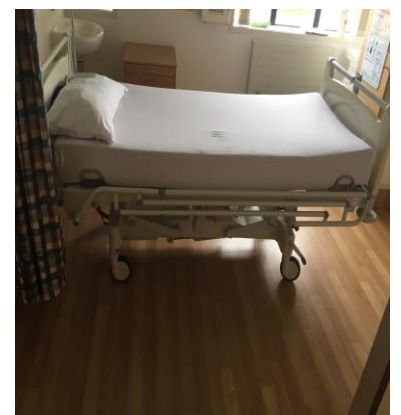
Photograph No.	026
Location/Area	Room 6
Suspected Material Identified	Vinyl Floor
Condition of Material Identified	Good
Categories: (Assessment type). 1: ACM common characteristics or 2: Presumed ACM or 3: Sample collected for analysis	Presumed ACM
Sample No.	N/A
Laboratory Analysis Findings	N/A
Quantity of Material Identified	23m ²

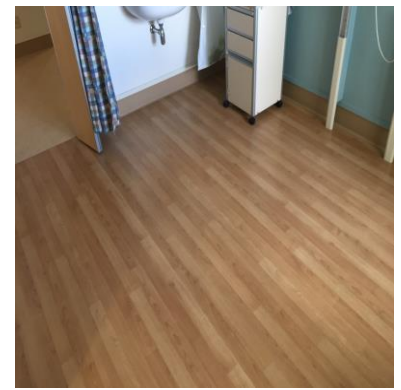
Photograph No.	027
Location/Area	Room 5
Suspected Material Identified	Vinyl Floor
Condition of Material Identified	Good
Categories: (Assessment type). 1: ACM common characteristics or 2: Presumed ACM or 3: Sample collected for analysis	Presumed ACM
Sample No.	N/A
Laboratory Analysis Findings	N/A
Quantity of Material Identified	45m ²

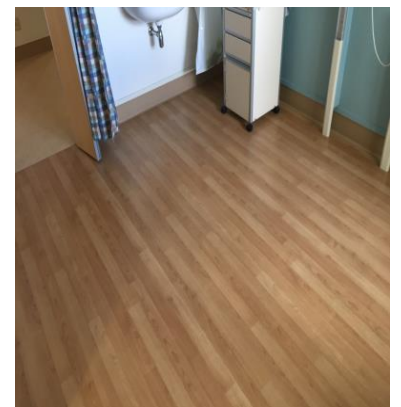
Photograph No.	028
Location/Area	Room 4
Suspected Material Identified	Vinyl Floor
Condition of Material Identified	Good
Categories: (Assessment type). 1: ACM common characteristics or 2: Presumed ACM or 3: Sample collected for analysis	Presumed ACM
Sample No.	N/A
Laboratory Analysis Findings	N/A
Quantity of Material Identified	45m ²

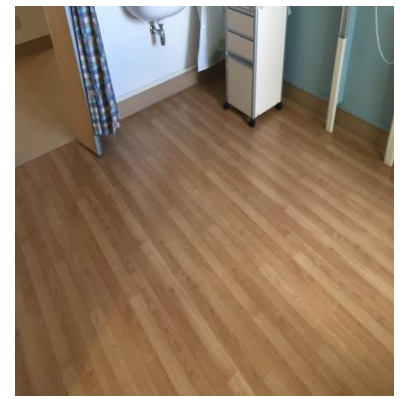
Photograph No.	029
Location/Area	Room 3
Suspected Material Identified	Vinyl Floor
Condition of Material Identified	Good
Categories: (Assessment type). 1: ACM common characteristics or 2: Presumed ACM or 3: Sample collected for analysis	Presumed ACM
Sample No.	N/A
Laboratory Analysis Findings	N/A
Quantity of Material Identified	45m ²

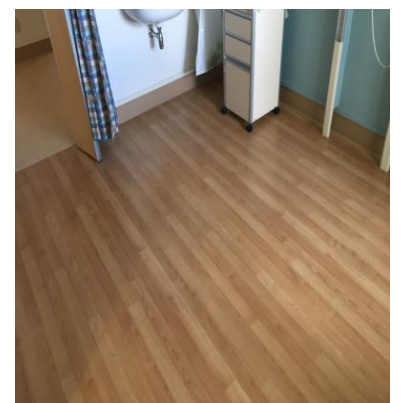
Photograph No.	030
Location/Area	Room 2
Suspected Material Identified	Vinyl Floor
Condition of Material Identified	Good
Categories: (Assessment type). 1: ACM common characteristics or 2: Presumed ACM or 3: Sample collected for analysis	Presumed ACM
Sample No.	N/A
Laboratory Analysis Findings	N/A
Quantity of Material Identified	45m ²

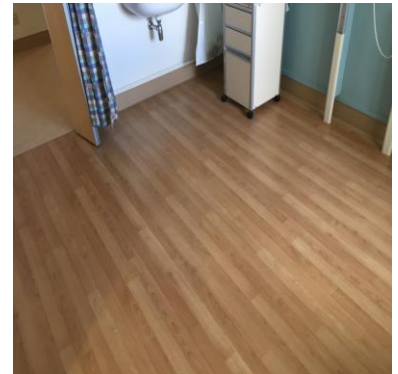
Photograph No.	031
Location/Area	Room 1
Suspected Material Identified	Vinyl Floor
Condition of Material Identified	Good
Categories: (Assessment type). 1: ACM common characteristics or 2: Presumed ACM or 3: Sample collected for analysis	Presumed ACM
Sample No.	N/A
Laboratory Analysis Findings	N/A
Quantity of Material Identified	45m ²

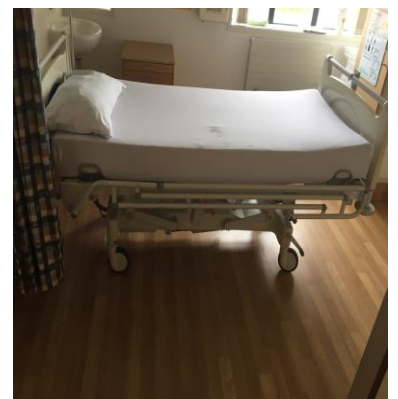
Photograph No.	032
Location/Area	Room 16
Suspected Material Identified	Vinyl Floor
Condition of Material Identified	Good
Categories: (Assessment type). 1: ACM common characteristics or 2: Presumed ACM or 3: Sample collected for analysis	Presumed ACM
Sample No.	N/A
Laboratory Analysis Findings	N/A
Quantity of Material Identified	11.5m ²

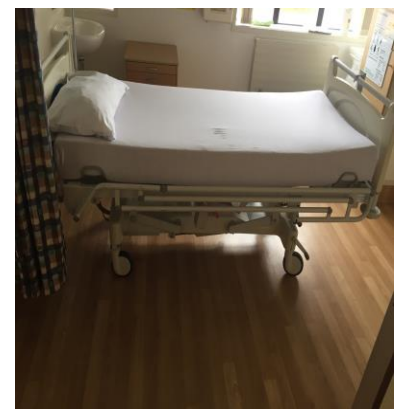
Photograph No.	033
Location/Area	Room 15
Suspected Material Identified	Vinyl Floor
Condition of Material Identified	Good
Categories: (Assessment type). 1: ACM common characteristics or 2: Presumed ACM or 3: Sample collected for analysis	Presumed ACM
Sample No.	N/A
Laboratory Analysis Findings	N/A
Quantity of Material Identified	11.5m ²

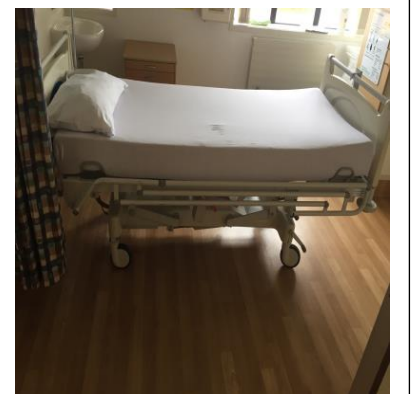
Photograph No.	034
Location/Area	Room 14
Suspected Material Identified	Vinyl Floor
Condition of Material Identified	Good
Categories: (Assessment type). 1: ACM common characteristics or 2: Presumed ACM or 3: Sample collected for analysis	Presumed ACM
Sample No.	N/A
Laboratory Analysis Findings	N/A
Quantity of Material Identified	11.5m ²

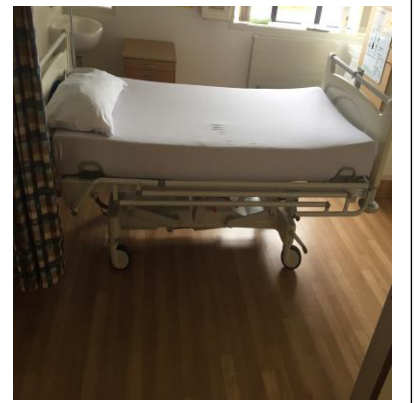
Photograph No.	035
Location/Area	Room 12
Suspected Material Identified	Vinyl Floor
Condition of Material Identified	Good
Categories: (Assessment type). 1: ACM common characteristics or 2: Presumed ACM or 3: Sample collected for analysis	Presumed ACM
Sample No.	N/A
Laboratory Analysis Findings	N/A
Quantity of Material Identified	11.5m ²

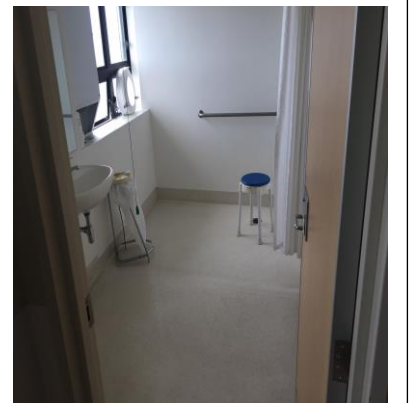
Photograph No.	036
Location/Area	Patient Toilet
Suspected Material Identified	Vinyl Floor/Walls
Condition of Material Identified	Good
Categories: (Assessment type). 1: ACM common characteristics or 2: Presumed ACM or 3: Sample collected for analysis	Presumed ACM
Sample No.	N/A
Laboratory Analysis Findings	N/A
Quantity of Material Identified	5m ² /15.5m ²

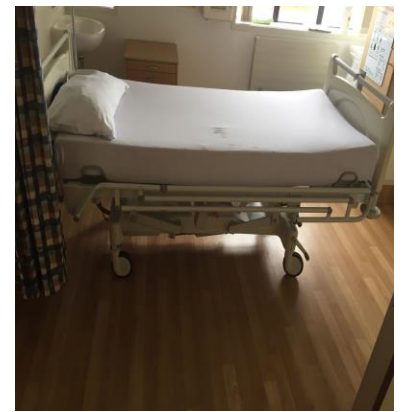
Photograph No.	037
Location/Area	Room 11
Suspected Material Identified	Vinyl Floor/Walls
Condition of Material Identified	Good
Categories: (Assessment type). 1: ACM common characteristics or 2: Presumed ACM or 3: Sample collected for analysis	Presumed ACM
Sample No.	N/A
Laboratory Analysis Findings	N/A
Quantity of Material Identified	15m ² /19m ²

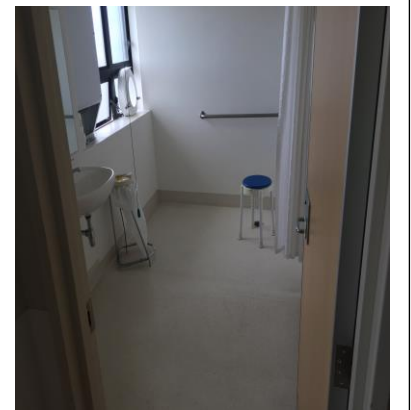
Photograph No.	038
Location/Area	Room 11 Bathroom
Suspected Material Identified	Vinyl Floor/Walls
Condition of Material Identified	Good
Categories: (Assessment type). 1: ACM common characteristics or 2: Presumed ACM or 3: Sample collected for analysis	Presumed ACM
Sample No.	N/A
Laboratory Analysis Findings	N/A
Quantity of Material Identified	6.5m ² /15m ²

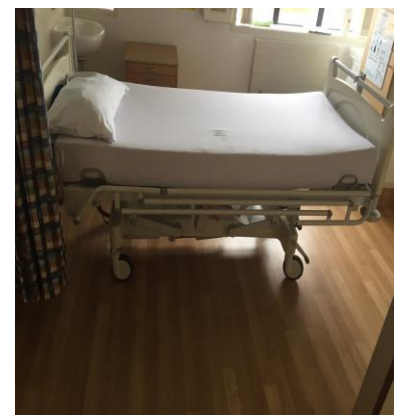
Photograph No.	039
Location/Area	Room 10
Suspected Material Identified	Vinyl Floor/Walls
Condition of Material Identified	Good
Categories: (Assessment type). 1: ACM common characteristics or 2: Presumed ACM or 3: Sample collected for analysis	Presumed ACM
Sample No.	N/A
Laboratory Analysis Findings	N/A
Quantity of Material Identified	15m ² /19m ²

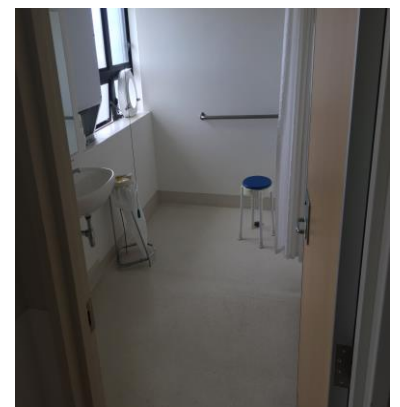
Photograph No.	040
Location/Area	Room 10 Bathroom
Suspected Material Identified	Vinyl Floor/Walls
Condition of Material Identified	Good
Categories: (Assessment type). 1: ACM common characteristics or 2: Presumed ACM or 3: Sample collected for analysis	Presumed ACM
Sample No.	N/A
Laboratory Analysis Findings	N/A
Quantity of Material Identified	6.5m ² /15m ²
