## FIRE INVESTIGATION REPORT

Catherine Place, Henderson, Auckland

Incident Information: F3237517 Suspicious Fire 8:17 p.m. 6 May 2021

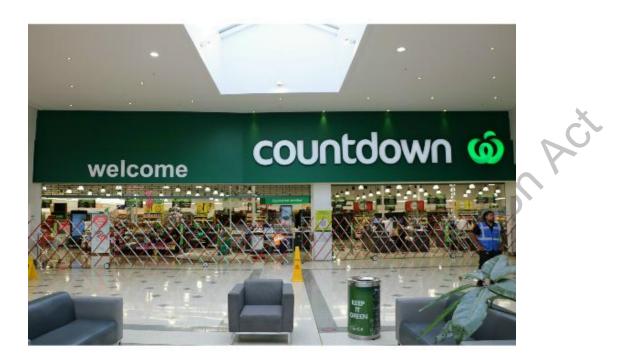
Photo 1: The main entrance to the Countdown Henderson Supermarket.

A scene examination commenced at the main entrance to Countdown Henderson Supermarket in West City mall. There were nil signs of smoke, heat or structural damage to the entrance.

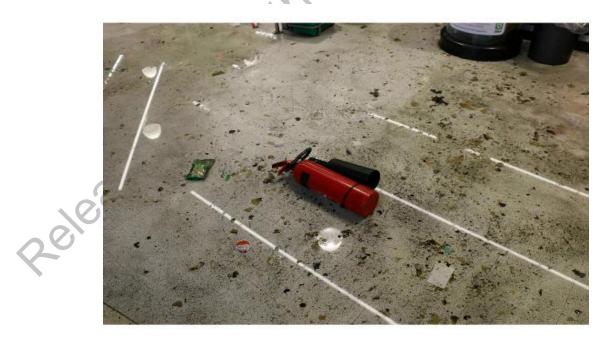
Photo 2: One of the fire extinguishers found inside the entrance to Countdown Henderson Supermarket.

Inside the entrance to Countdown Henderson Supermarket several fire extinguishers were discovered out of their housings indicating that they may have been used in an attempt to control the fire.

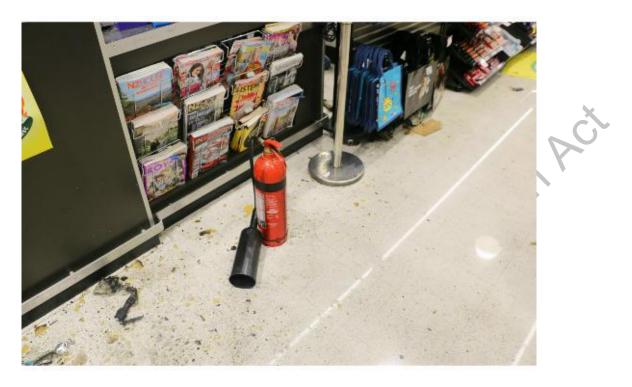
Photo 3: A second fire extinguisher that was found inside the entrance to Countdown Henderson Supermarket.

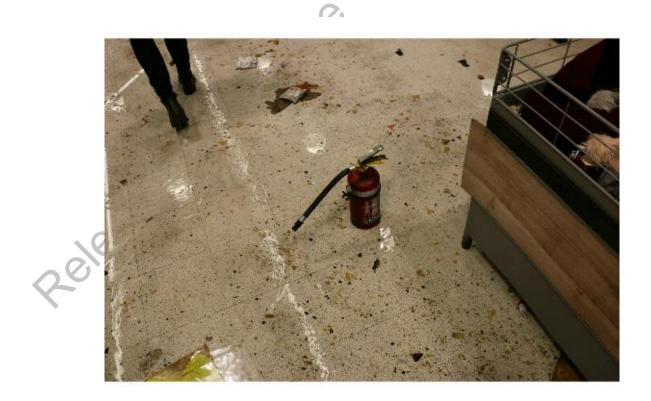
#### Photo 4: A third fire extinguisher that was found inside the entrance to Countdown Henderson Supermarket.

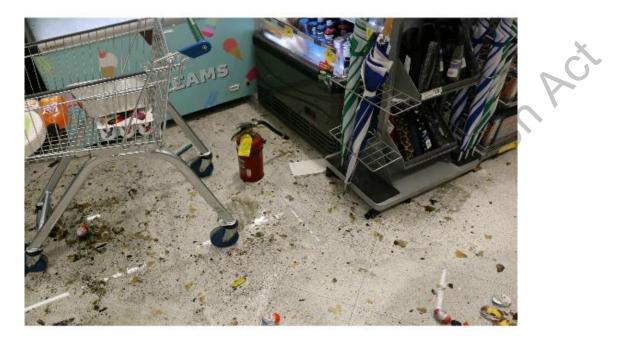
Photo 5: A fourth fire extinguisher that was found inside the entrance to Countdown Henderson Supermarket.

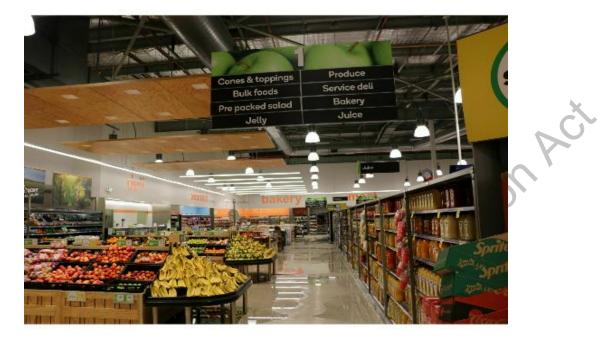
Photo 6: Aisle number 1 looking towards the fruit, vegetable, deli and bakery departments.

Aisles 5, 6 and 7 were the only aisles that showed signs of smoke and heat damage. All other aisles showed only water damage from a combination of the activation of the sprinkler system and firefighting delivery hoses. See photos 6 through 19 for the aisles showing only water damage.

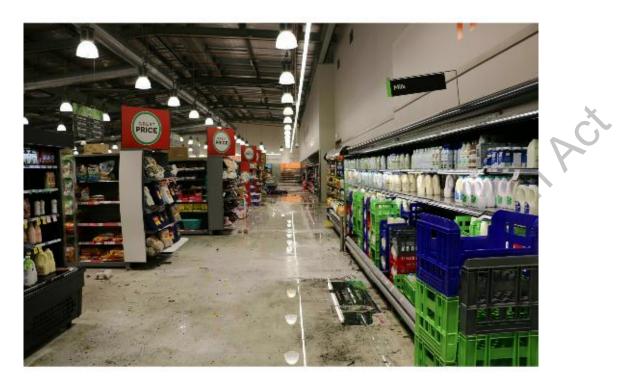
Photo 17: The rear of the supermarket looking towards the dairy and meat departments.

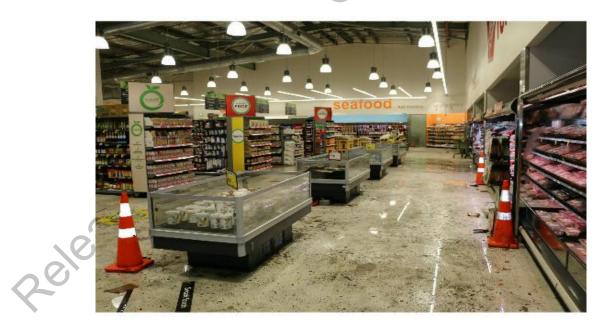
Photo 18: The rear of the supermarket looking towards the seafood department.

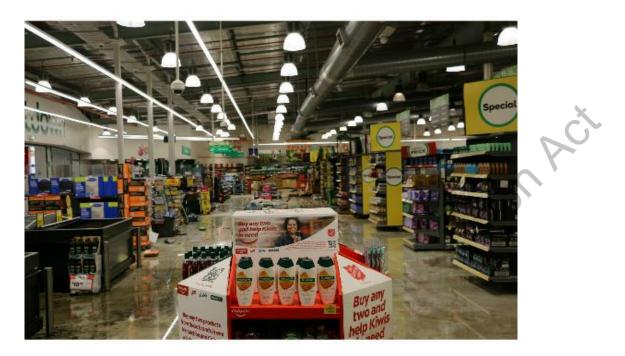
Photo 19: The front of the supermarket looking towards the checkouts on the left of the photo.

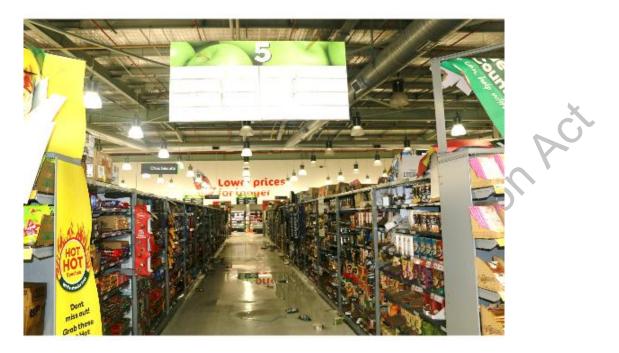
Photo 20: Aisle number 5 showing minor smoke and heat damage.

Aisle number 5 and aisle number 7 showed minor signs of smoke and heat damage. Fire patterns in aisle

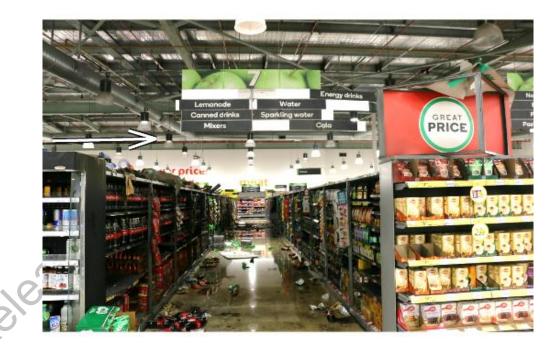
Photo 21: Aisle number 7. The fire travel from aisle number 6 into aisle number 7 through the back of the shelf is shown by the white arrow.

number 7 indicated that the fire had travelled from aisle number 6 into aisle number 7 through the back of the shelf.

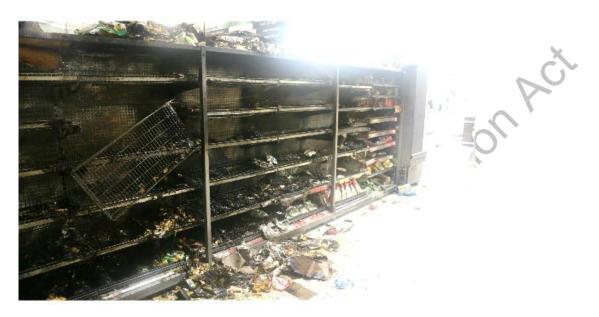
Photo 22: The section of the shelves that had the most damage in comparison to the other shelves.

Aisle number 6 showed signs of severe smoke and heat damage to the right-hand side of the aisle when looking from the entrance. Video footage obtained by the Police showed two persons walking in this aisle

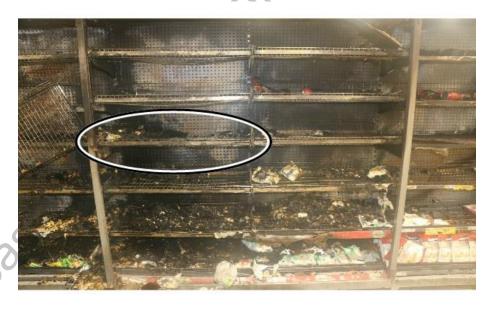
Photo 23: The section of the shelving units where the fire originated from. The shelf that the fire started on is shown by the white circle.

immediately prior to the fire occurring. One person approached the aisle shelving and held what appeared to be an ignition source to one of the sections of the shelf. Shortly afterwards, flames were seen coming from the shelf. The burn patterns to this shelf support what can be seen on the footage obtained by the Police.

The area of origin was aisle number six (6).

The cause of this fire is believed to be the deliberate ignition of combustibles via an introduced ignition source (such as a match or a lighter). Although I could not find the remains of such an ignition source, it is most likely that this was either added and then removed or burnt by the resulting fire.
