Annual Inspection

Auckland Council Ventia Wha

Llyod Elsmore(by pool)

Inspection Ref: 1374932

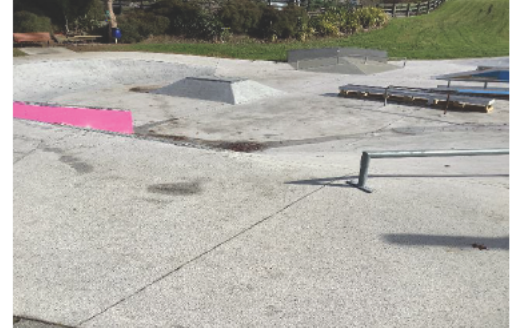
Prop placed under pip for stability - Look at adding a new pipe to help with stability

Portable skate ramps are present on site - Ensure the ramps are used sensibly and that they are not left lying in the area when not in use

Some cracks in surface - Make sure cracks not raised

A number of fixings has worked loose - Secure all loose fixings

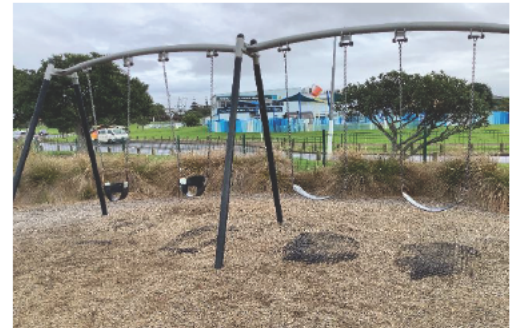
The bushes are showing signs of wear - Monitor for any further deterioration and replace as required

There is surface corrosion present on the item - Consider treating and repainting the item

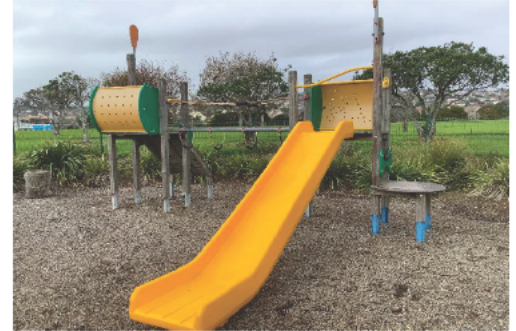
Cover is loose - Secure all loose fixings

The rope has worn and broken wire strands are exposed - Replace rope or net

There is surface corrosion present on the item - Consider treating and repainting the item

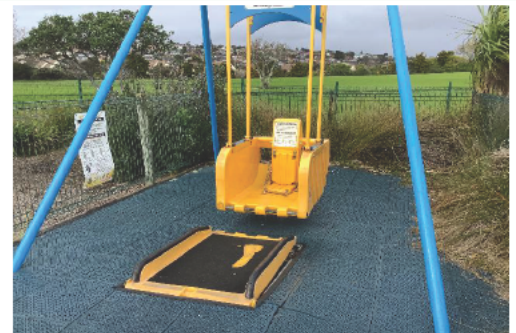
Fixings are damaged and/or have sharp edges - Repair or replace as required

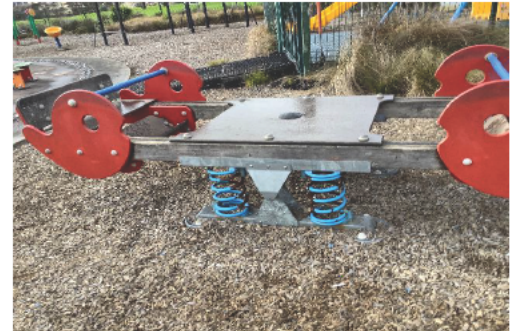
The paintwork on the spring has been damaged or worn exposing the metal underneath which is rusting - Treat any rusting components and repaint

Bolts show signs of rust - inspect and replace bolts, screws and or nails as required

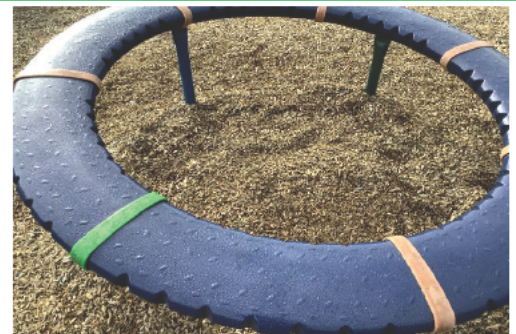
The surface has eroded and the foundations are exposed - Reinstate surrounding surfaces to cover the foundations

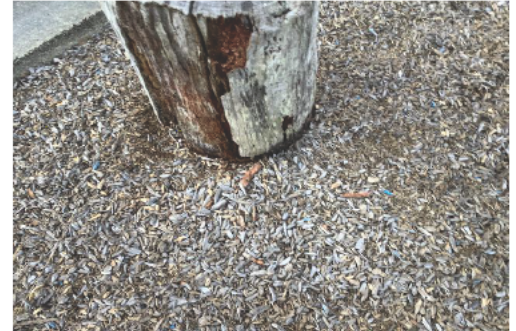
The timber on this item has severe rot - Remove and replace all affected timber sections

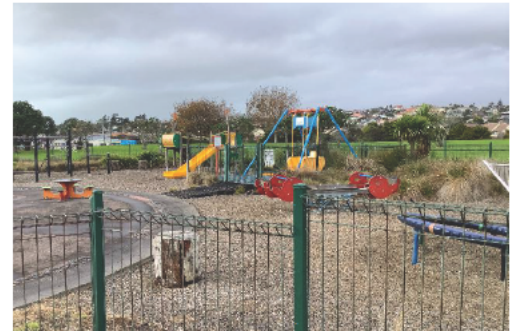
The level of loose fill surfacing has fallen significantly below the minimum 300mm recommended by NZS 5828:2015 Part 1 - Top up loose fill surfacing to recommended levels.

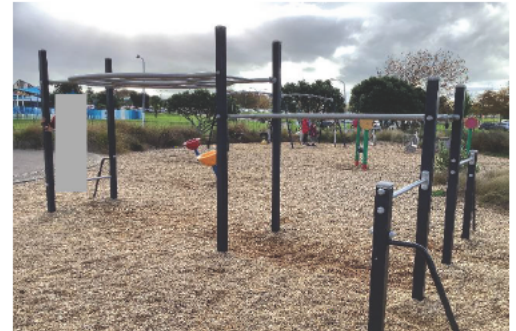
The use of S hooks to connect chains is not recommended as they can catch users clothes or jewellery - Recommend change to D shackle, monitor

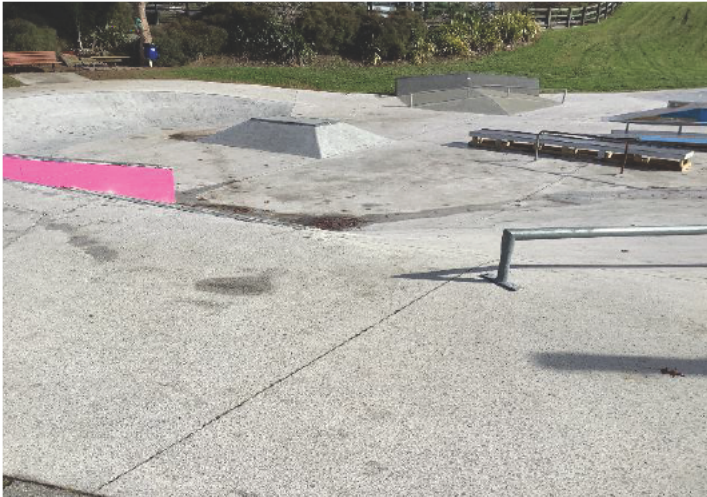
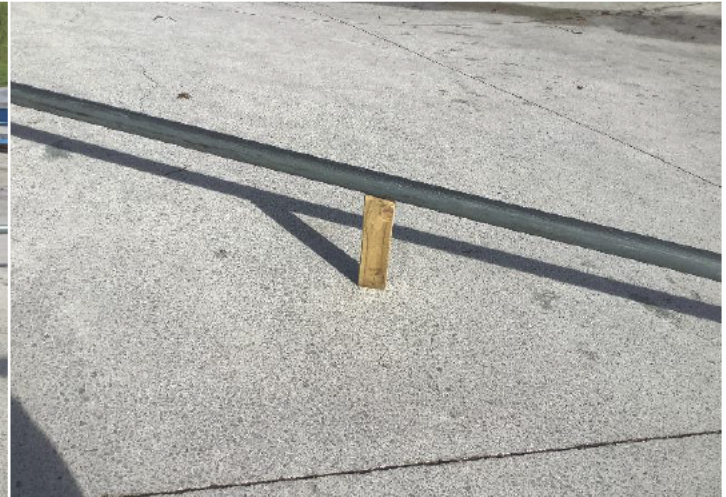
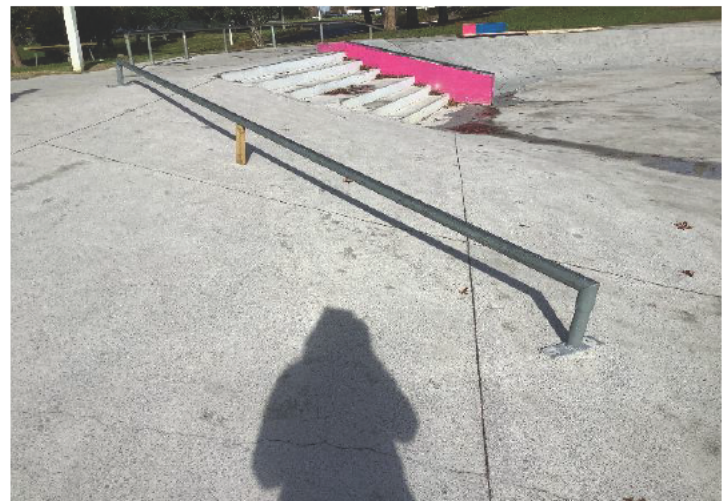
i 6 - Low Risk (Finding 1)

Finding: Prop placed under pip for stability

Action: Look at adding a new pipe to help with stability

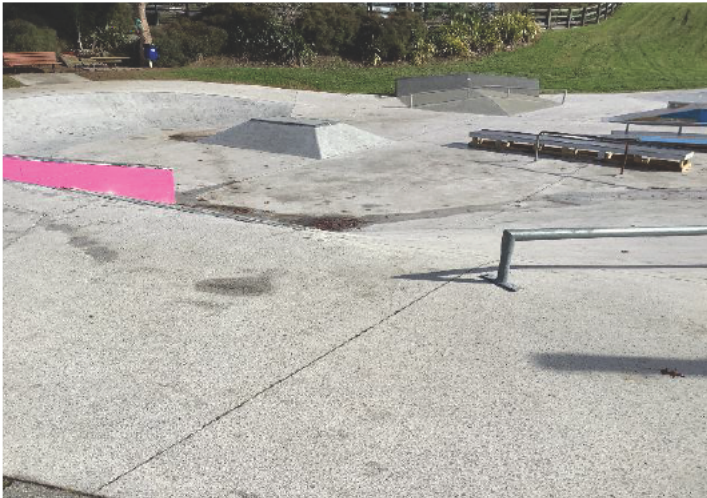
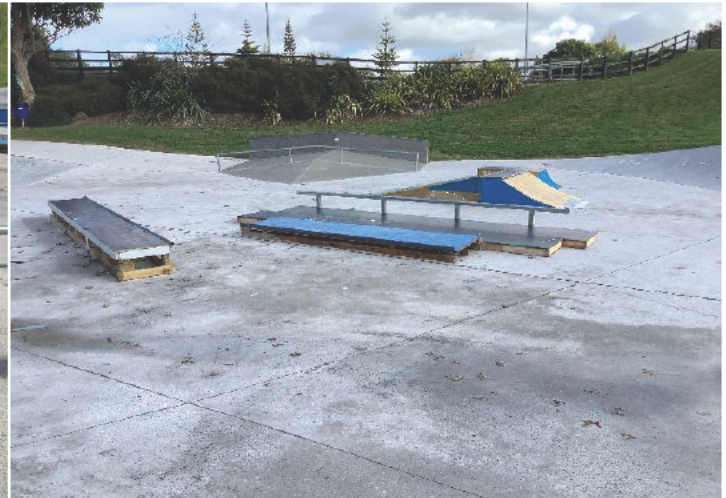
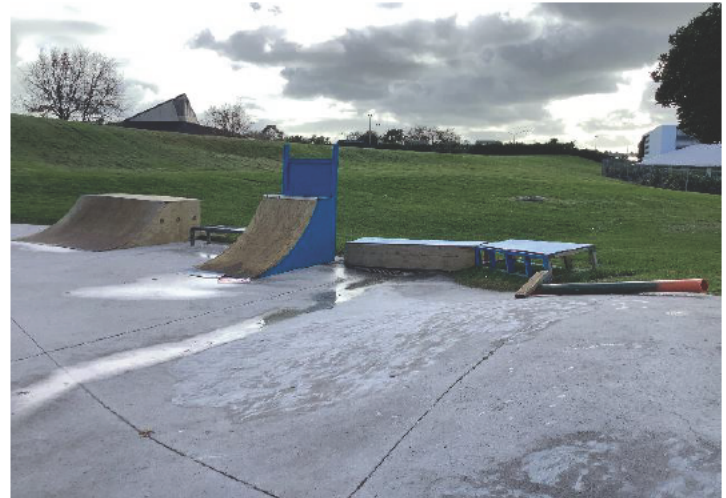
i 10 - Low Risk (Finding 2)

Finding: Portable skate ramps are present on site

Action: Ensure the ramps are used sensibly and that they are not left lying in the area when not in use

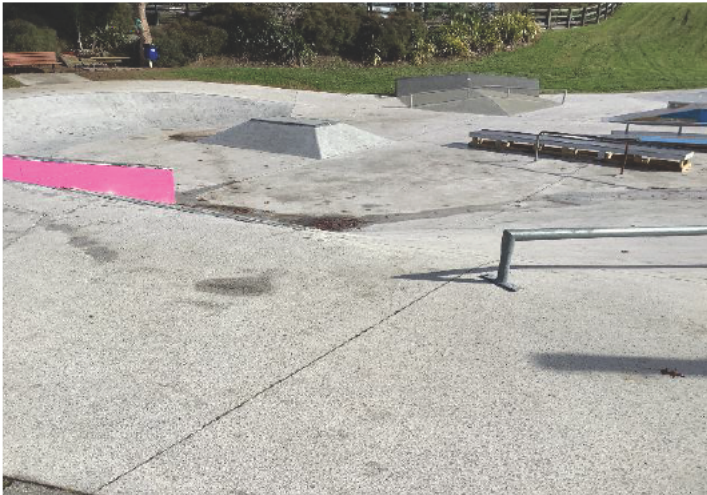
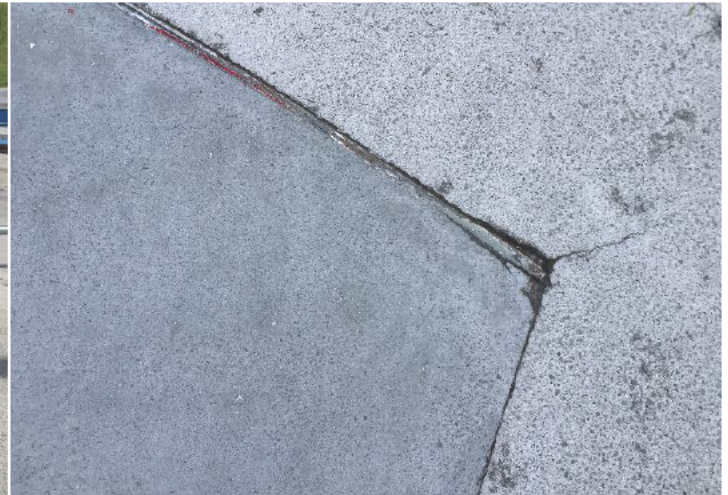
i 4 - Very Low Risk (Finding 3)

Finding: Some cracks in surface

Action: Make sure cracks not raised

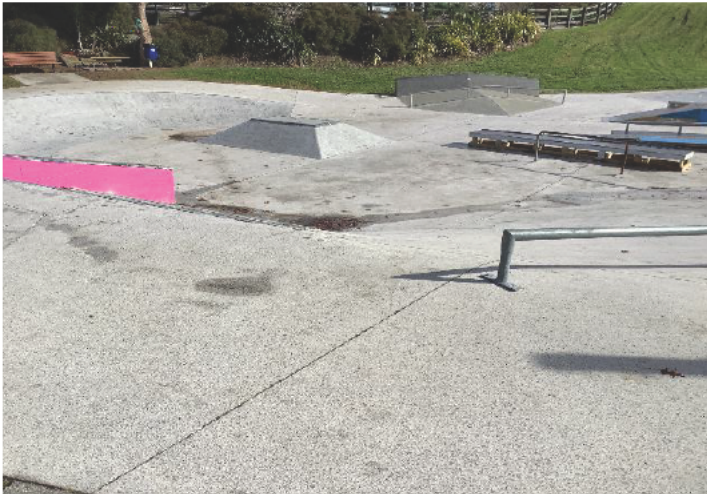
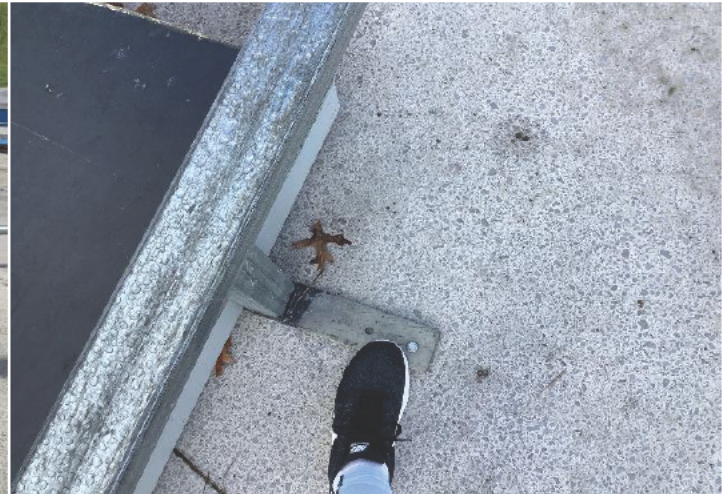
i 6 - Low Risk (Finding 4)

Finding: A number of fixings has worked loose

Action: Secure all loose fixings

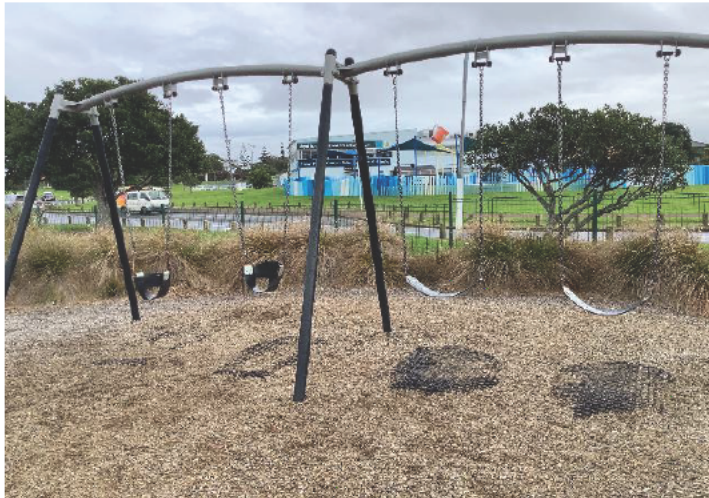
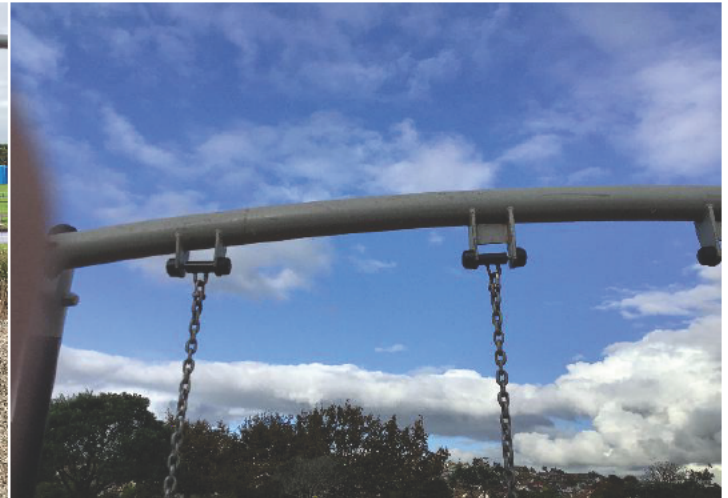
i 4 - Very Low Risk (Finding 1)

Finding: The bushes are showing signs of wear

Action: Monitor for any further deterioration and replace as required

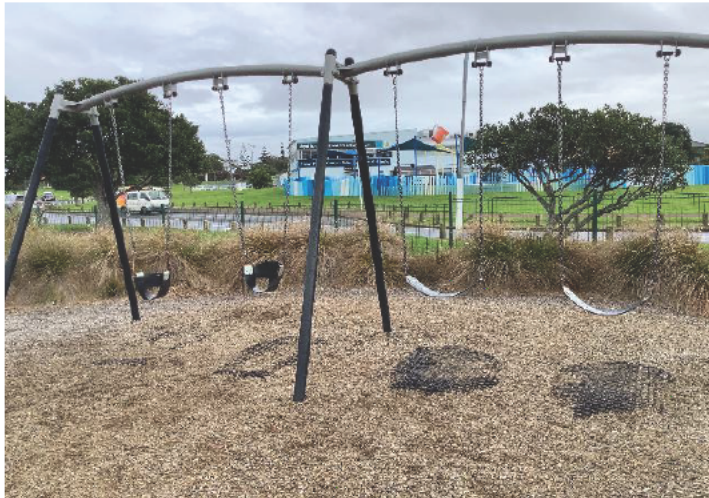
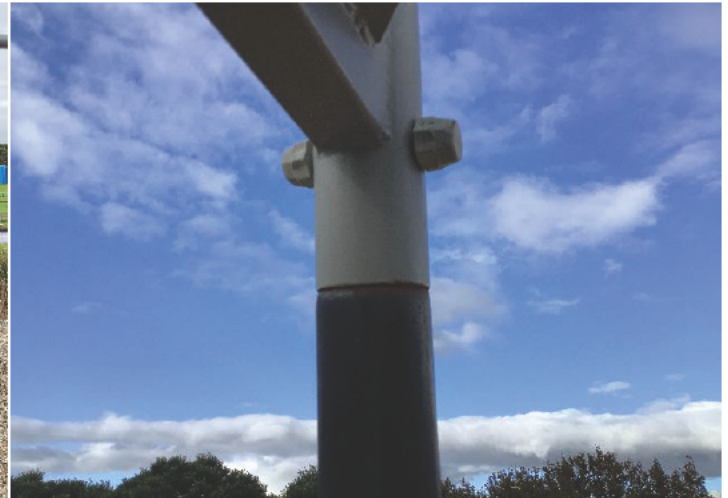
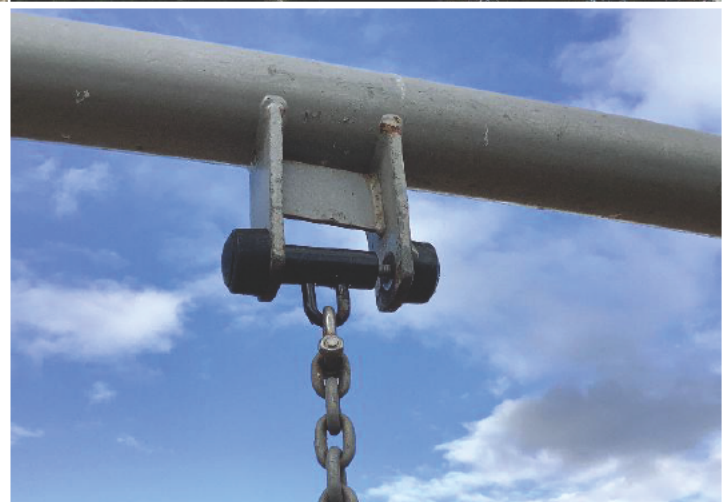
i 6 - Low Risk (Finding 2)

Finding: There is surface corrosion present on the item

Action: Consider treating and repainting the item

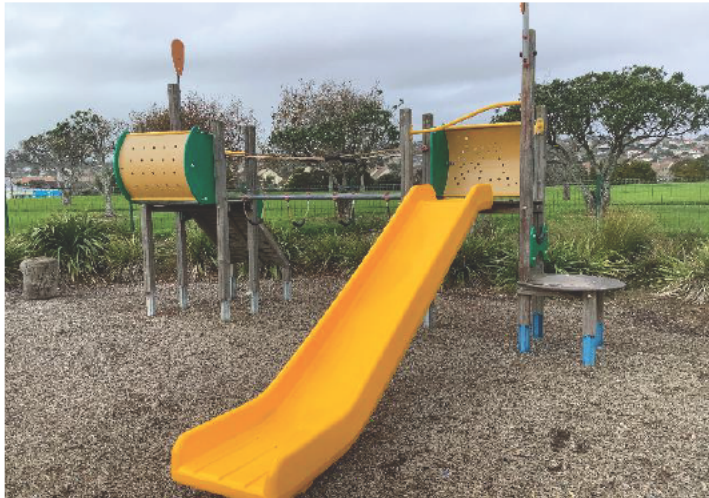
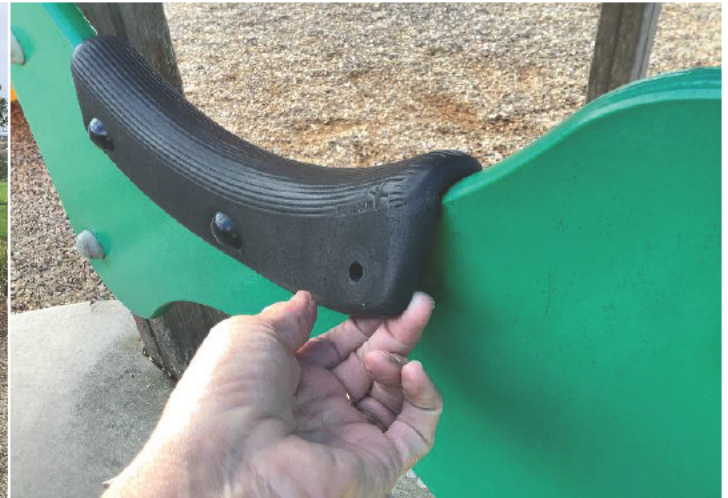
i 6 - Low Risk (Finding 1)

Finding: Cover is loose

Action: Secure all loose fixings

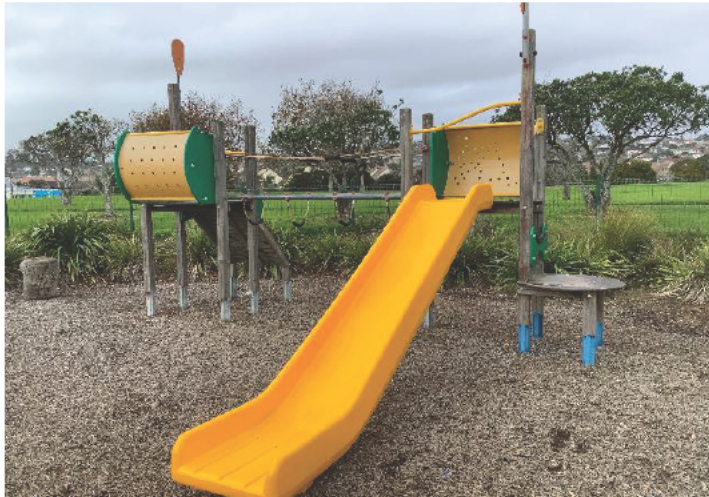
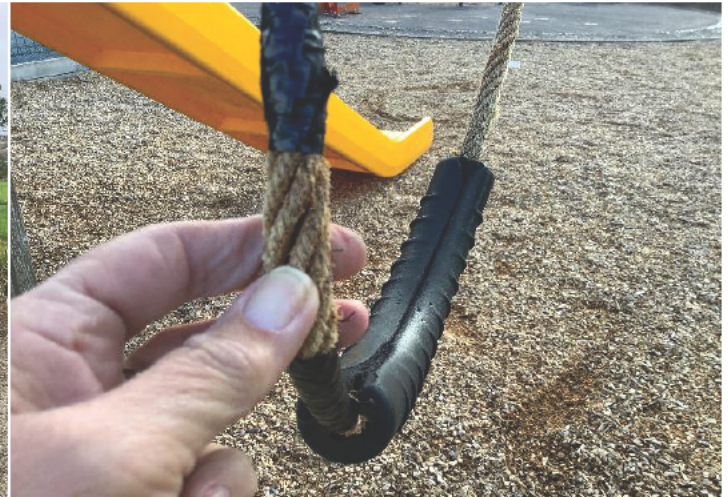
i 9 - Low Risk (Finding 2)

Finding: The rope has worn and broken wire strands are exposed

Action: Replace rope or net

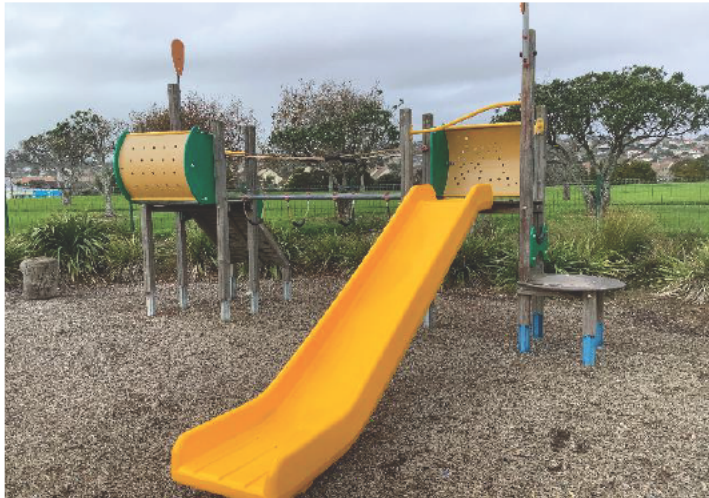
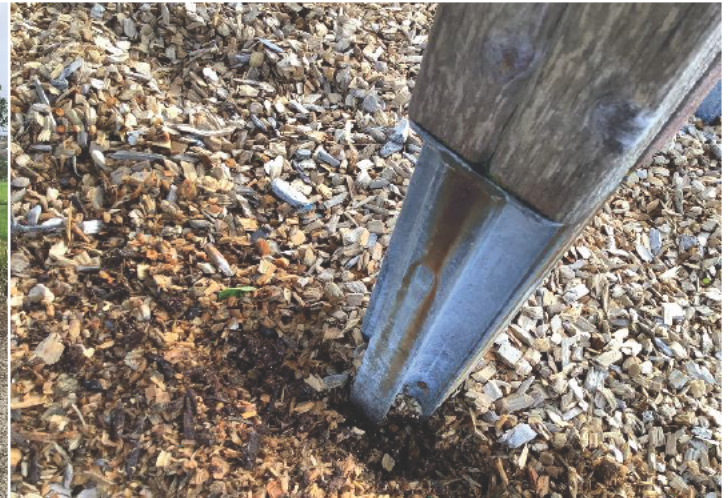
i 6 - Low Risk (Finding 3)

Finding: There is surface corrosion present on the item

Action: Consider treating and repainting the item

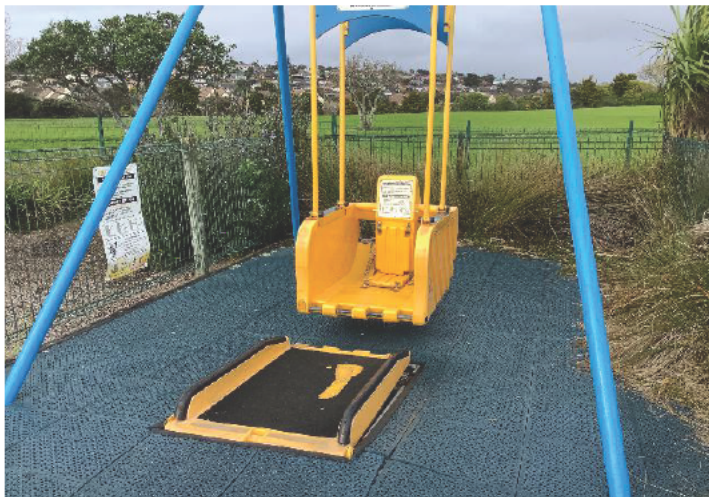
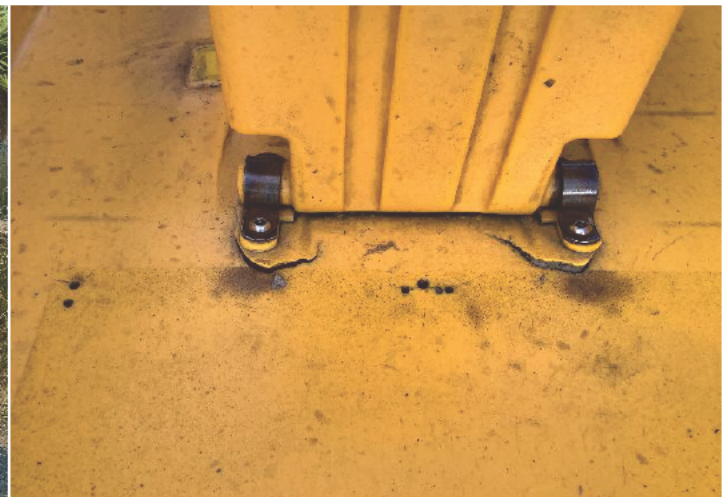
i 6 - Low Risk (Finding 1)

Finding: Fixings are damaged and/or have sharp edges

Action: Repair or replace as required

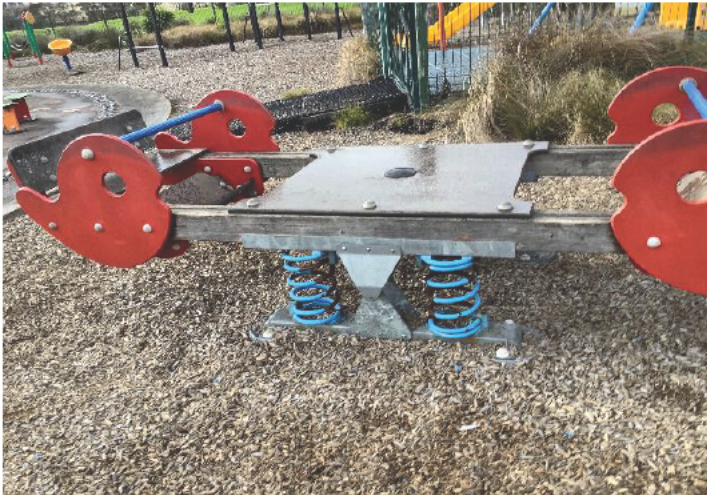
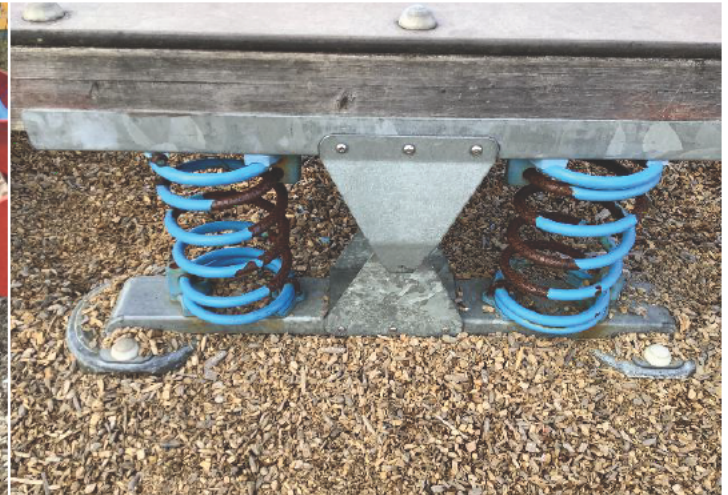
i 6 - Low Risk (Finding 1)

Finding: The paintwork on the spring has been damaged or worn exposing the metal underneath which is rusting
Action: Treat any rusting components and repaint

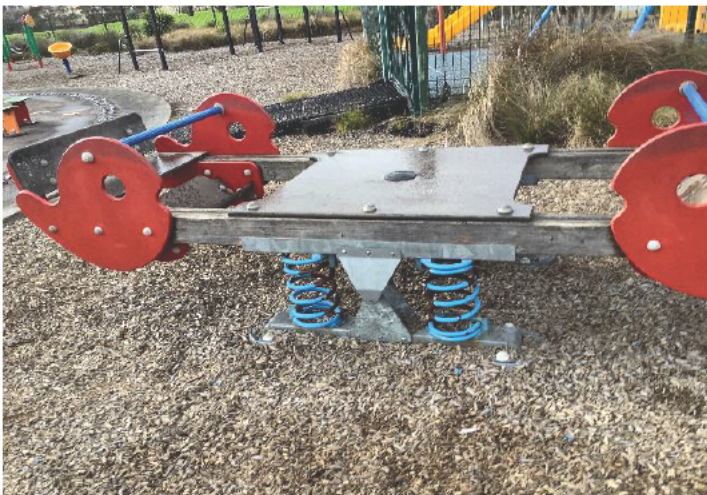
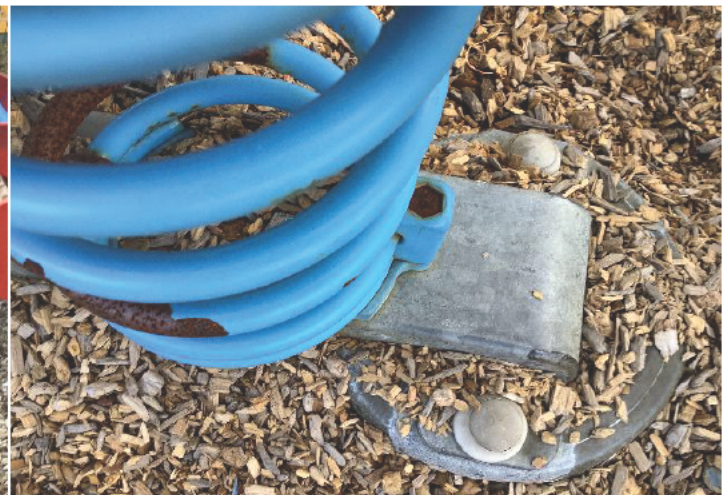
i 10 - Low Risk (Finding 2)

Finding: Bolts show signs of rust
Action: inspect and replace bolts, screws and or nails as required

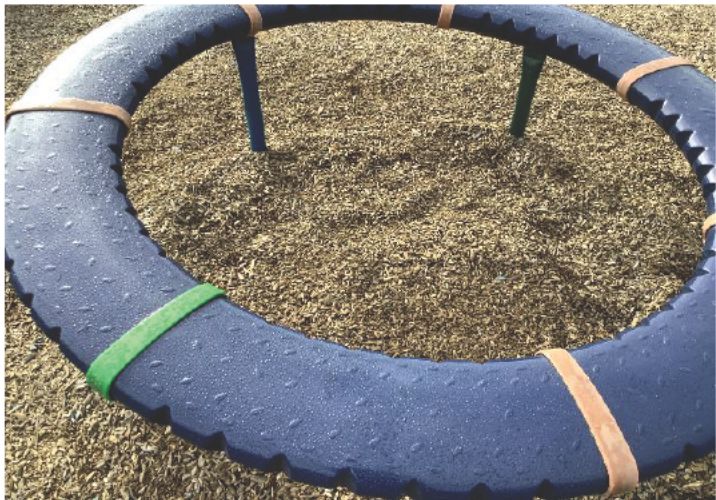
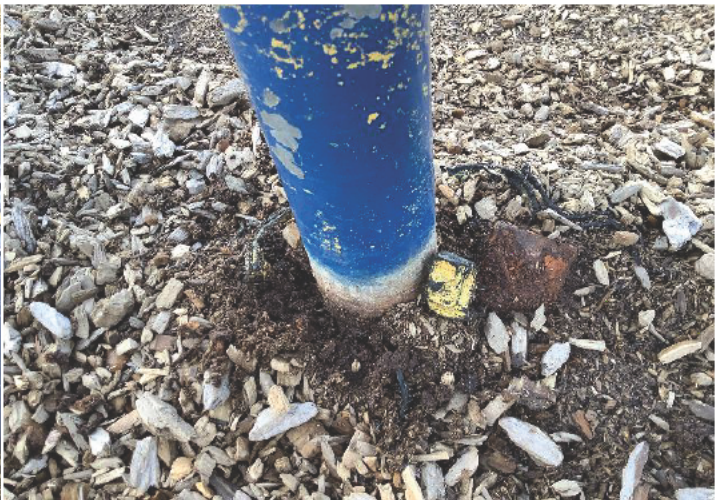
i 8 - Low Risk (Finding 1)

| Finding: | The surface has eroded and the foundations are exposed | Action: | Reinstate surrounding surfaces to cover the foundations |

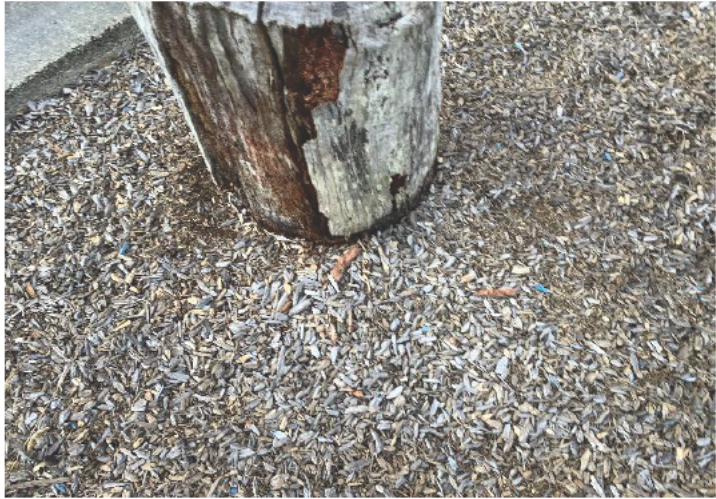
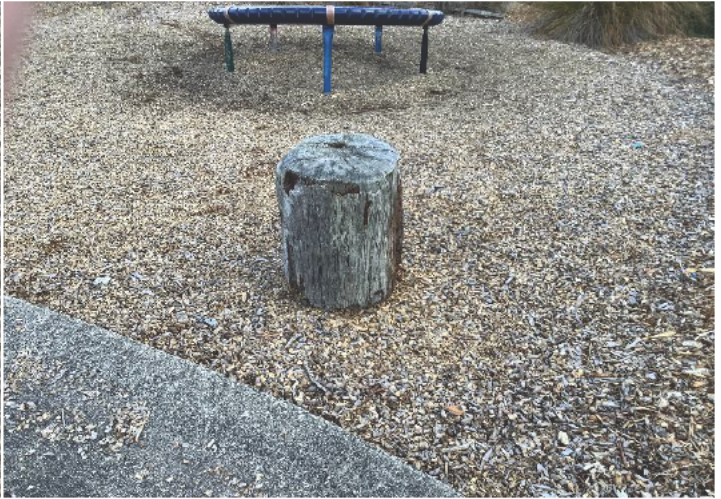
! 12 - Moderate Risk (Finding 1)

| Finding: | The timber on this item has severe rot | Action: | Remove and replace all affected timber sections |

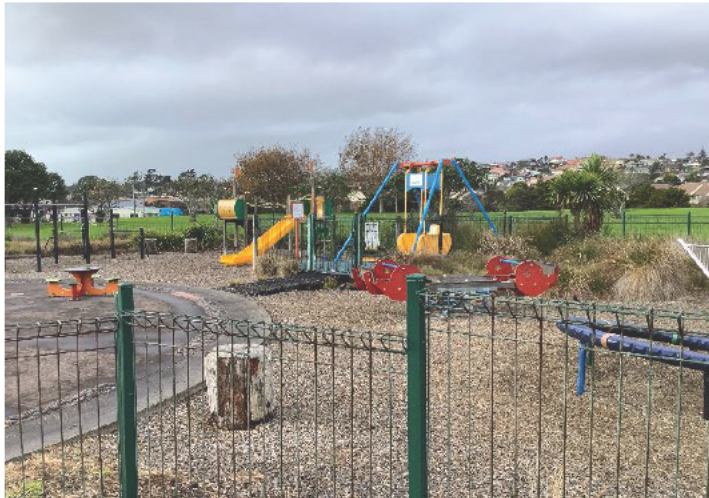
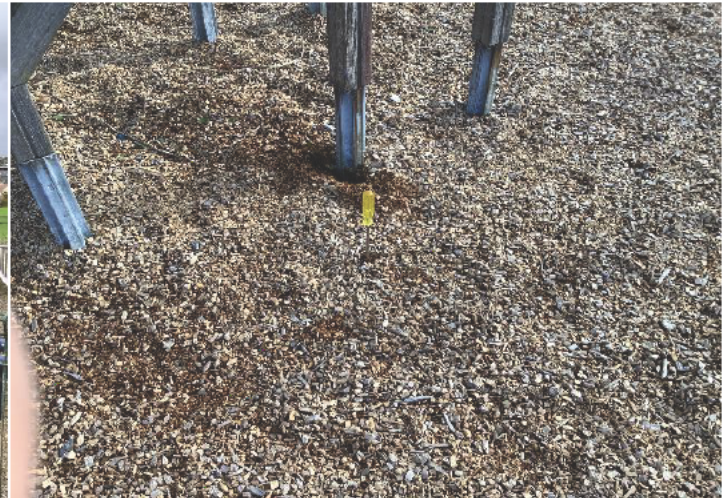
10 - Low Risk (Finding 1)

Finding: The level of loose fill surfacing has fallen significantly below the minimum 300mm recommended by NZS 5828:2015 Part 1

Action: Top up loose fill surfacing to recommended levels.

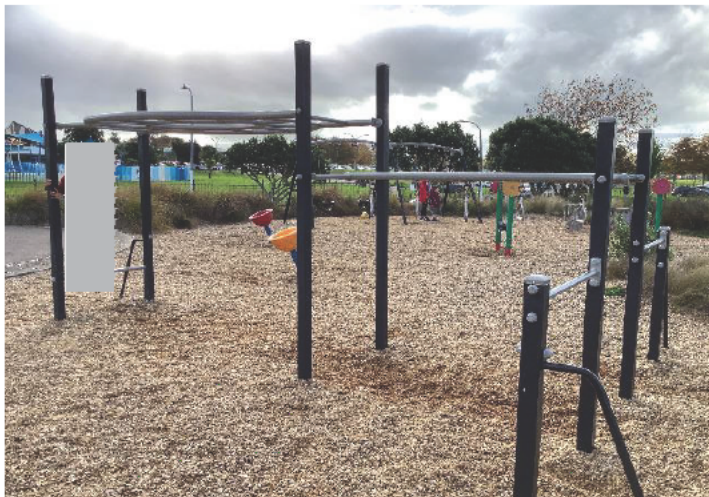
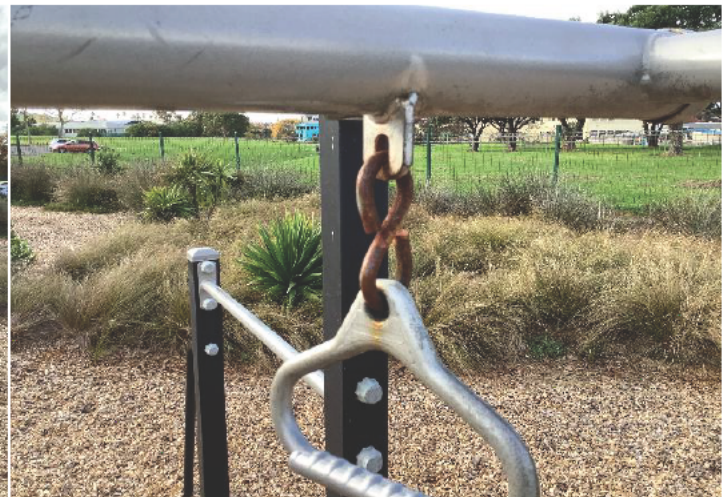
5 - Very Low Risk (Finding 1)

Finding: The use of S hooks to connect chains is not recommended as they can catch users clothes or jewellery

Action: Recommend change to D shackle, monitor
