Whirokino Trestle and Manawatu River Bridge Replacement
Post Construction Road Safety Audit

July 2021

This audit is a Post Construction (Pre-Opening) Stage Safety Audit of Whirokino Trestle and Manawatu River Bridge Replacement. This audit includes all works completed prior to the shifting of traffic onto the new alignment. Elements not audited include:

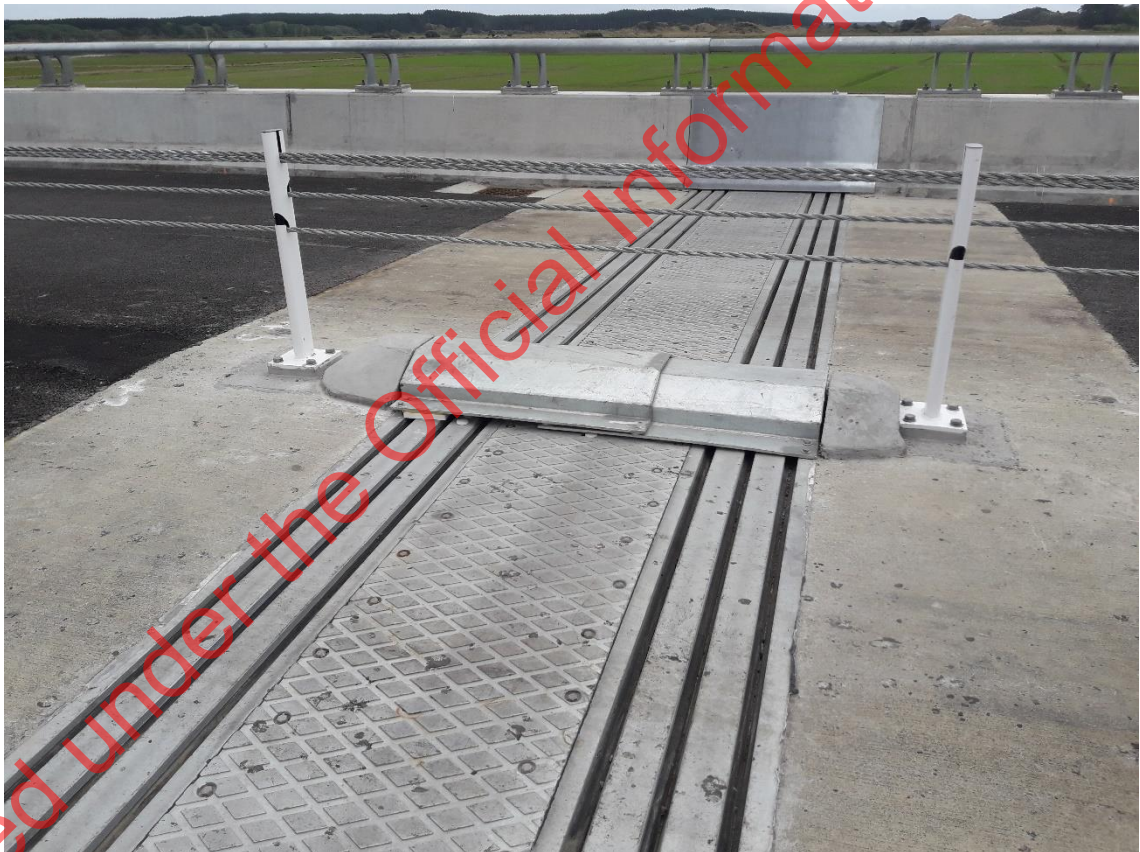
The mountable kerb will raise the height at which vehicles hit the median barrier, effectively reducing the height of the barrier. Vehicles should not strike a wire-rope barrier 50 mm below design height, as it will not perform to manufacturer's specifications, potentially causing wheel stags, overturning, etc. Impacts into wire-rope barriers redirect vehicles along the path of the barrier which reduces the impact severity, potentially allowing the vehicle to regain control and safely come to a stop or re-join the carriageway. With this device in place (Expansion joint cover and kerbing) effectively creating an abrupt obstacle within the path of the vehicle there's a high possibility that this will cause a significant accident.

Develop options that allow for vehicles to strike the barrier at the correct height. This could include extending and widening the mountable kerb and placing support post on top of the mountable kerb, or removing the need for a mountable kerb or cover.

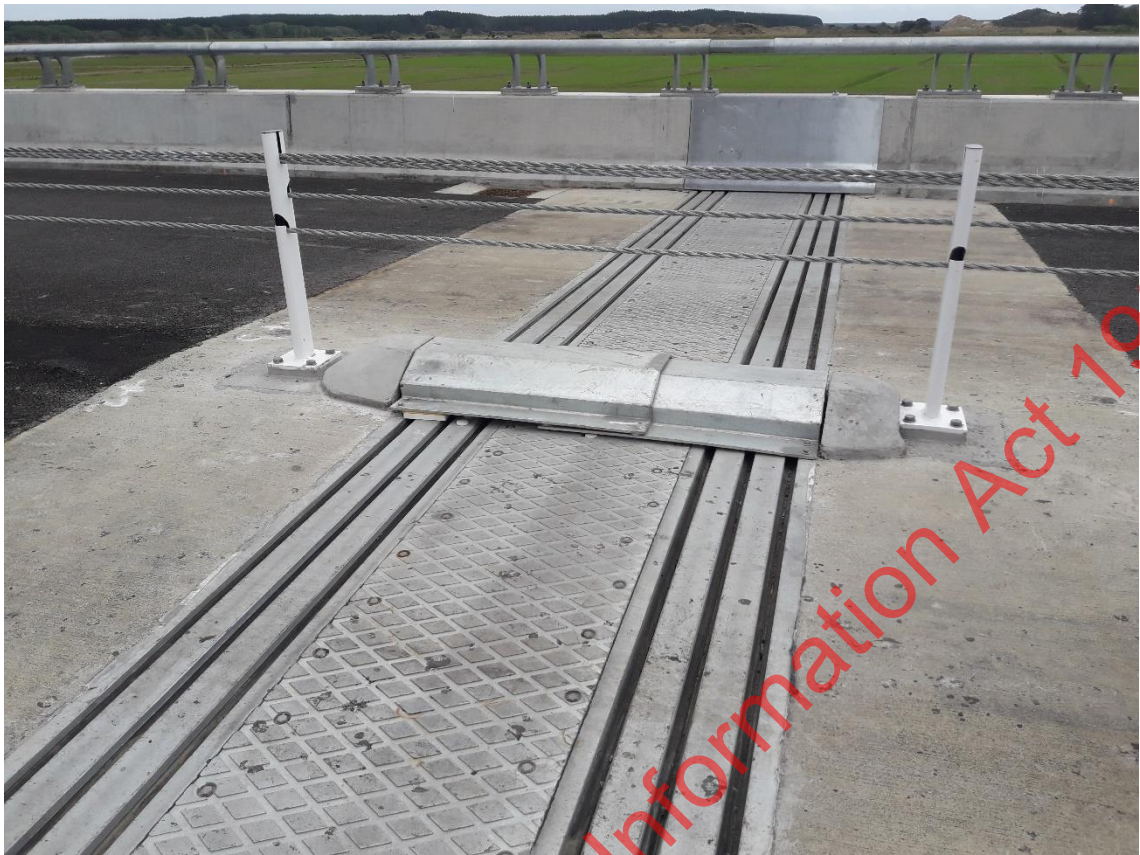
The mountable kerb (concrete nose and metal side covering) at the expansion joint is a hazard. Impacts to the kerb nose (particularly when adjusted for barrier posts) and sides by errant motorcyclists or vehicles could cause harm, however infrequent they may be.

BBO: Extending the mountable kerb nose will require relocation of the barrier posts. As discussed in 2.1.1 above, the existing system should perform adequately when impacted by cars. For motorcycles to hit the kerb they will already have impacted the WRSB so outcomes will already be severe. Propose no change be made.

Safety Engineer	Considering the overall length of the barrier and the relatively short length of mountable kerb, the risk is low that it will be struck and if struck the risk will be low that the system will fail.
Client Decision	Agree with BBO and Safety Engineer's responses. No further action required.
Action Taken	N/A

Consider developing options that remove the need for a mountable kerb or cover.

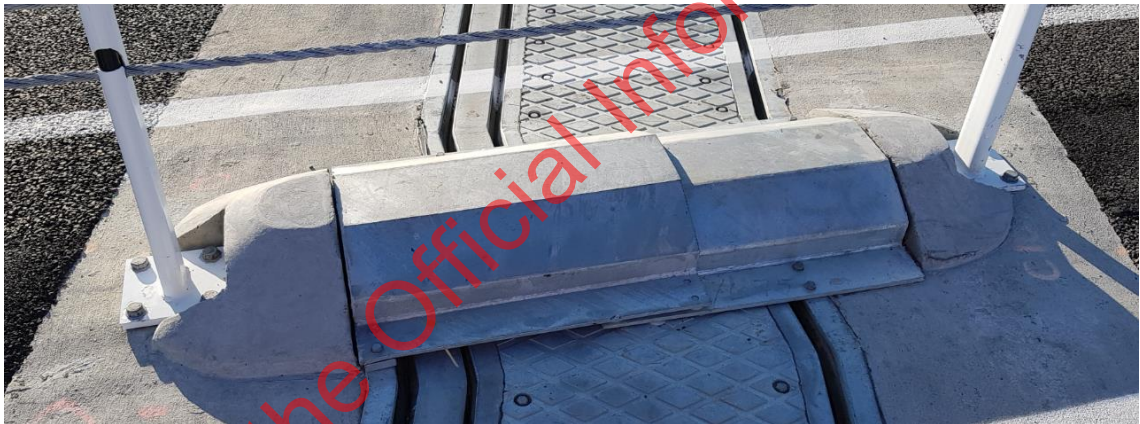
Wire-ropes barrier posts are placed within or immediately adjacent to mountable kerb. It is unclear if these posts are designed to shear or their bolt-connection with the bridge will shear on impact. This may result in performance different to manufacturer's specifications. Impacts into wire-rope barrier are redirected along the path of the barrier and so vehicles impacting the barrier prior to the mountable kerb will be directed into striking them.

Designer to confirm that NZTA has accepted the use of the shear-posts at this location.

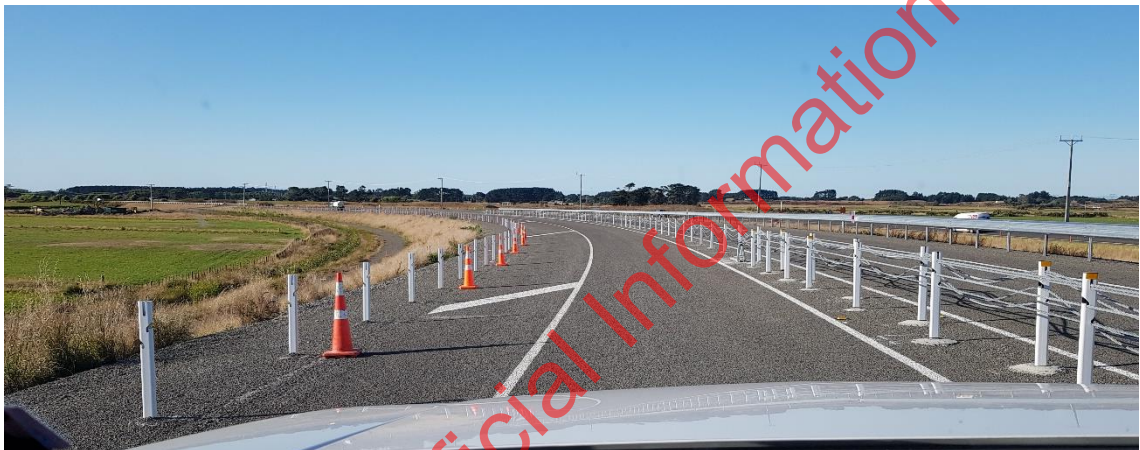
Median shoulder width of 1.5 m is provided throughout the project extent. A vehicle that has lost control on the 450 m radius (approx.) curve at the northern end may deflect into oncoming traffic. When struck, the barrier debris could fall loosely within the northbound traffic lane.

Consider adjusting the median edge line on the southbound approach to the Moutoa Floodway Bridge (Whirokino) to increase the deflection zone of the barrier if struck.

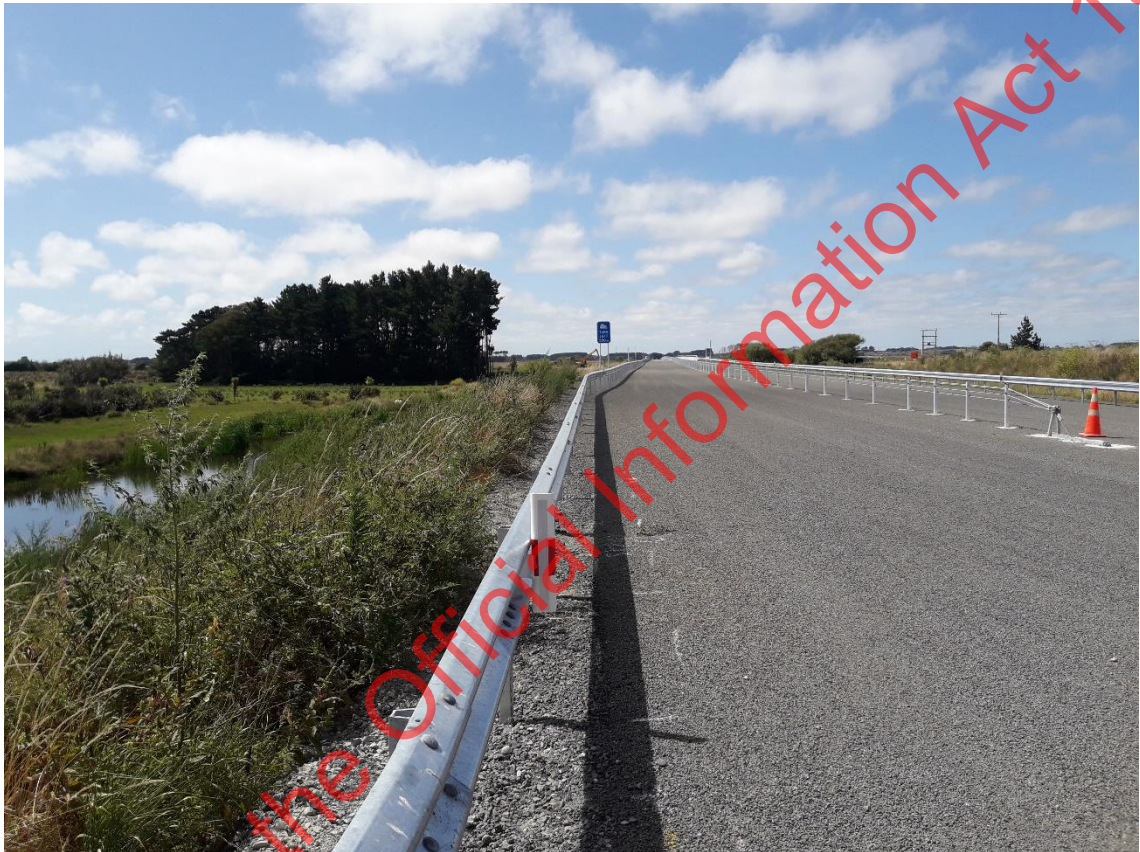
There is a sharp change in direction greater than 1:30 taper rate of the edge barrier between the farm access and the motorists service sign.

Safety Engineer	As the barrier is outside the shy line 1:17 should be the max flare rate. At 1:16.8, this is steeper than acceptable. If a decision is made to change the flare rate, it is recommended that the change be made to flatten the flare beyond 1:17 as going to the expense of making the change should try to improve it beyond the minimum.
Client Decision	Agree with BBO response. No further action required.
Action Taken	N/A

Reinstall barrier with appropriate taper rate.

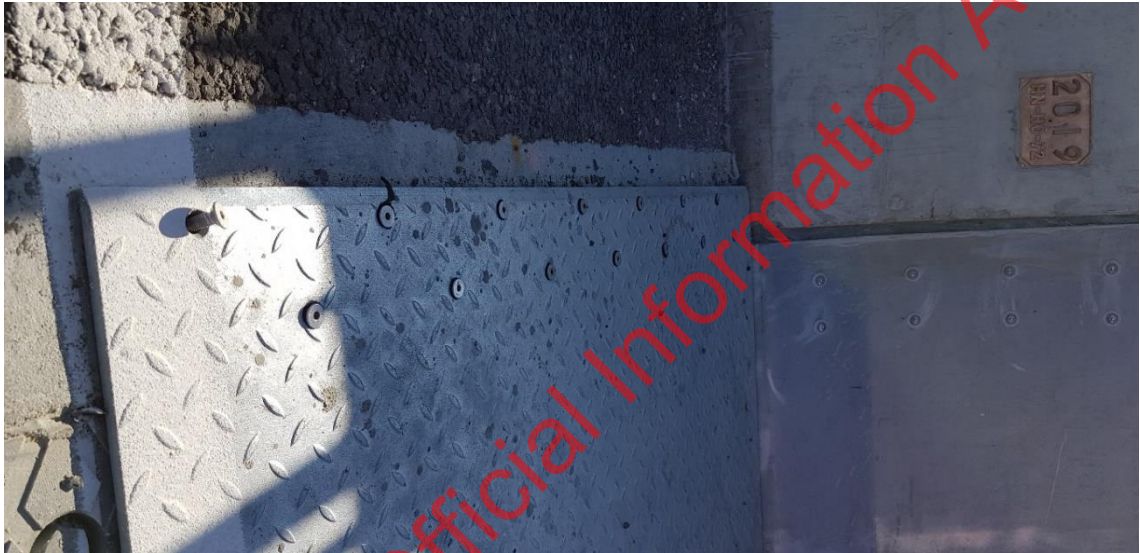
Metal plates covering the expansion joints have been provided on the shoulders to be traversable by cyclists. These metal plates are attached on the leading edge only with short screws approximately 2 cm in length. During the line marking inspection screws were observed to be loose and easy to loosen. With traffic passing over the bridge and other sources of vibrations, these plates are likely to become detached becoming a hazard for all road users if kicked up by vehicle traffic and caught in the wind.

Revisit this detail of how this is going to be mounted so that it does not vibrate loose and become a hazard for cars driving over/next to the plate.

Designer Response	<p><i>Novare:</i> All the screws have been tack welded at the cover plate to ensure it is securely in place and the issue has not been observed since.</p> <p><i>BBO:</i> Suggest this is monitored and thoroughly inspected at the end of the DNP before accepting as a permanent solution.</p>
Safety Engineer	Recommend this is monitored <u>during</u> the defects period as this issue should be fixed immediately. Loose plates and loose screws are hazardous to traffic immediately, especially motorcyclists.
Client Decision	Agree with BBO and Safety Engineer's responses. No further action required.
Action Taken	<p>Plates to be carefully monitored during DLP.</p> <p>November 2020 update: Plates are being monitored. Bolts are holding well to date.</p>

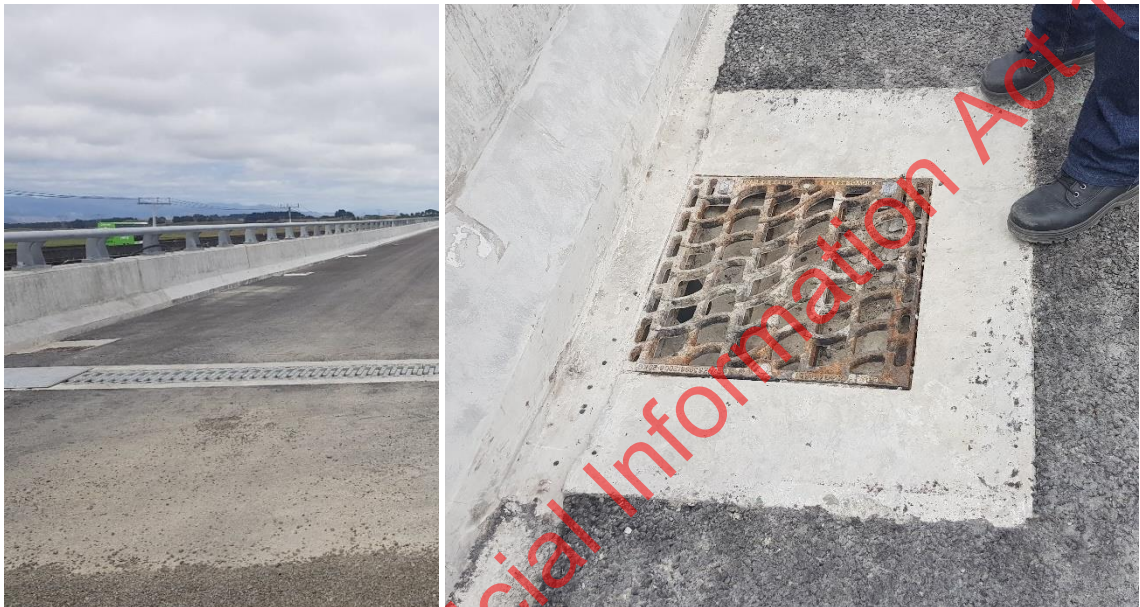
Sumps along the sealed shoulders of the bridges are located approximately 50 mm below the seal surface. On the Moutoa Floodway Bridge (Whirokino) sumps are spaced approximately every 50 m. “Confident and courageous” type of cyclists will use the shoulder rather than the shared path. The dips at 50 m spacing will create an uncomfortable ride for cyclists who consistently use the shoulder, and will cause them to ride on the non-undulating surface closer to the traffic lanes, increasing their risk.

Consider a sump solution level with the surfacing.

Designer Response: *Novare:* A solution has been proposed. If we get a go-ahead from everyone, we can start working on the details.

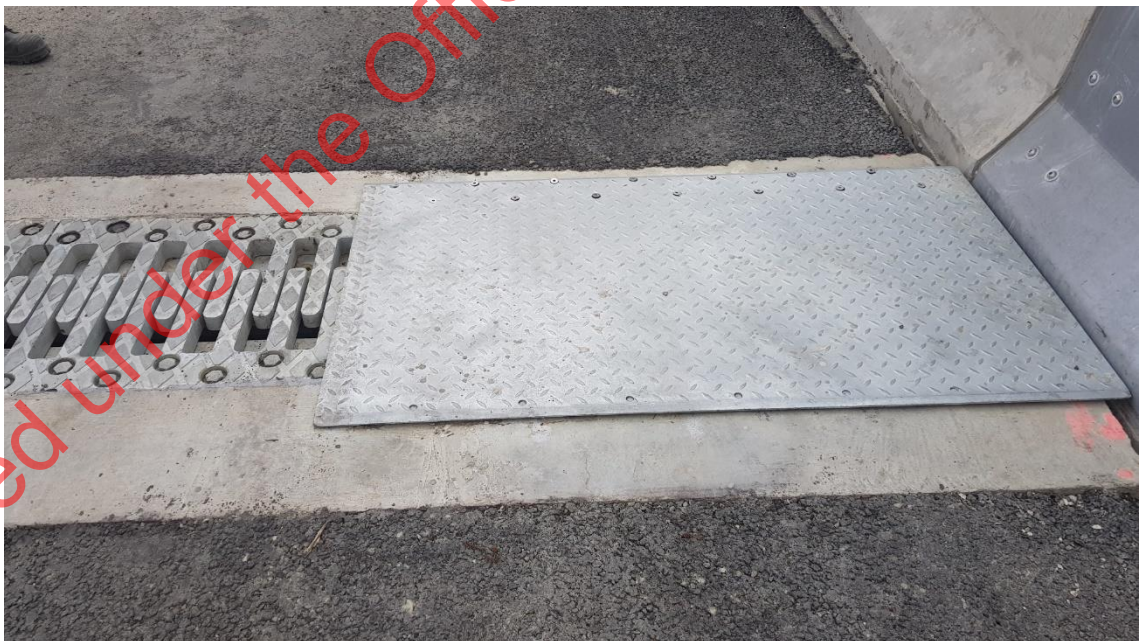
Metal plates cover the expansion joints on the shoulder of the two bridges within the project. These metal plates have marco-grip pattern on their top side, but lack grip between and so have lower grip than typical surfacing, particularly when damp/wet. This reduced grip will increase the likelihood of cyclists or motorcyclists riding on the across the joint losing control.

Consider methods to increase the grip on the metal plates.

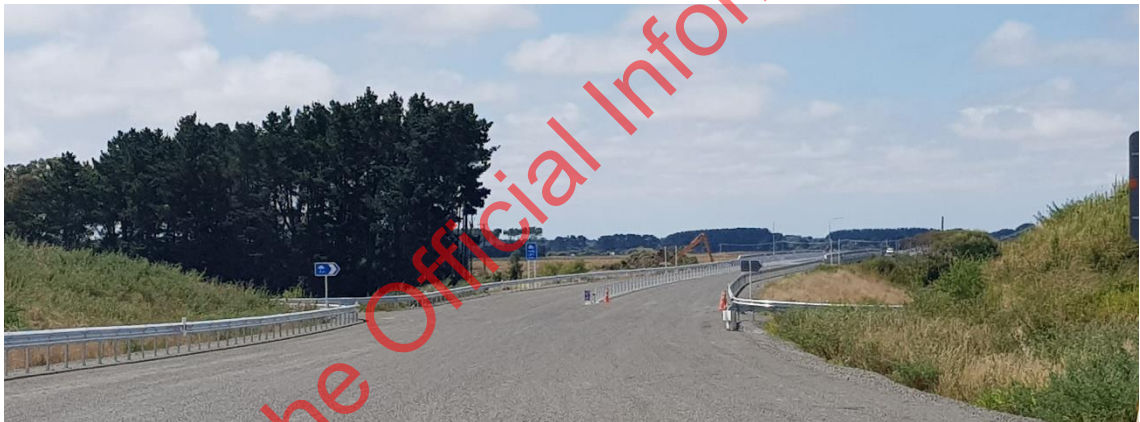
In a previous phase Road Safety Audit, concern around right turn movements into the rest area was identified, the accepted solution was to only signpost the rest area for southbound traffic. However the rest area has now been signed for northbound traffic as well.

Remove the northbound facing rest area sign, or explain what mitigation has been implemented to reduce risk for the northbound right turn movements.

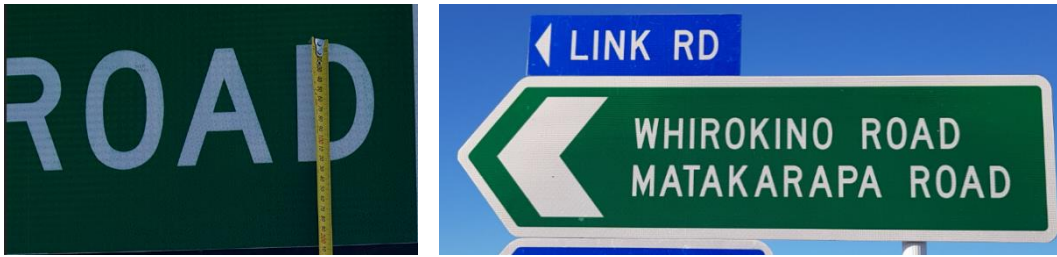
- Whirokino Road and Matarapa Road text height on directional sign approaching Link Road.

Recommend reviewing all of the signs within the project extent to confirm they meet TCD / MOTSAM requirements.

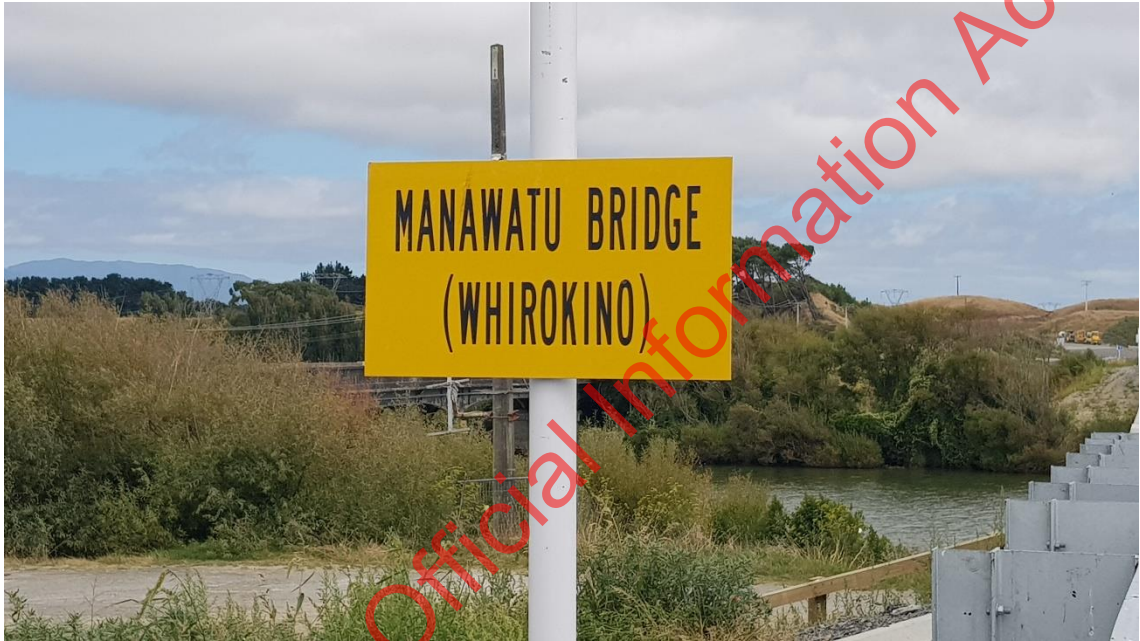
- Manawatu River Bridge place sign (IG-14) has narrowly spaced lettering making it difficult to read.

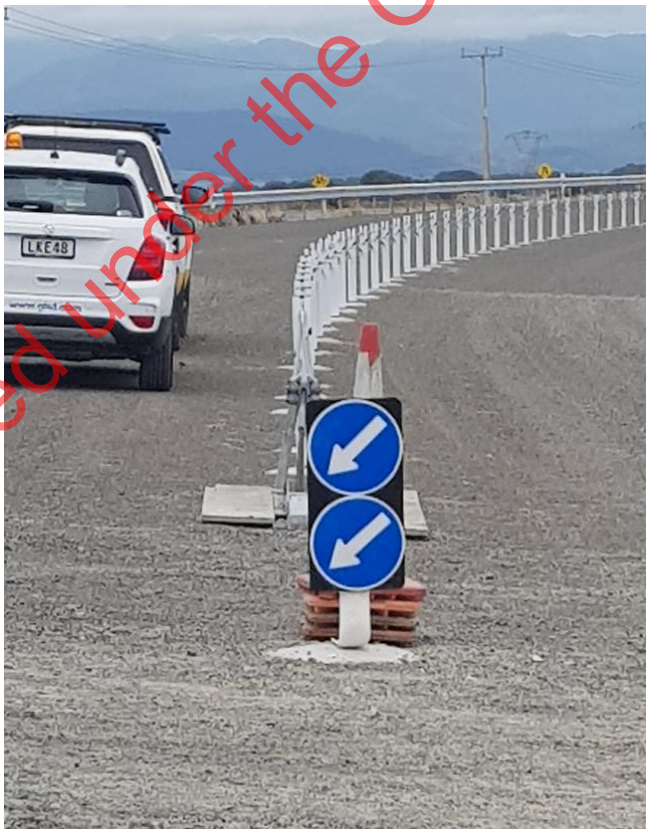
The RG-17 "keep left" sign mounted on the southbound approach to the northern end of the median barrier is slightly off-set to the right of the barrier terminal. This could cause a slight perception issue for the location of the barrier.

Shift the RG-17 sign slightly left to align the centre of the sign with the barrier terminal.

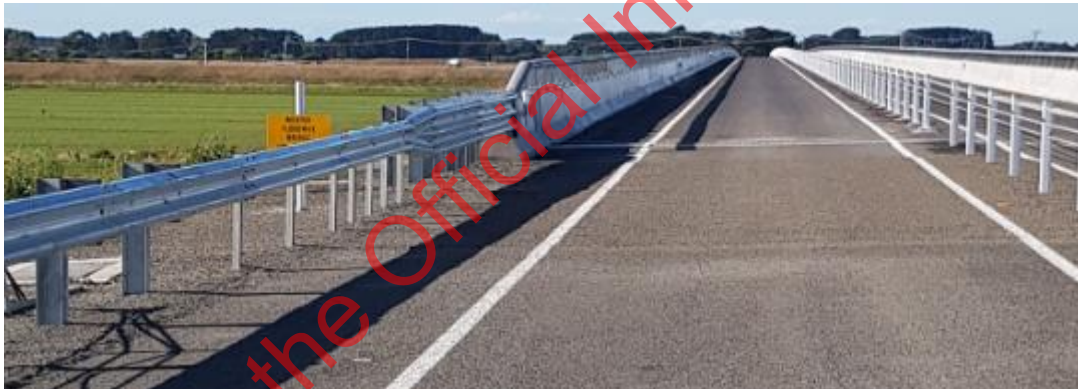
The sign for the northbound facing Moutoa Floodway Bridge (Whirokino) is too low on its support post and is obscured behind the barrier.

BBO Comment: The sign height should be adjusted by the Contractor.

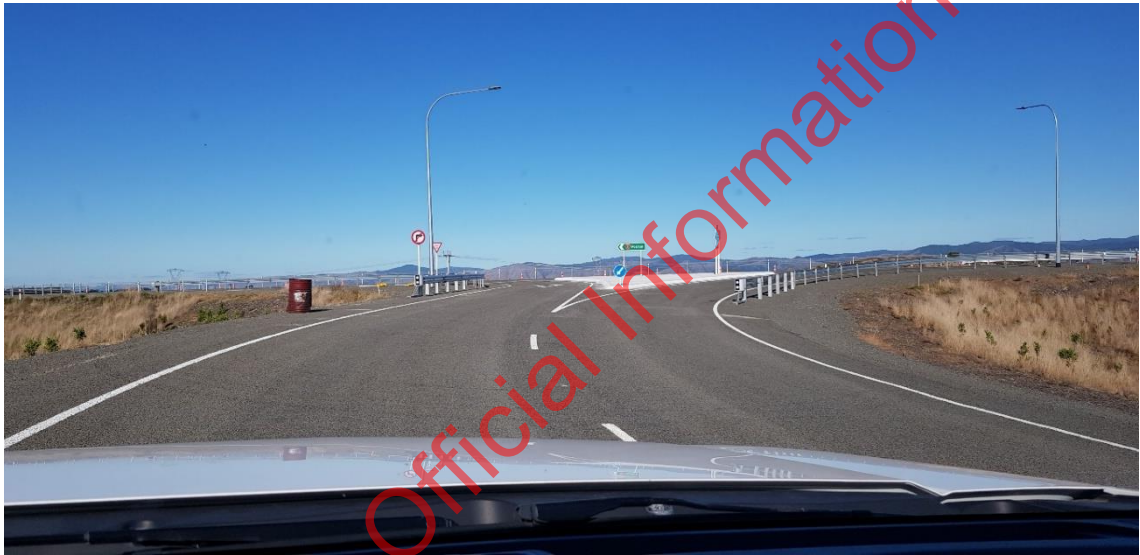
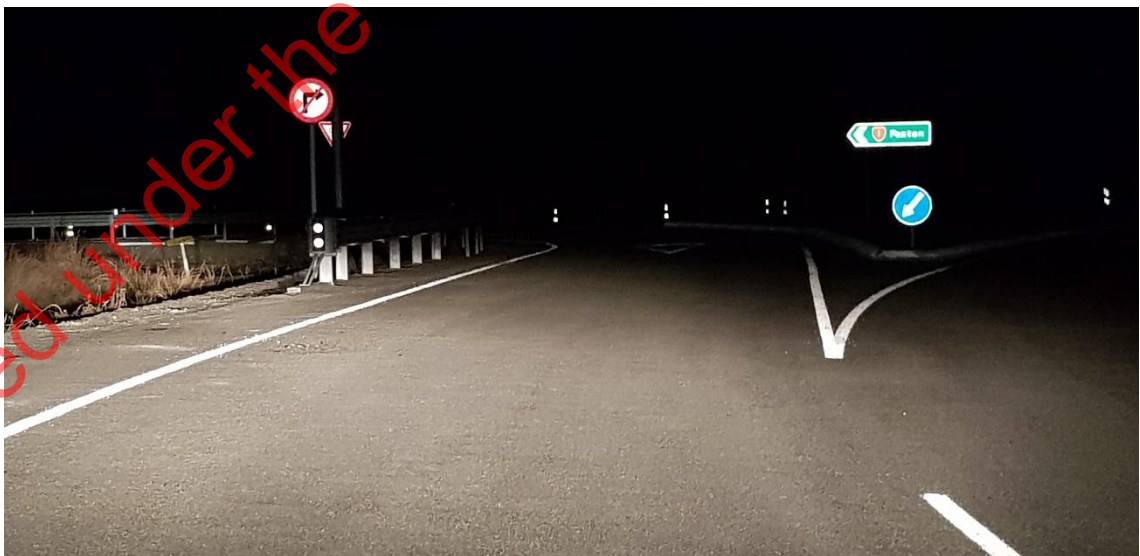
The advanced warning giveway pavement marking is too close to the limit line to be visible.

The giveway sign size appears to be 600 mm, and should be 900 mm.

1. Gate the giveway sign so that approaching road users do not overshoot the intersection and hit the median barrier.
2. Raised intersection chevron board sign for opposite intersection to improve intersection visibility.

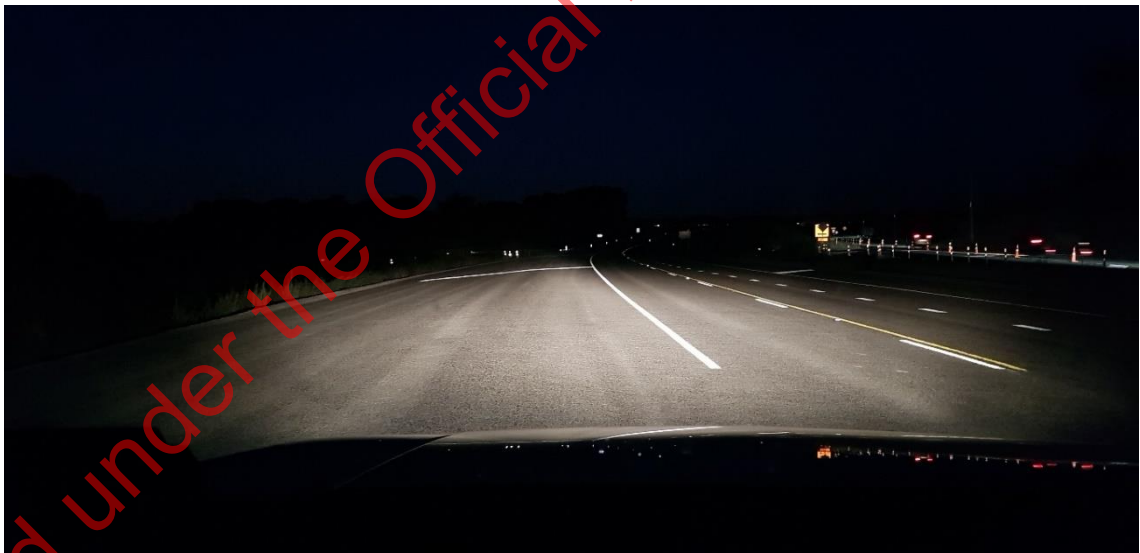
The northbound over-dimension vehicle staging area south of the start of median barrier is a significantly wide shoulder currently hatched. The purpose of this area could be unclear for most road users and could encourage undesirable road user behaviours, and at night may even be mistaken as the actual live lane. This issue was previously identified as a comment in the previous audit.

Consider providing some form of delineation and / or separation, either in the form of a mountable island between the carriageway (incl. standard hard-shoulder) and over-dimension vehicle staging area, with edge marker posts and red edgeline RRPMS at the entry.

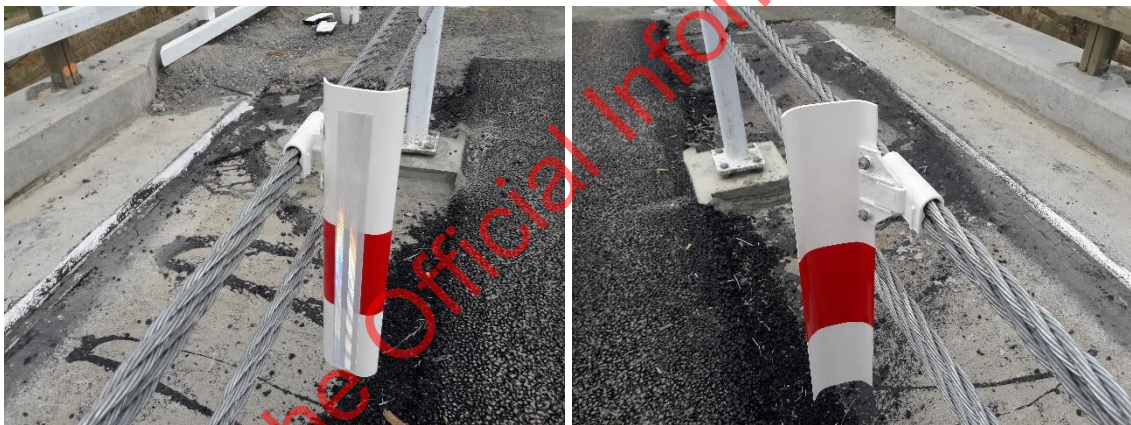
The edge marker posts on the wire rope barrier can move under force, or during adverse weather conditions, at a time when they are required the most. This will result a slight offset discrepancy between the opposite edge marker posts. Additionally during the audit the spacing between edge marker posts was inconsistent.

Identify a solution to reduce movement of edge marker posts between wire rope barrier supports.

Designer Response	<i>Novare:</i> It is understood that this is the standard that is being used across the country. To ensure a sturdier connection, another clamp could be attached the lower wire. <i>BBO:</i> The attachment needs to be improved so that posts don't slide during weather events, cleaning etc. Spacings need to be uniform.
Safety Engineer	The need for the spacing to remain consistent is important and we recommend that the Novare solution is explored.
Client Decision	Agree with BBO and Safety Engineer's responses.
Action Taken	November 2020 update: Edge marker posts are not moving. Spacing to be checked; otherwise no action required.

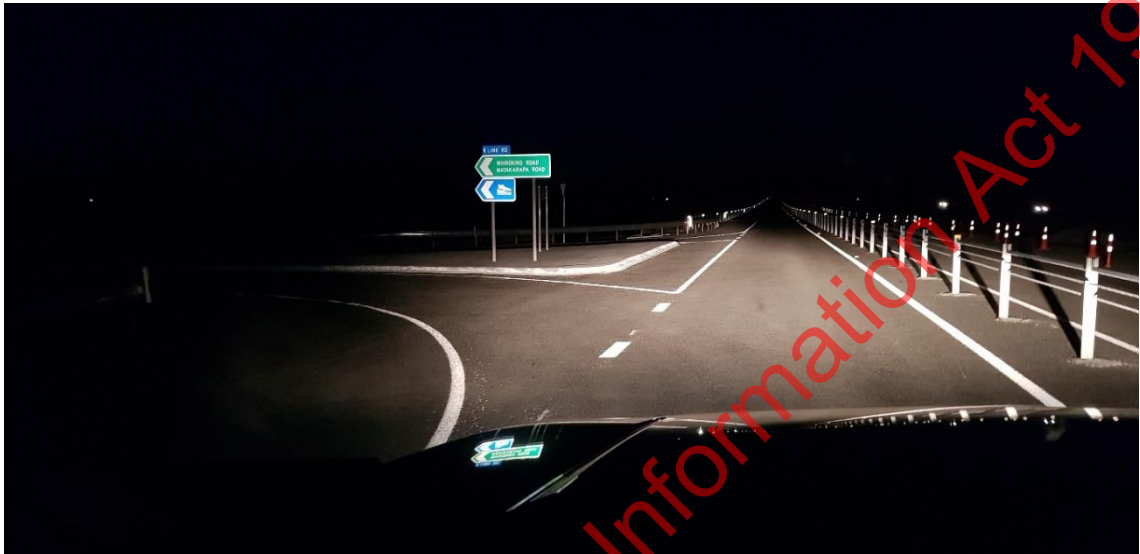
Poor visibility to the left turn northbound onto Link Road. Additional delineation may assist with visibility of the edgeline and traffic island.

Note that street lighting at the intersection was not operating during the time of the audit and may alter intersection and turning visibility.

Provide white hatched marking as per MOTSAM.

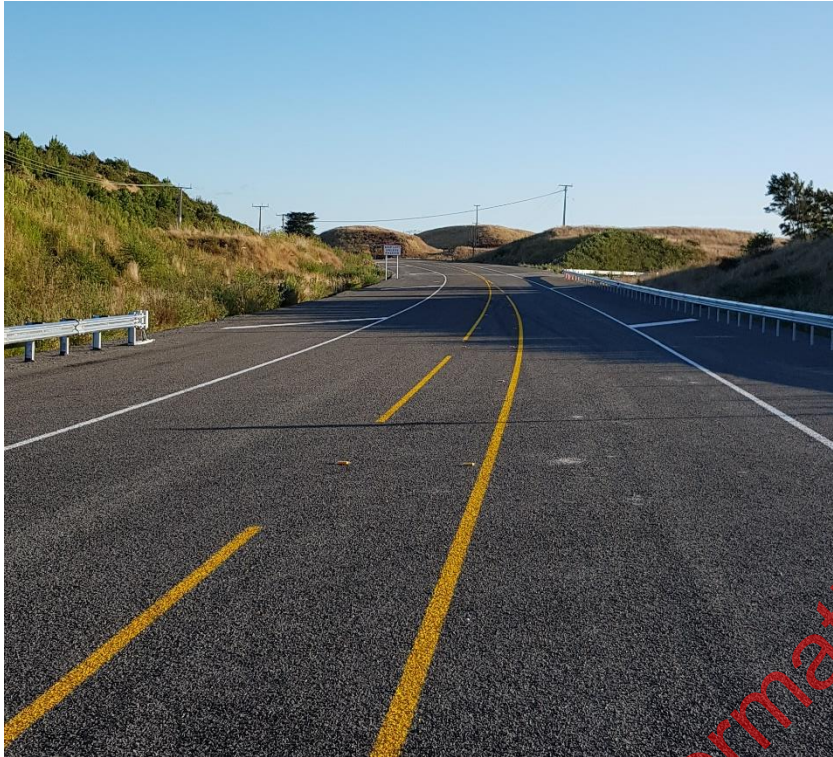
There are several locations within the project extent with very wide shoulders, this provides a significant offset between edge marker posts (free standing or barrier mounted) and the edgeline.

Additional night time delineation of the edgeline should be provided where there is a shoulder wider than 2.0 m. This could be red RRPM or other edgeline delineation methods.

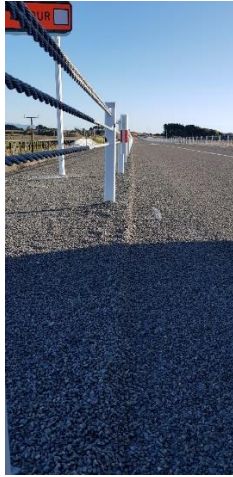
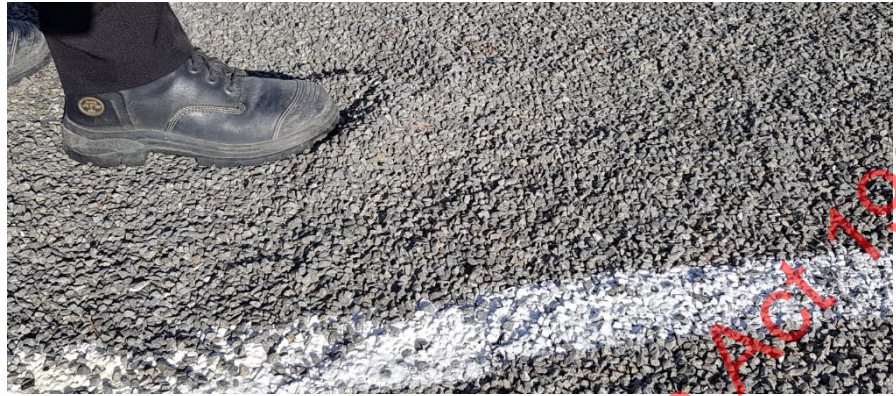
There is a build-up of loose chip in front of Scruffy Dome sumps at either end of the bridge, this should be cleared away to reduce potential ponding.

There is also a large amount of loose chip at the northern end of the bridge where the seal changes from the bridge surfacing back to chip seal, creating a bump when driving over at low speeds.

Sweep up loose chip on shoulders and traffic lanes of the project extent.

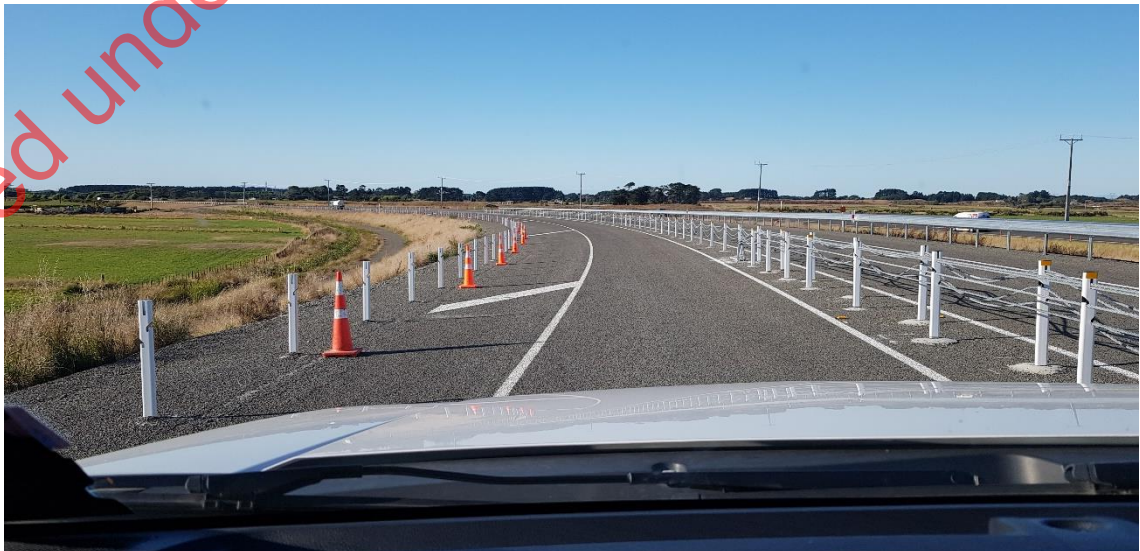
There is a potential for future vegetation growth on the embankment north of the Moutoa Floodway Bridge (Whirokino) to reduce sight distance to the farm access.

Ensure that low grow plants are used on the embankment.

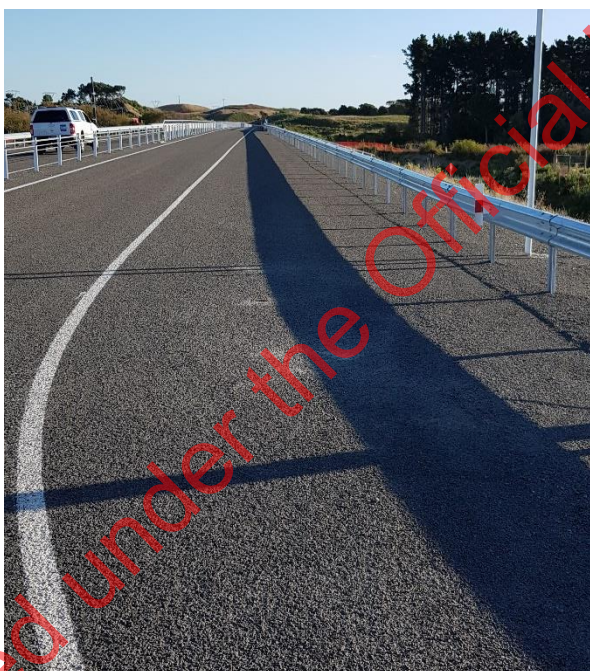
Barrier is over 3.0 m back from edge line prior to the intersection, which will encourage drivers to use the shoulder as a deceleration lane or slow vehicle bay. This is unsafe as drivers overtake turning traffic will be obscured from drivers at the intersection turning left out.

Consider methods of reducing the effective shoulder width, this could include:

edge line markings, this should discourage vehicles from using the shoulders as an auxiliary lane.
Safety Engineer	The approach recommended by BBO is adequate.
Client Decision	Agree with BBO and Safety Engineer's responses.
Action Taken	All road marking changes to be implemented. November 2020 update: Diagonal shoulder bars to be applied after second coat sealing. June 2021 update: Additional bars have been added. No further action required.

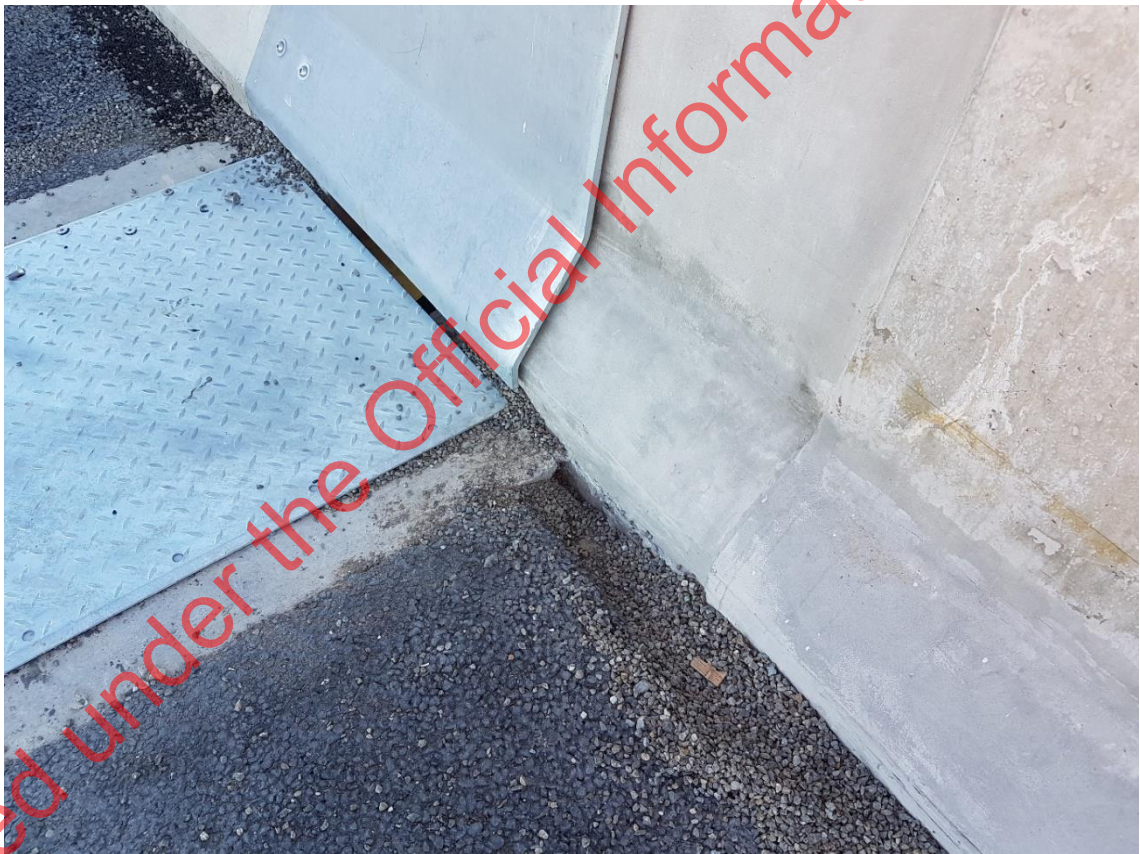
There is a gap in the surfacing at the northern bridge expansion joint.

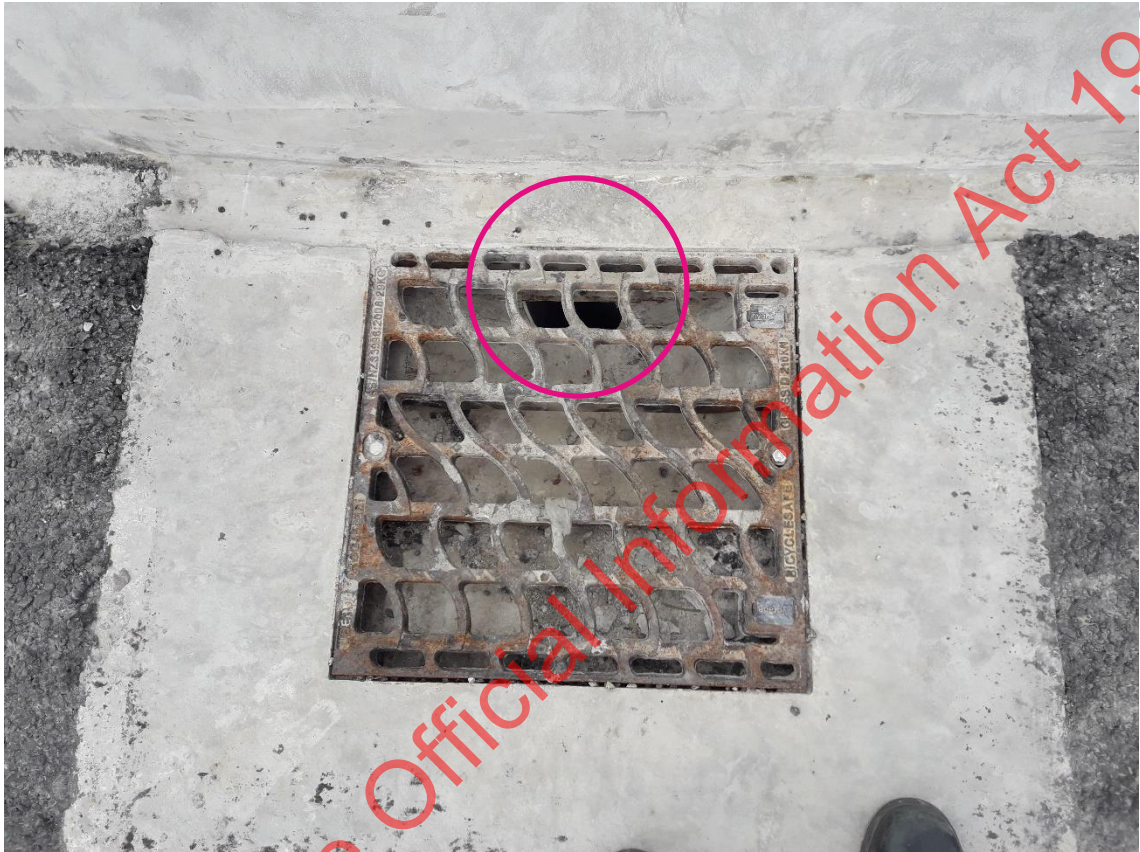
The drain outlets within sumps on and near the bridges appear to have a very small diameter outfall, and could easily clog with vehicle and wind-blown debris. Clogged drains can cause ponding on the bridge surface. With no visible access from the underside of the bridge for the northbound traffic lane sumps and scruffy dome at bridge abutments, there is concern that

Novare Comment: Downpipe nominal diameter is 150mm. In some locations a portion of the pipe is partly obscured beneath the edge of the TL5 barrier. Full access to the top of the 150 dia pipe is available when the sump grate is raised and the pipe inlet is not partially blocked.

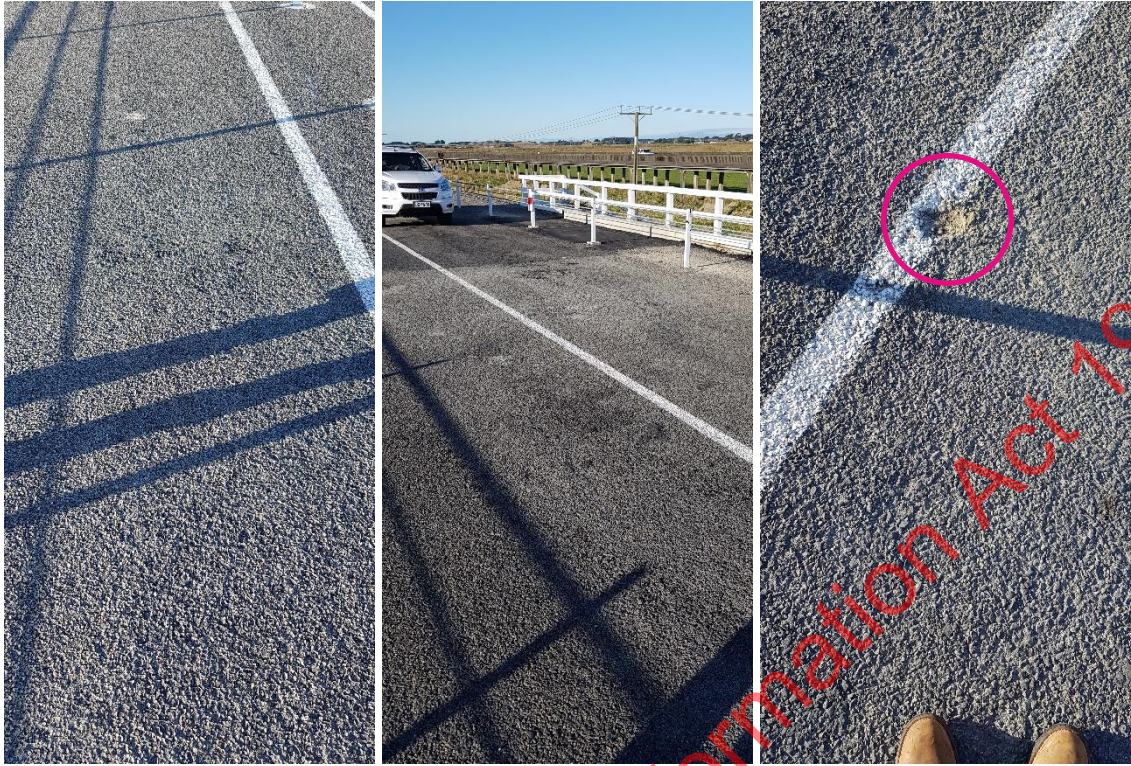
Surfacing at the stock underpass appears to be failing, this will require maintenance. In the right hand photo below, there is a crater in the surfacing exposing base course.
