SEDDON EARTHQUAKES
DETAILED DAMAGE REPORT

WCC CIVIC ADMIN BUILDING (CAB)

WELLINGTON CITY COUNCIL

CIVIC ADMIN BUILDING – DETAILED DAMAGE REPORT

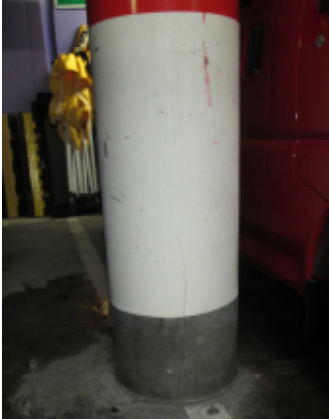
Basement Column G/12 – inspected after a vertical crack was noted by council workers. The area around the crack was chiselled away to reveal cracking was only in aesthetic render layer. However, exposing column found that stirrups at bottom of column lack cover concrete and corroding reinforcing was evident which should be repaired to maintain longer term durability.

Damaged Item	Location	Example	Recommended Repair
1.0 Vertical crack in base of basement column	Basement carpark, column G/12

Re-mortar column render layer – once boney concrete is removed and rusting reinforcing is addressed.
1.1. Stirrup exposed at base of column	Column G/12

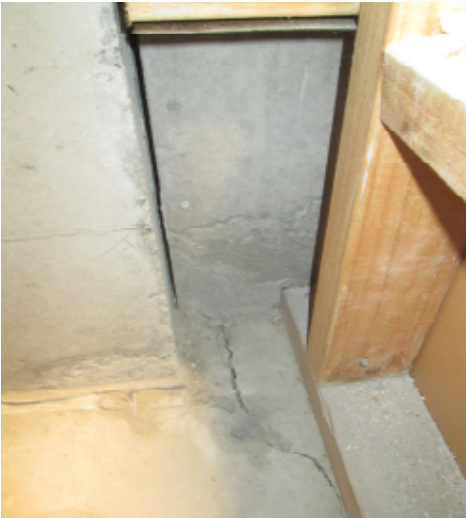
cavity. Supported (grid C) beam does not seem to have moved significantly on seating. However cracking and spalling observed in the beam directly adjacent to the connection on the western side indicates the supported beam has moved during the earthquake but come to rest back in its original position. Such cracking was only seen in the corbel on top of the beam which is not a critical part of the structural member and is due to concrete being cast directly onto a beam that is designed to move. Cracking indicates reasonable levels of movement occurred and further reinforces need to progress building seismic securing works.

Damaged Item	Location	Example	Recommended Repair
2.0 Cracking >1.5mm adjacent to RHS supported column	Top face of beam on western side of column C/28 on floor 3

No urgent action required – progress documented seismic securing works.
2.1	Same as above.

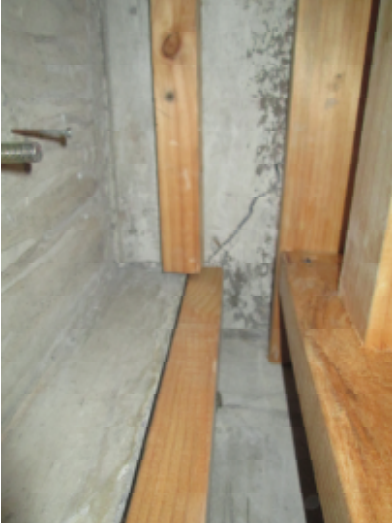
Damaged Item	Location	Example	Recommended Repair
2.2	Bottom face of beam on western side of column C/28 on floor 3

As above.
2.3	Top face of beam on western side of column C/28 on floor 2

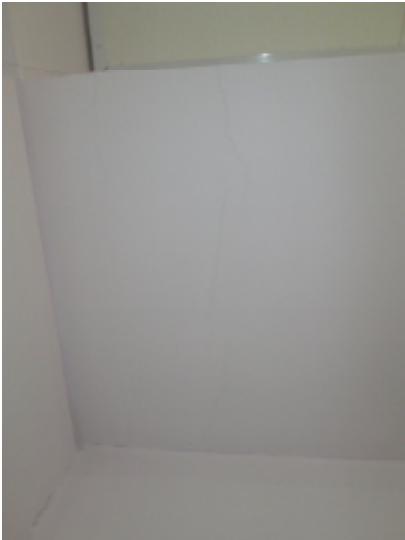
Damaged Item	Location	Example	Recommended Repair
3.0 Two hairline cracks on bottom face of beam	Seen from L2, end bay of grid line 28, next to column D/28

No remedial action required.
3.1 Two hairline cracks seen from beneath beam	Seen from L2, Grid line 11, adjacent to column A/11

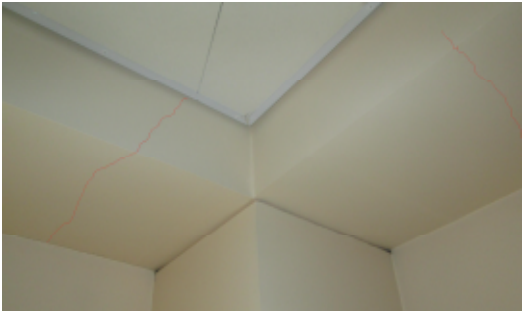
Damaged Item	Location	Example	Recommended Repair
3.2 Hairline cracking of beams at corner joint.	Seen from L2, around column D/11

As above.
3.3 Two hairline cracks seen from beneath beam (only one shown in photo as other crack was further along same beam)	Seen from L3, grid line 11, adjacent to column A/11

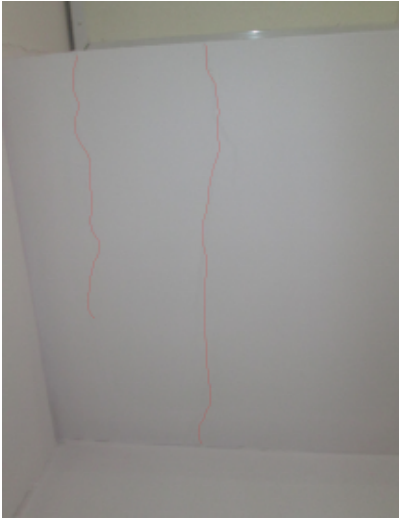
Damaged Item	Location	Example	Recommended Repair
<p>3.4 Two hairline cracks seen from beneath beam</p>	<p>Seen from L3, grid line 28, adjacent to column D/28</p>

<p>As above.</p>
<p>4.0 Cracking seen on top surface of concrete floor topping layer at beam to Dycore interface. Example shows largest cracking seen on L2, located in corner A/11.</p>	<p>Floor of L2, cracking seen in corner bays around column A/11</p>

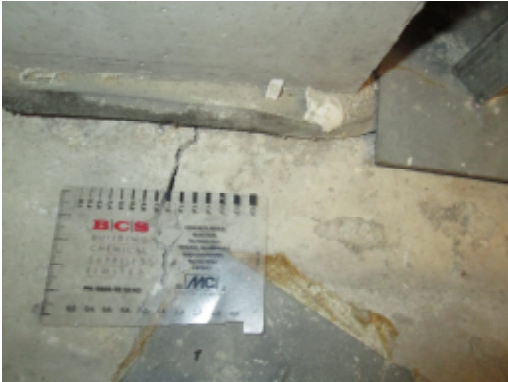
Damaged Item	Location	Example	Recommended Repair
<p>4.1 Same as 4.0. Showing worst crack observed on L2 , ~1.4mm</p>	<p>Floor of L2, cracking seen in corner bays around column A/11</p>

<p>Localised issue – no remedial action required.</p>
<p>4.2 Cracking seen on top surface of concrete floor topping layer at beam to Dycore interface. ~0.4mm</p>	<p>Floor of L2, cracking seen in middle bay between A/11 and B/11</p>

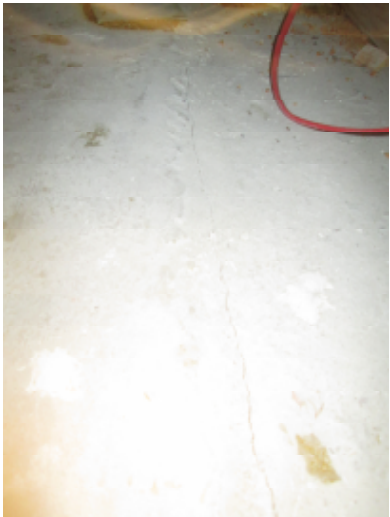
Damaged Item	Location	Example	Recommended Repair
<p>4.3 Cracking seen on top surface of concrete floor topping layer at beam to Dycore interface.</p>	<p>Floor of L2, cracking seen between A/11 and B/11, in bay adjacent to B/11</p>

<p>As above.</p>
<p>4.4 Cracking seen on top surface of concrete floor topping layer at beam to Dycore interface. ~0.4mm</p>	<p>Floor of L2, cracking seen in corner of building around column D/11</p>

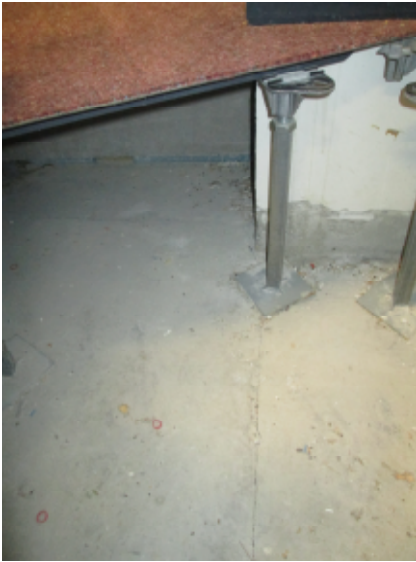
Damaged Item	Location	Example	Recommended Repair
<p>4.5 Cracking seen on top surface of concrete floor topping layer at beam to Dycore interface.</p> <p>~0.6mm</p>	<p>Floor of L2, cracking seen in corner of building around column D/28</p>

<p>As above.</p>
<p>4.6 Cracking seen on top surface of concrete floor topping layer at beam to Dycore interface.</p> <p>~1.0mm</p>	<p>Floor of L3, cracking seen in corner bay around column A/11</p>

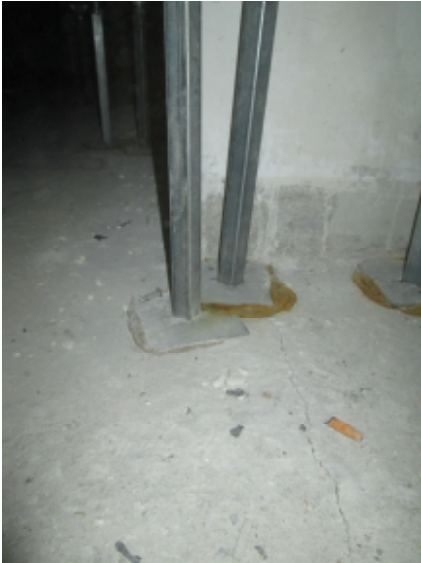
Damaged Item	Location	Example	Recommended Repair
<p>4.7 Cracking seen on top surface of concrete floor topping layer at beam to Dycore interface.</p> <p>~0.5mm</p>	<p>Floor of L3, cracking seen in middle bay between A/11 and B/11</p>

<p>No remedial action required.</p>
<p>4.8 Cracking seen on top surface of concrete floor topping layer at beam to Dycore interface.</p> <p>~1.8mm</p>	<p>Floor of L3, cracking seen between A/11 and B/11, in bay adjacent to B/11</p>

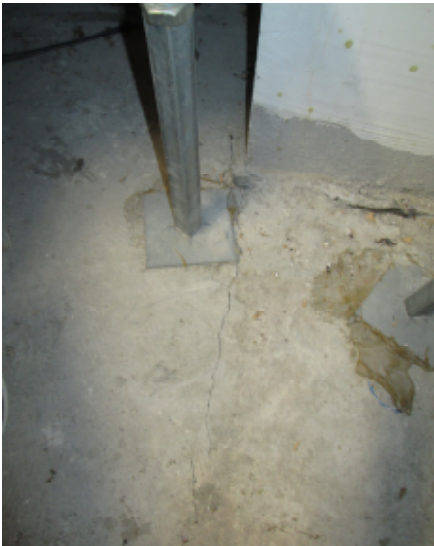
Damaged Item	Location	Example	Recommended Repair
<p>4.9 Cracking seen on top surface of concrete floor topping layer at beam to Dycore interface.</p> <p>~0.6mm</p>	<p>Floor of L3, cracking seen in corner of building around column D/28</p>

<p>No remedial action required.</p>
<p>5.0 It is evident the Portico has experienced approximately 50-100mm of movement with approx 10-15mm residual displacement. Some of which may be pre-existing.</p>	<p>Carpet movement above sliding joint on Library side of portico.</p>

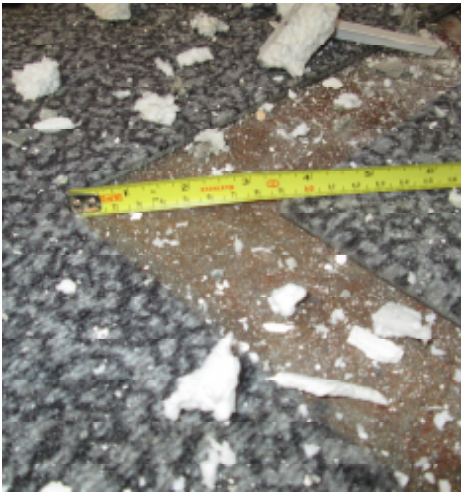
CAB/Portico-Central Library – significant non-structural damage at seismic joint between Portico and Central Library in ceilings, flashing and some external glazing panels. In addition damage to structural sliding bearing supports was identified. Displacement in the range 50-100mm at this junction (larger at L5) was apparent. Some residual displacement 10-15mm might remain although this is difficult to quantify.

<p>Restricted access to Portico and advance Portico demolition planning.</p>

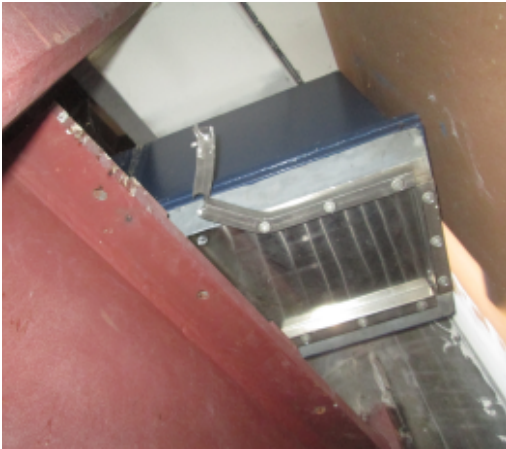
Damaged Item	Location	Example	Recommended Repair
<p>5.1 The Portico sliding bearings with “frozen” puck and subsequent damage to bearing guides.</p>	<p>Portico sliding bearings on Central Library side within access spaces at Library L2.</p>

<p>As above.</p>
<p>5.2 Damage to non-structural elements at connections to Portico. Damage was more extensive on Central Library side due to sliding joint.</p>	<p>Example photo is on CAB side.</p>

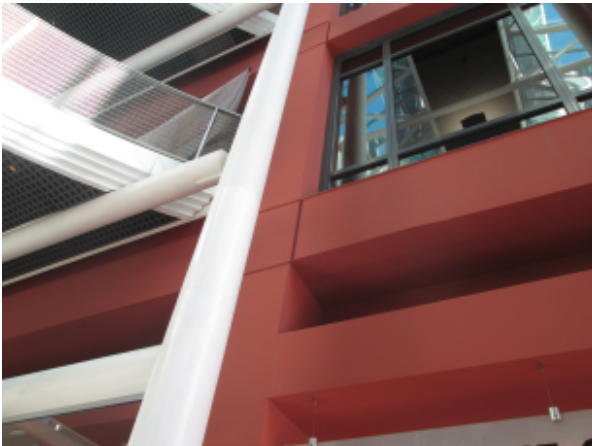
Damaged Item	Location	Example	Recommended Repair
8.0 Crack visible on exterior of L1 beam	Visible from lobby/atrium of MOB building.

No remedial action required.

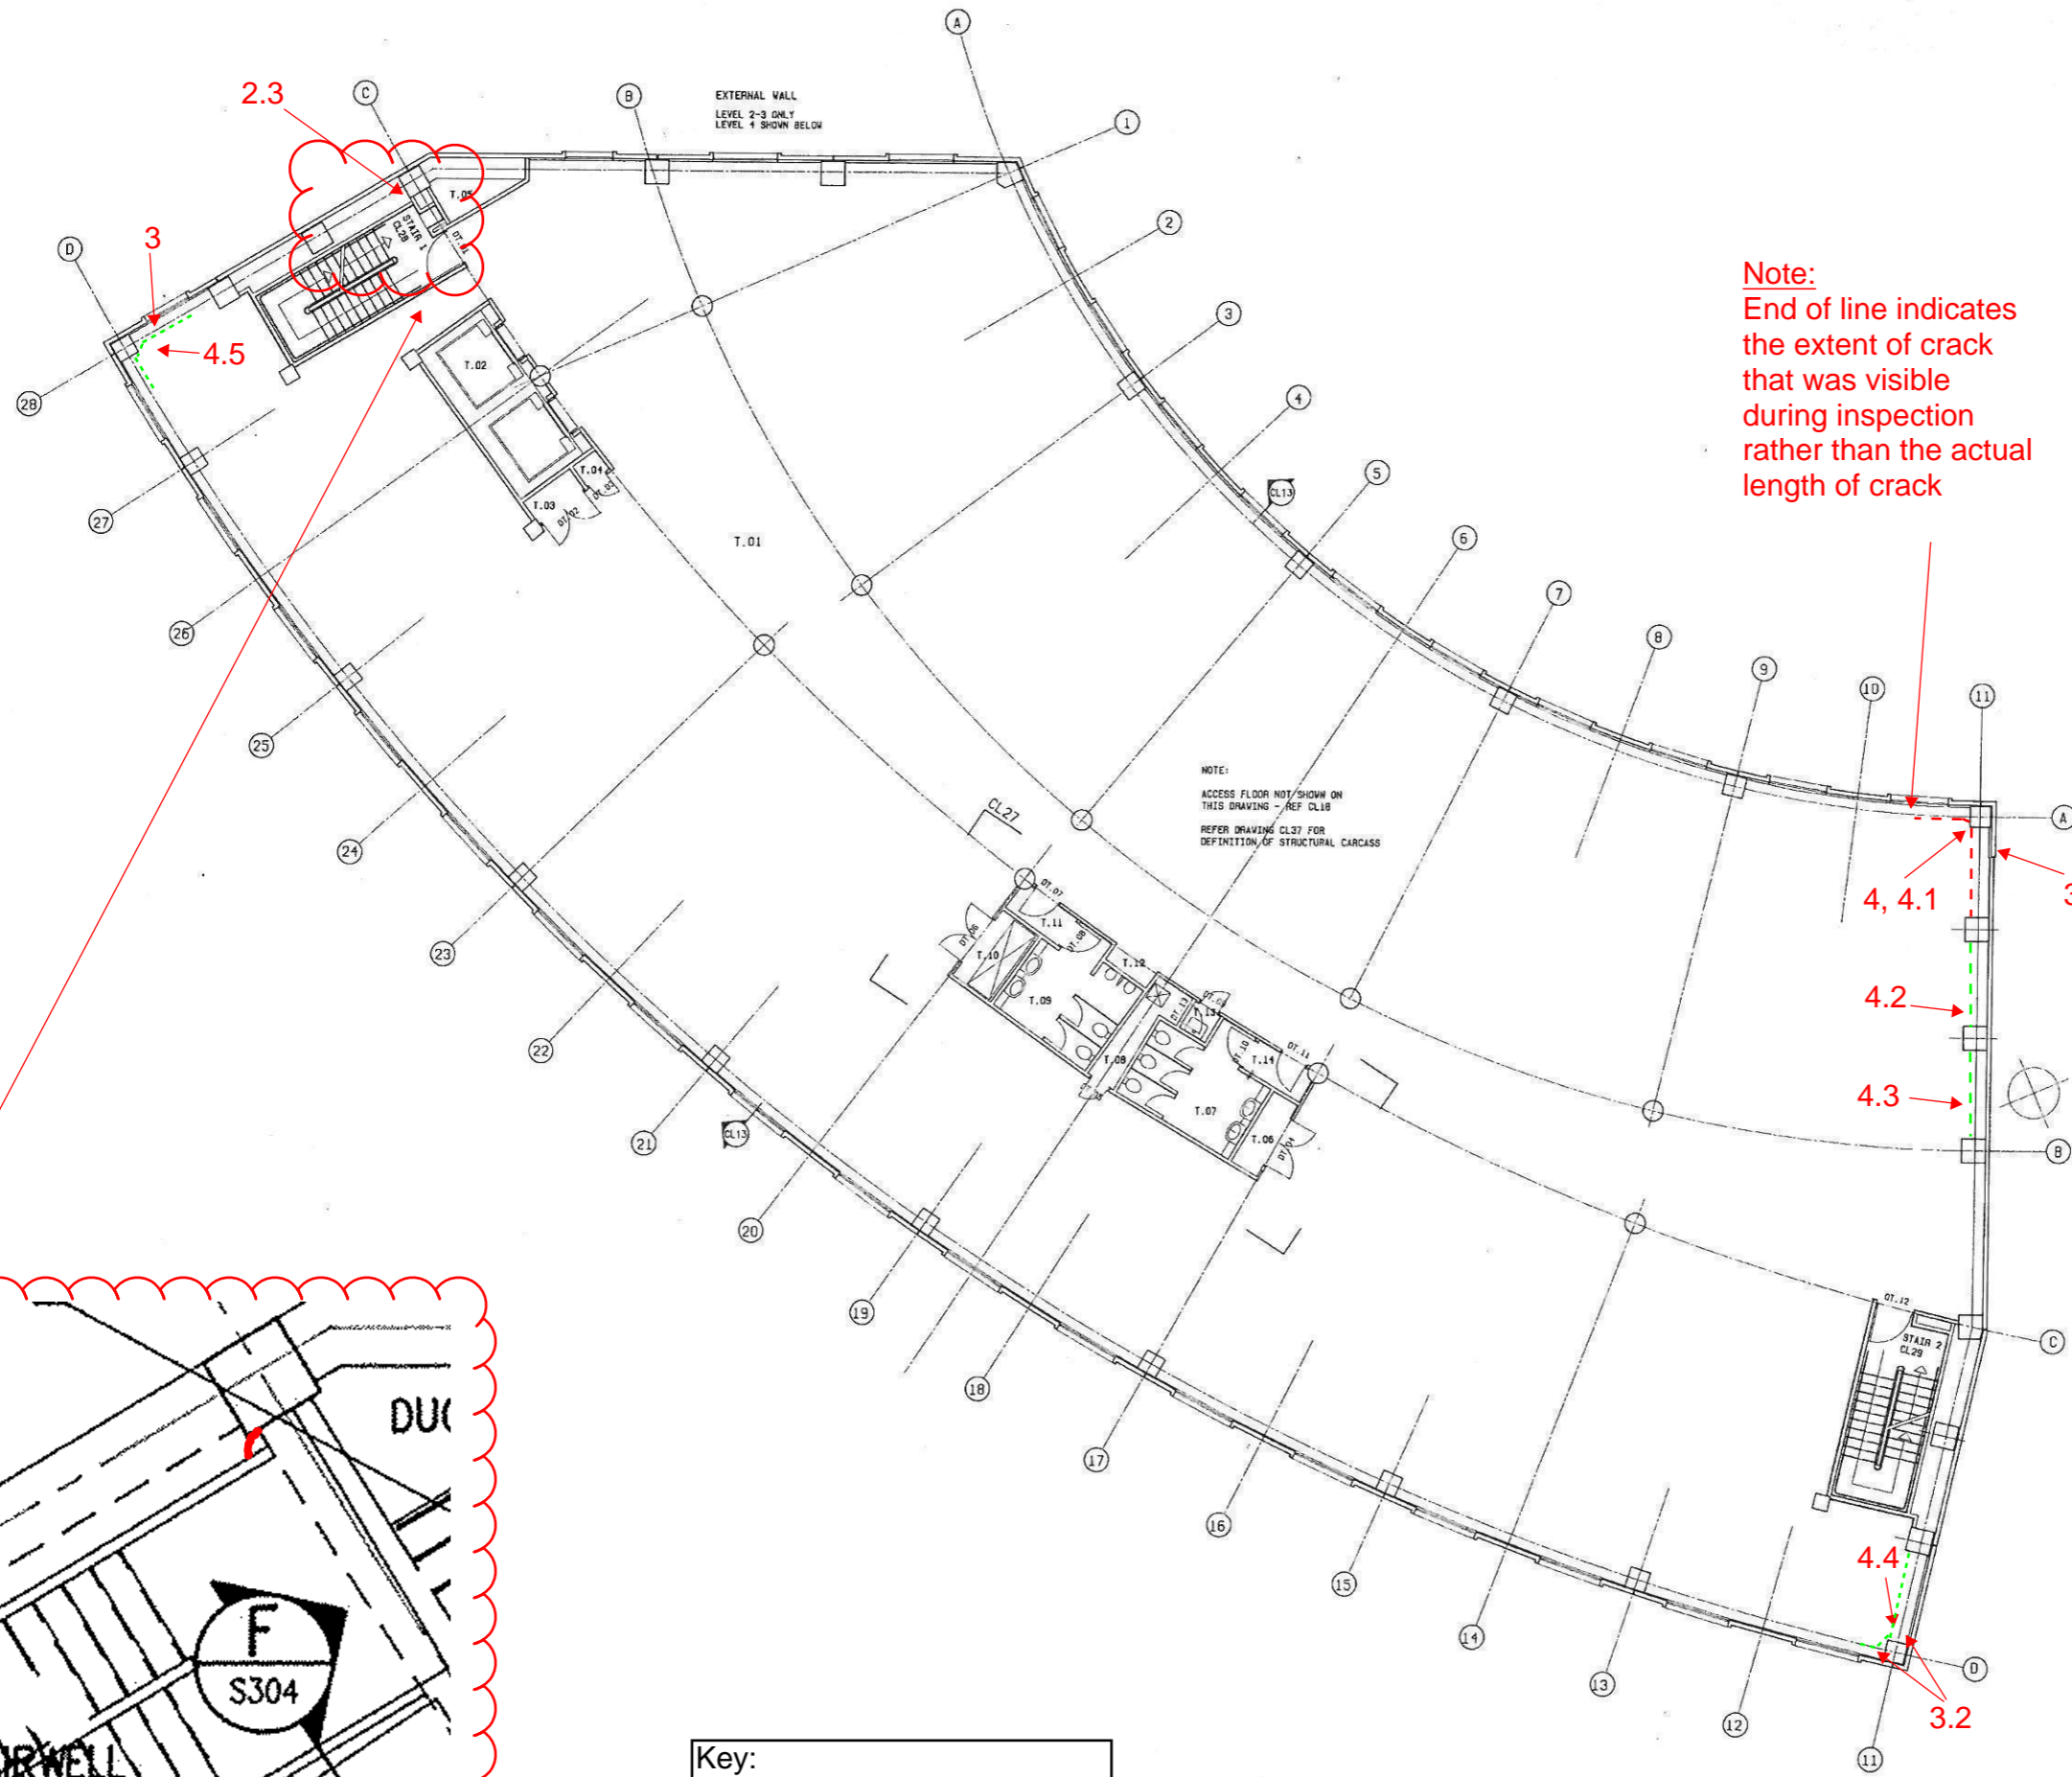
Floor of Level Two

Note:
End of line indicates
the extent of crack
that was visible
during inspection
rather than the actual
length of crack
