Thorndon connections cycleway audit - safety and accessibility

90% design audit

Paneke Pōneke
Bike network plan

January 2023

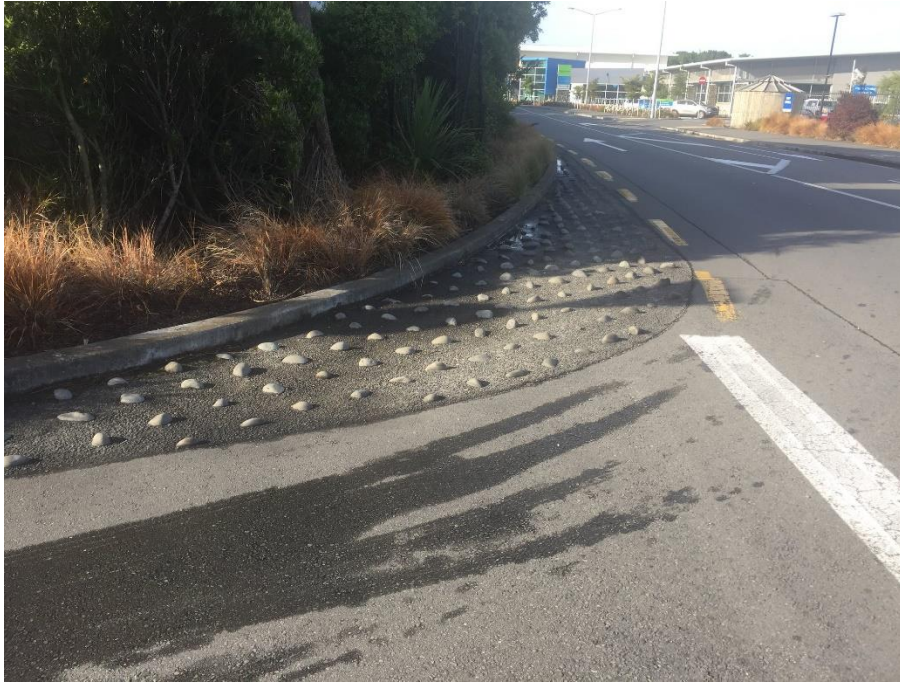
Figure 4-1: River stones on Sisson Drive

The safety issue is the potential high-speed turns between Hill Street and Tinakori Road which could lead to conflict with pedestrians. The proposed changes to this approach are unlikely to slow vehicles.

The risk factors include: the width of Hill Street – i.e. increased pedestrian crossing distance; and the side road angle, which allows for faster right turns in and left turns out of Hill Street.

Crashes are expected to be very unlikely (one every 7+ years), but those that do occur would likely result in serious injury, due to the vehicle speeds involved.

| 4.1.1 | <p>Rather than a painted edge line, the area could be filled with river stones set in concrete (similar to the Northlands Mall approach to Sisson Drive in Christchurch – see Figure 4-1). This would be traversable by heavy trucks, but avoided by car drivers.</p> <p>Consider whether the area of the river stone island can be increased above that of the painted edge line currently proposed (based on light vehicle tracking).</p> <p>Ensure a flat pedestrian path through the stony area is included.</p> | |

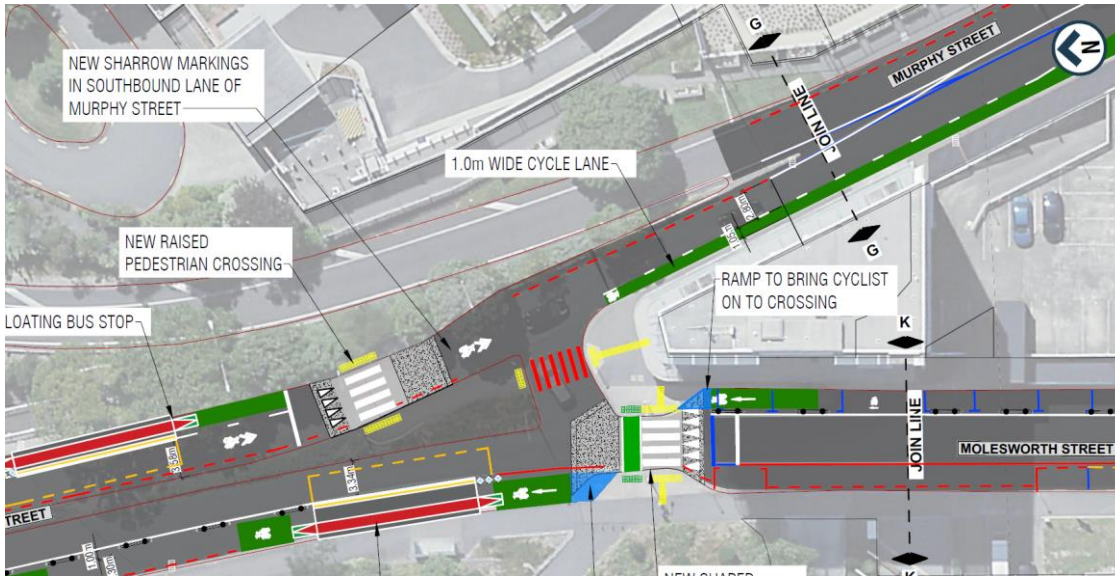
Figure 4-2: cycleway transition in vicinity of bus stop and pedestrian crossing

The safety issue is that the merge point for cyclists and motorists appears to be on the pedestrian crossing platform; this could cause confusion for cyclists or motorists and could ultimately result in motorists failing to merge correctly with cyclists or give way to pedestrians on the crossing.

Firstly, shifting the bus stop back has improved the distance available for cyclists and motorists to merge.

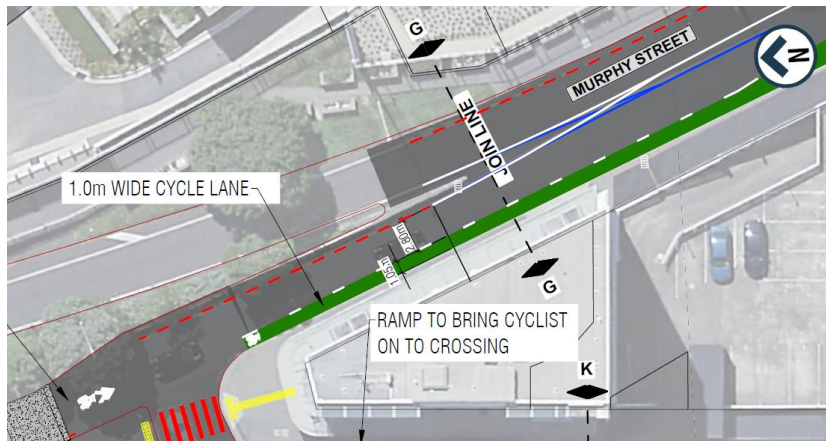
Figure 4-3: narrow cycle lane on Murphy Street

The safety issue is the cycle lane on Murphy Street after the pedestrian crossing (see Figure 4-3) is too narrow.

The crash type expected is cyclist vs motorist.

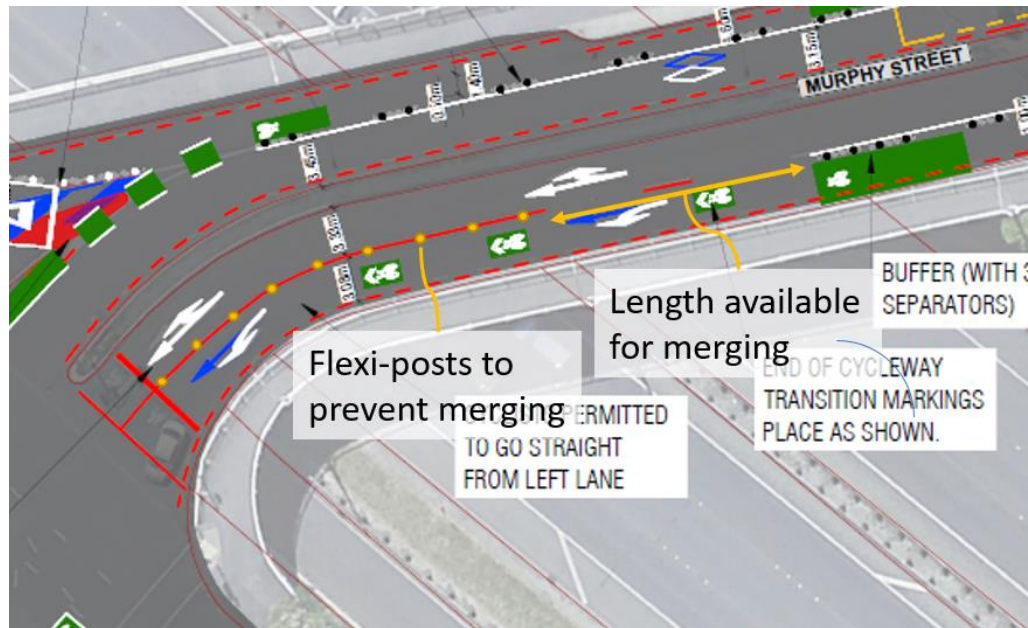
Figure 4-4: Mixing lane with defined merging length

reduce the size of the zone of potential conflict and increase predictability.

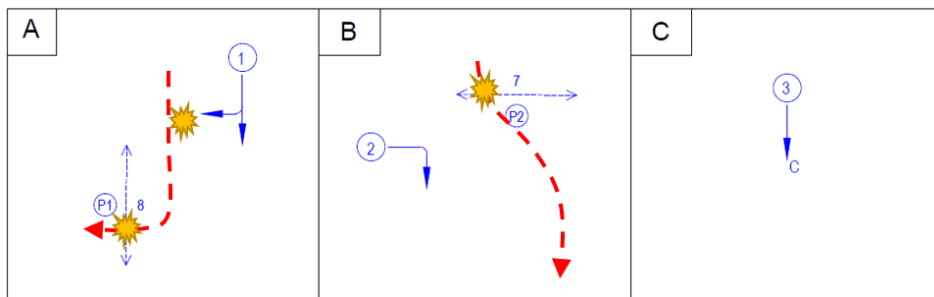
Figure 4-5: Likely cyclist non-compliant manoeuvres and resulting conflicts

The safety issue is the fully protected cycle movement at this intersection will increase cyclist waiting time, reduce cyclist LOS, and lead to some cyclists undertaking unsafe manoeuvres.

The problem is that, in either the A or B phase, there will be cyclists waiting at the limit line believing that they could progress safely, and some cyclists will choose to run a red light to improve their efficiency – these are illustrated in Figure 4-5. In the B phase, cyclists travelling along Mulgrave Street would be safe to cross on a sharp diagonal, provided they do not conflict with any pedestrians crossing Mulgrave Street. In the A phase, cyclists turning right might do so, but they would risk conflict with any pedestrians crossing Aitken Street and, of greater concern, they would be at risk of being hit by vehicles turning right into Aitken Street.

Furthermore, whilst one cyclist may be able to judge a safe manoeuvre, subsequent cyclists may follow along without adequately judging the situation. For example, a confident right turning cyclist may move in the B phase, knowing they can make it before an approaching right turning vehicle, but the cyclist behind them may not notice the vehicle or judge the

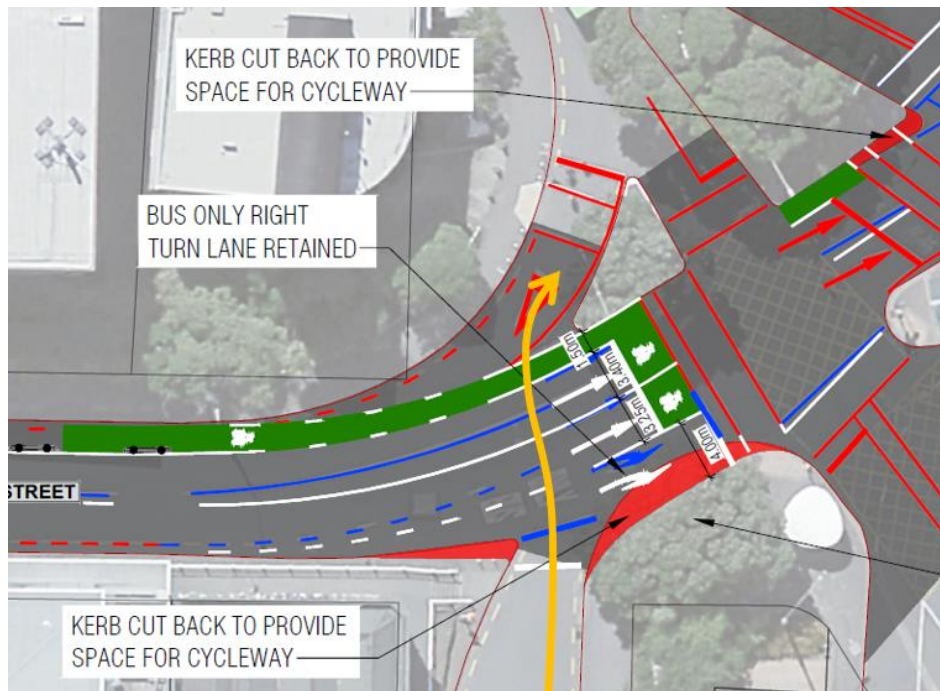
Figure 4-6: Existing illegal manoeuvre from Kate Sheppard Place eastern end

presence of contra-flow cyclists, plus the complication that these cyclists will be travelling fast in the downhill direction. Moreover, the CAT was informed that it was decided to retain the two-way functionality of Kate Sheppard Place at Molesworth Street because making it one-way would exacerbate the existing problem of drivers disregarding the right turn-only restriction at the other end of Kate Sheppard Place and crossing three lanes of traffic to access the left turn from Mulgrave Street to Thorndon Quay.

The CAT acknowledges that adding the cycle lane would worsen the consequences of this existing illegal manoeuvre, as drivers then have an additional lane to cross and cyclists are more vulnerable than motorists. However, we suggest that the risk to the cyclists on Murphy Street would not be as great as the risk to the contraflow cyclists on Molesworth Street, as the Murphy Street cyclists are travelling in the same direction as the general traffic and therefore more likely to be seen the drivers exiting Kate Sheppard Place. Furthermore, it

| 4.7.3 | Consider physical devices that make the illegal movement more difficult, e.g. flexiposts on the edge of the cycle lane. |

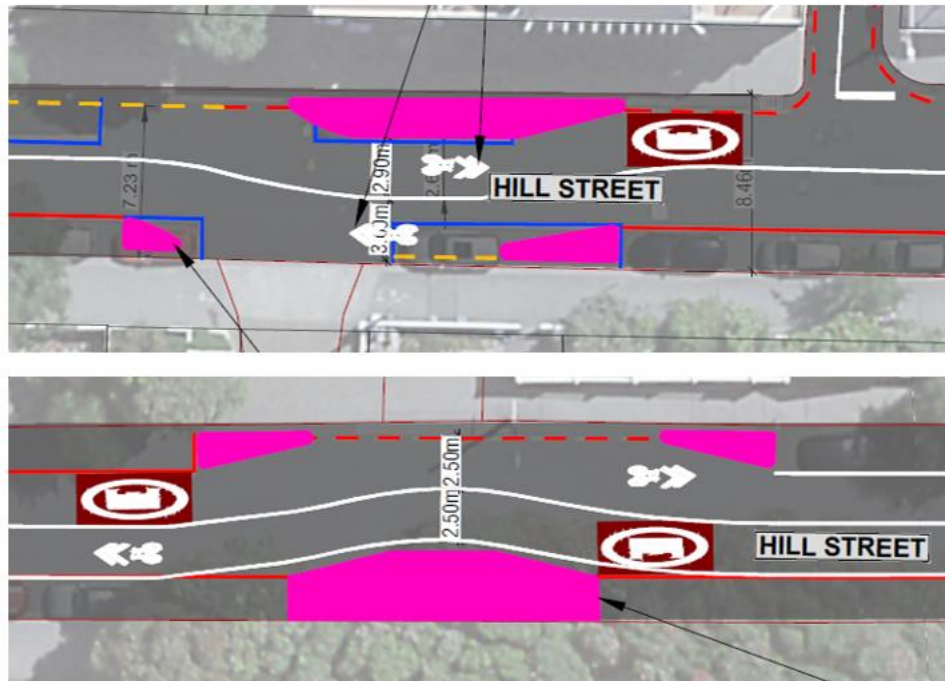
Figure 5-1: Different chicane designs on Hill Street

The two chicanes on Hill Street employ different marking layouts regarding the use of the 30 and sharrows markings (Figure 5-1). It would be preferable to have a consistent design.

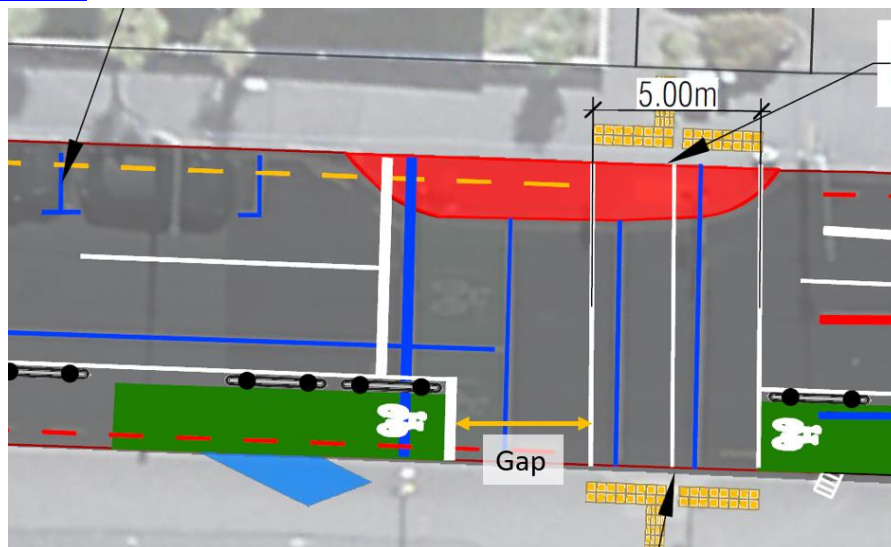
Figure 5-2: Gap between limit line and pedestrian crosswalk

There is a large gap between the advanced stop line and the pedestrian / cycle midblock crossing line; this is only required to be 200mm – see CNG section on [cyclist waiting facilities at intersections](#).
