Site Location: Waikowhai Boardwalk (stage 1) / Bamfield Reserve & Accessway

2 landslips onto the Waikowhai Boardwalk (stage 1) Bamfield Reserve

1 landslip onto the concrete bush track pathway, Bamfield Reserve & Accessway

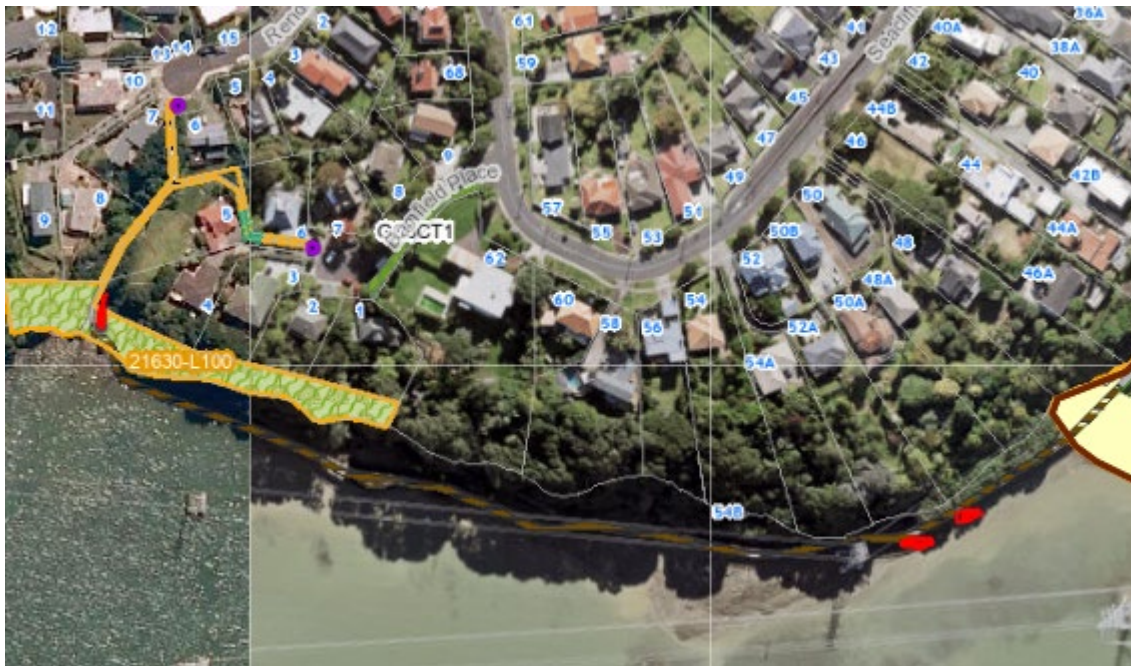
Aerial of damage

2 x landslips onto the Waikowhai timber boardwalk – approximate location shown in red on R/H side of above area snapshot,

1 x landslip onto the bush track concrete pathway – approximate location shown in red on L/H side of area snapshot.

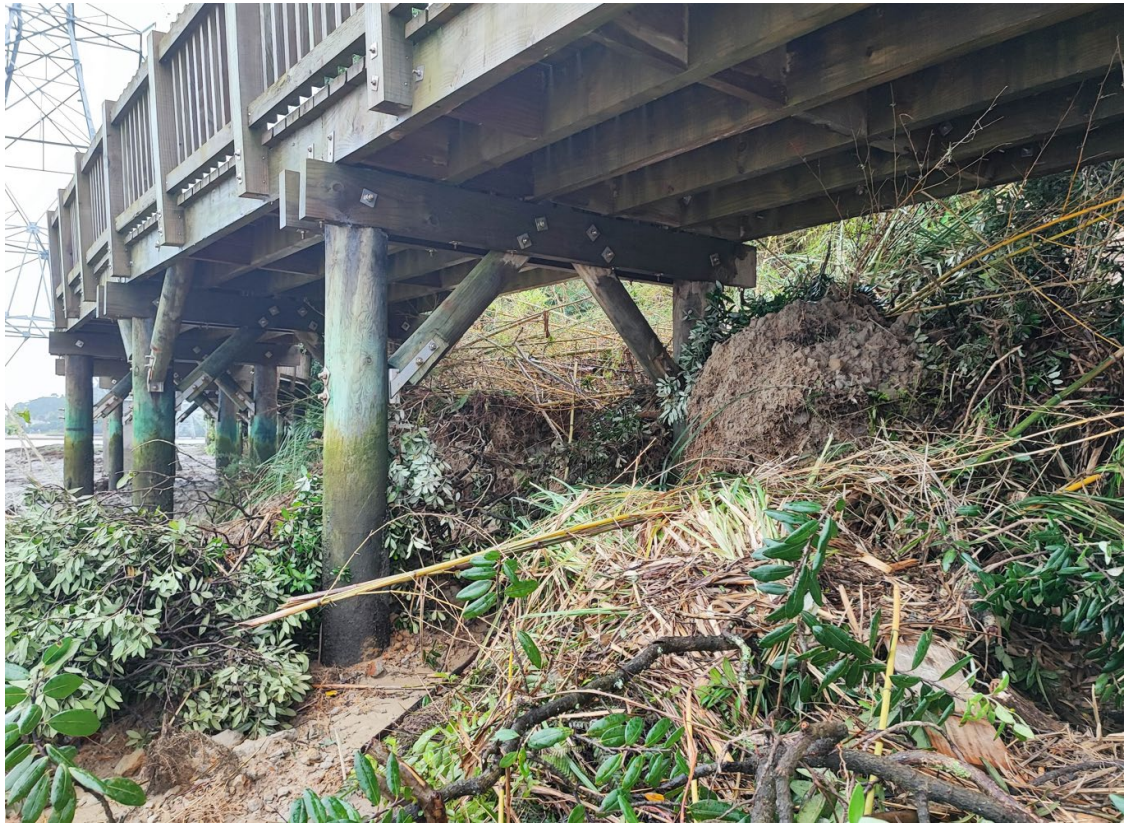
1.

4 photos follow of the damaged timber boardwalk structure.
