# Housing New Zealand Corporation

## Comprehensive Methamphetamine

### Assessment

6<sup>th</sup> August 2015

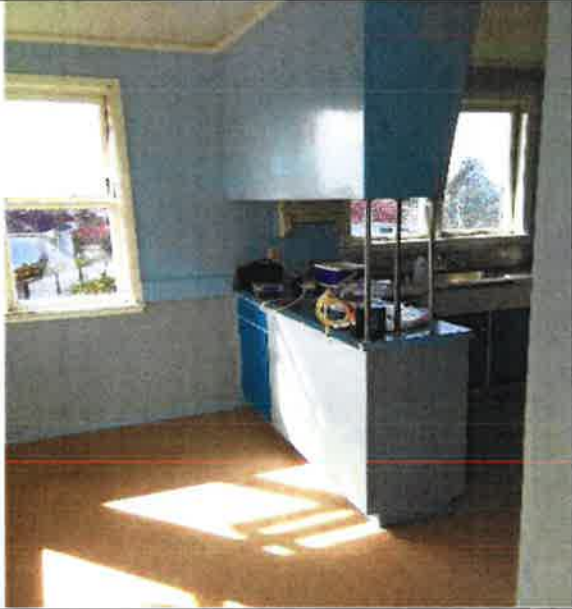
**Q126 Kitchen VOC Sample**

- Kitchen had been cleaned since the initial survey.

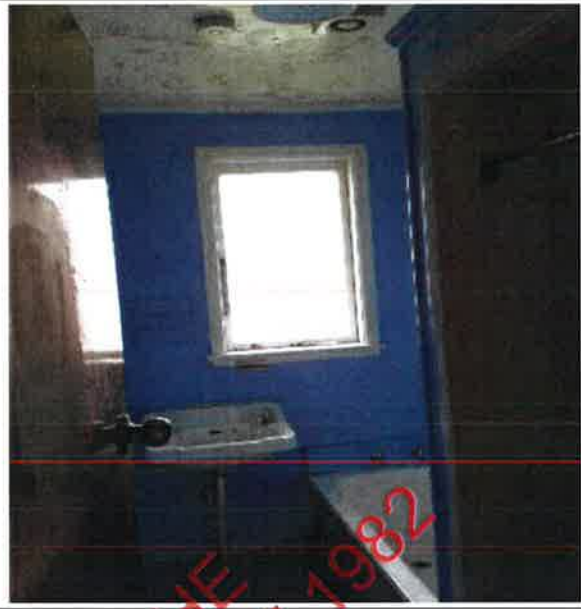
**Q095 Bathroom**

- Bathroom had extensive mould on the ceiling on both visits.

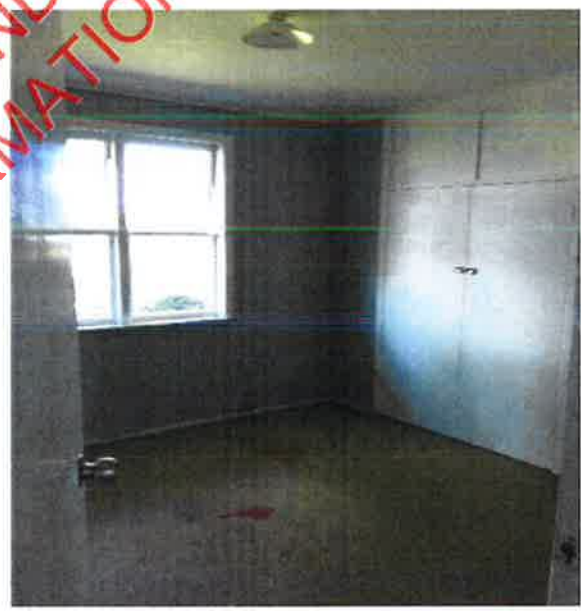
**Q126 Bedroom 1**

- Extensive staining on the carpets.
- Windows open.

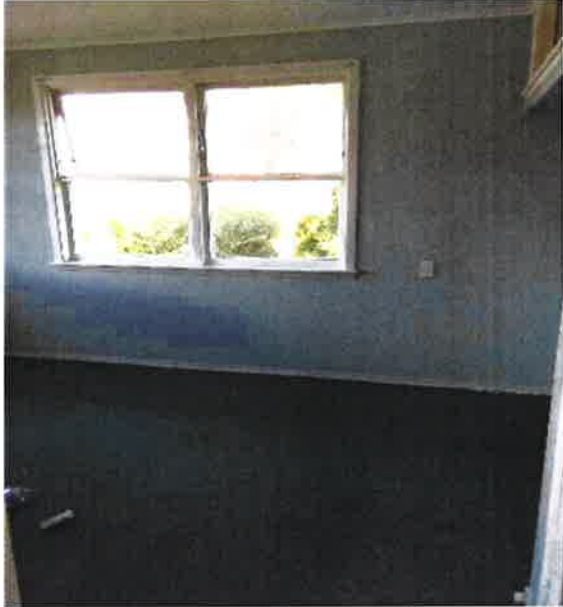
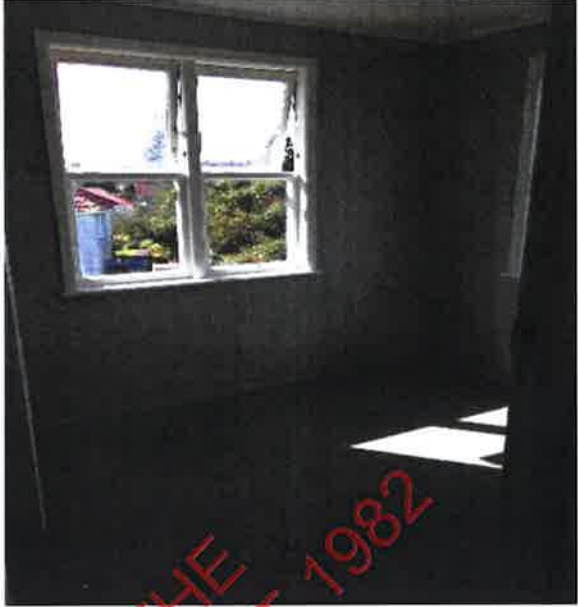
<p><b>Q126 Bedroom 2</b></p> <ul style="list-style-type: none"><li>• Extensive staining on the carpets.</li><li>• Windows open.</li></ul>	<p><b>Q126 Bedroom 3</b></p> <ul style="list-style-type: none"><li>• Extensive staining on the carpets.</li><li>• Windows open.</li></ul>

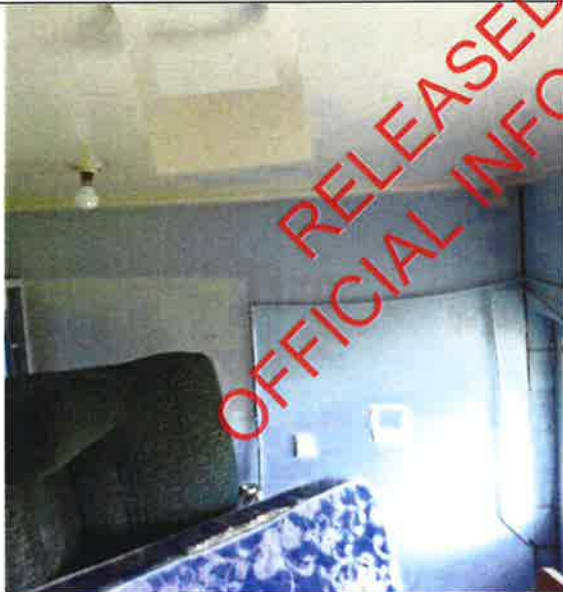
<p><b>Q095 Laundry</b></p>	<p><b>Q095 Laundry</b></p> <ul style="list-style-type: none"><li>• Robond Emulsion tank found in the laundry.</li><li>• Large amounts of paint, floor cleaner and odd material stored in here.</li></ul>

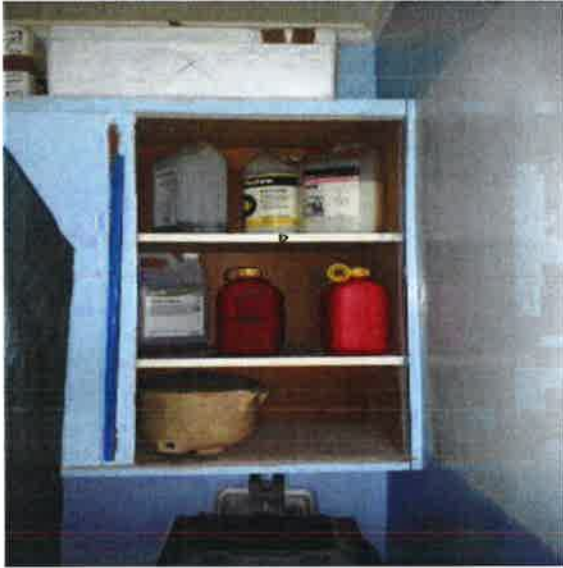
**Q095 Laundry Cupboard**

- A mixture of chemicals found in the laundry.
- Only some of them are household chemicals

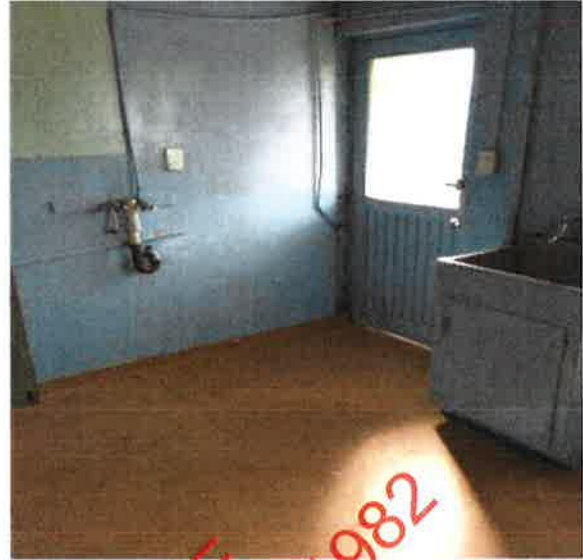
**Q126 Laundry, Back door side**

- Laundry empty on second visit

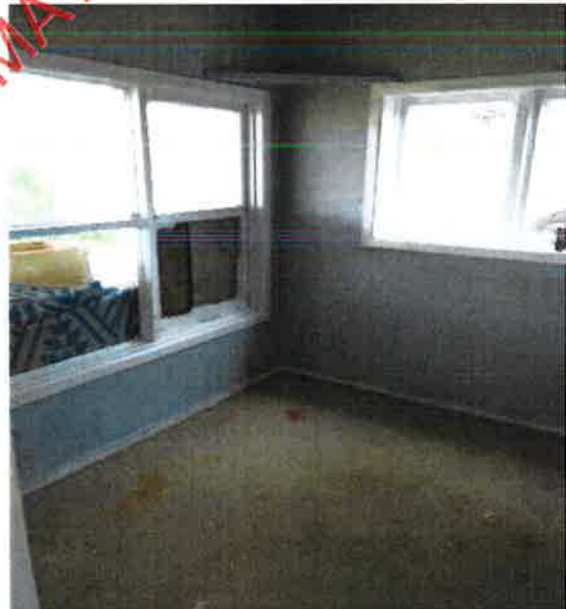
**Q126 Bedroom 4 carport side**

- Two broken windows in this room
- Carpet stained the worst in this room

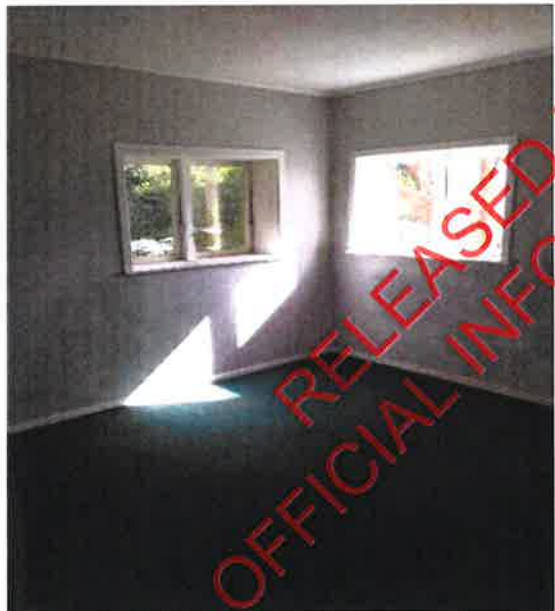
**Q126 Bedroom 5**

- Staining on the carpet
- Windows open
- Walls newly painted

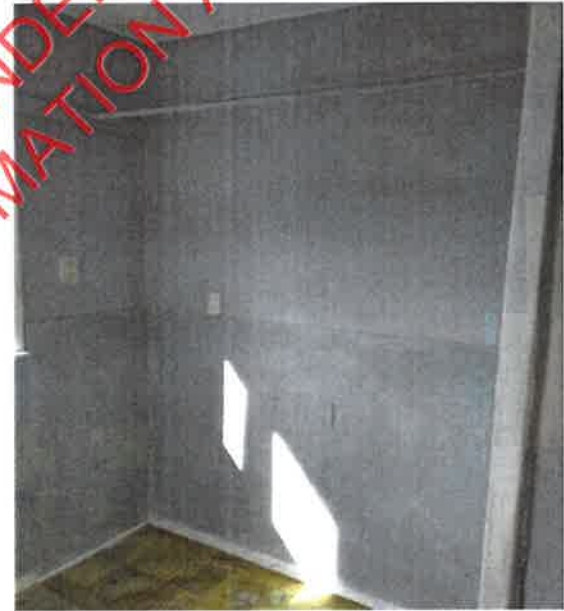
**Q126 Bedroom 6**

- Flooring here is vinyl, not carpet.
- Staining on floor suggests room was used for storage

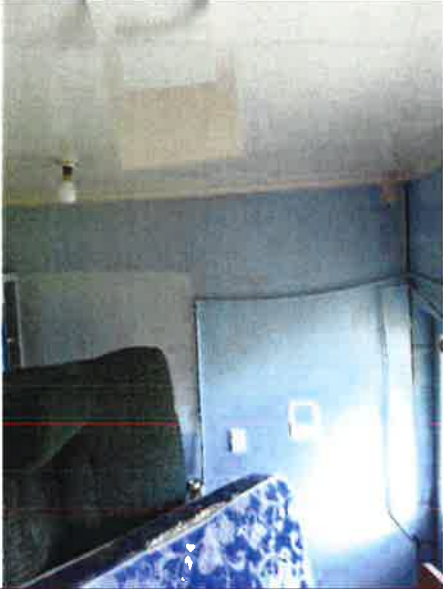
<p align="center"><b>Photo 5: Laundry</b></p> <p>A swab was taken from the wall and ceiling in the laundry.</p>	<p align="center"><b>Photo 6: Bathroom</b></p> <p>A swab was taken from the ceiling and wall in the downstairs bathroom.</p>

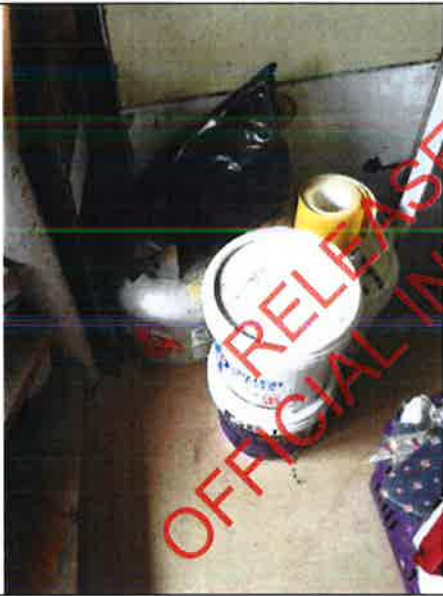
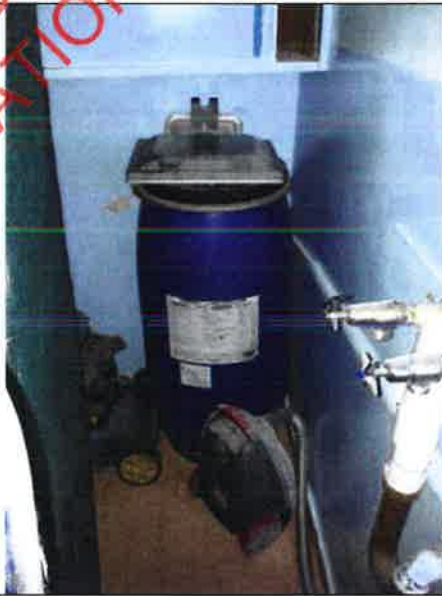
<p align="center"><b>Photo 7: Laundry</b></p> <ul style="list-style-type: none"> <li>• Large amounts of paint, floor cleaner and odd material stored in here.</li> <li>• Could be for painters doing renovations?</li> </ul>	<p align="center"><b>Photo 8: Bedroom</b></p> <p>Robond Emulsion tank found in the laundry.</p>
