Project Number: 5-C3532.00

# Te Ara Tupua

## Concept Design Road Safety Audit

26 July 2021

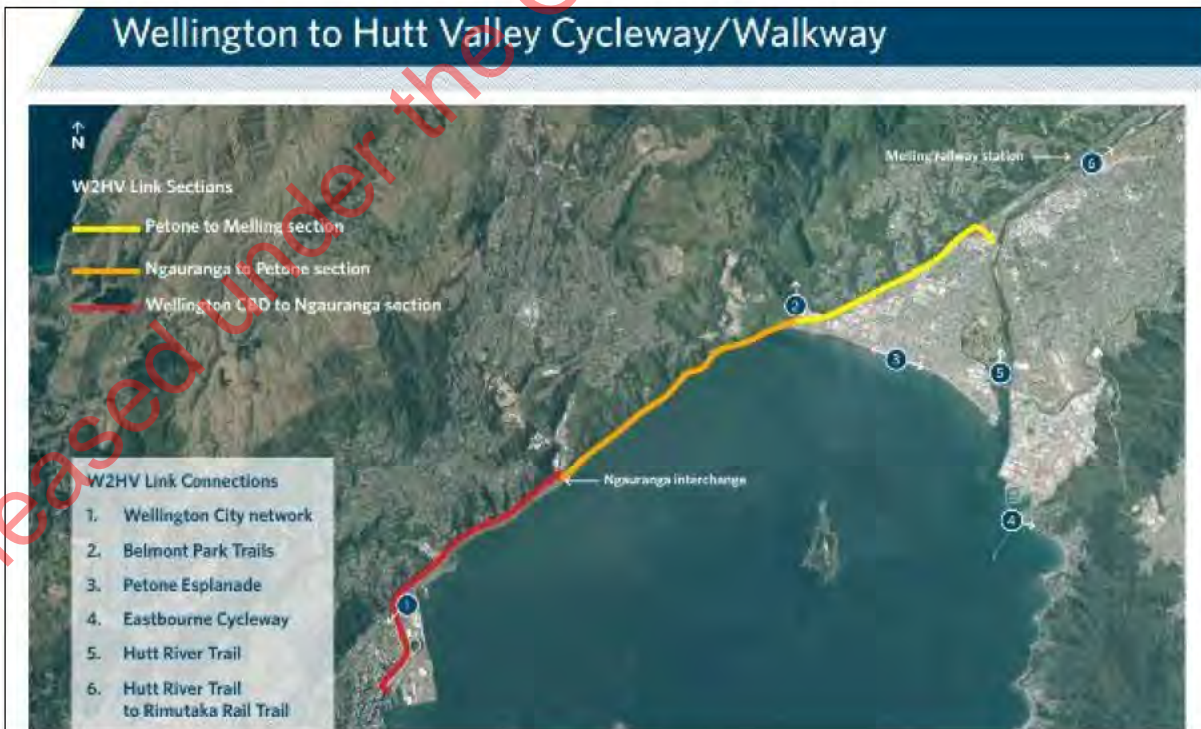
Figure 3: Wellington to Hutt Valley proposed cycle and walkway connections.<sup>4</sup>

This project is being constructed as part of the wider Te Ara Tupua Project, aiming to create a cycle and walkway linking Wellington CBD to Lower Hutt. The planned off-road shared path from Petone to Melling is to join the Te Ara Tupua path as shown in Figure 3.

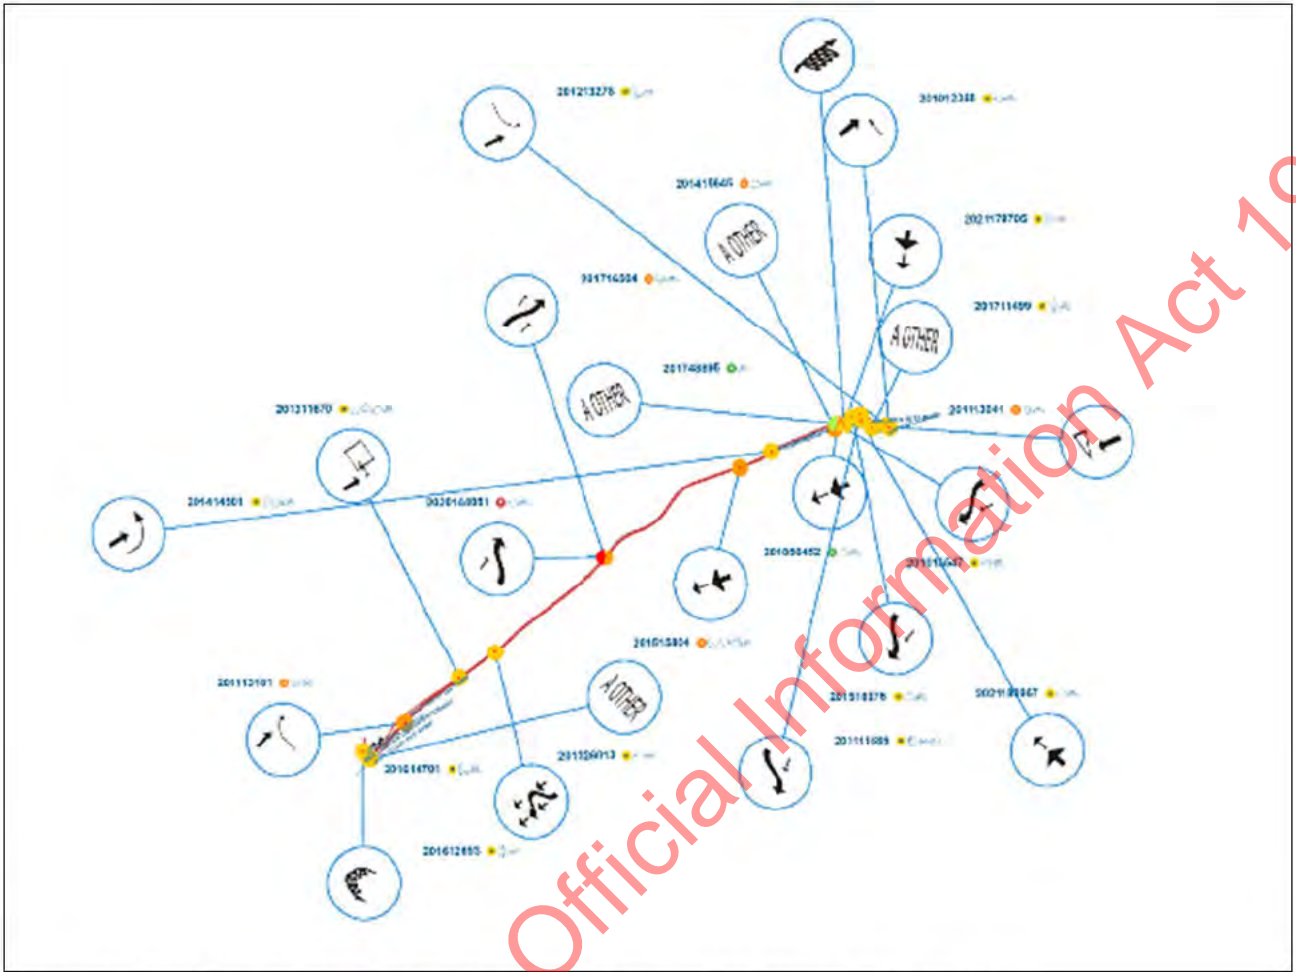
Figure 4: Collision diagram for cyclist crashes occurred between 2010-2020 and 2021 to date.

Figure 4 displays the collision diagram for all cyclist crashes between the Hutt road intersection, SH2, and Petone roundabout

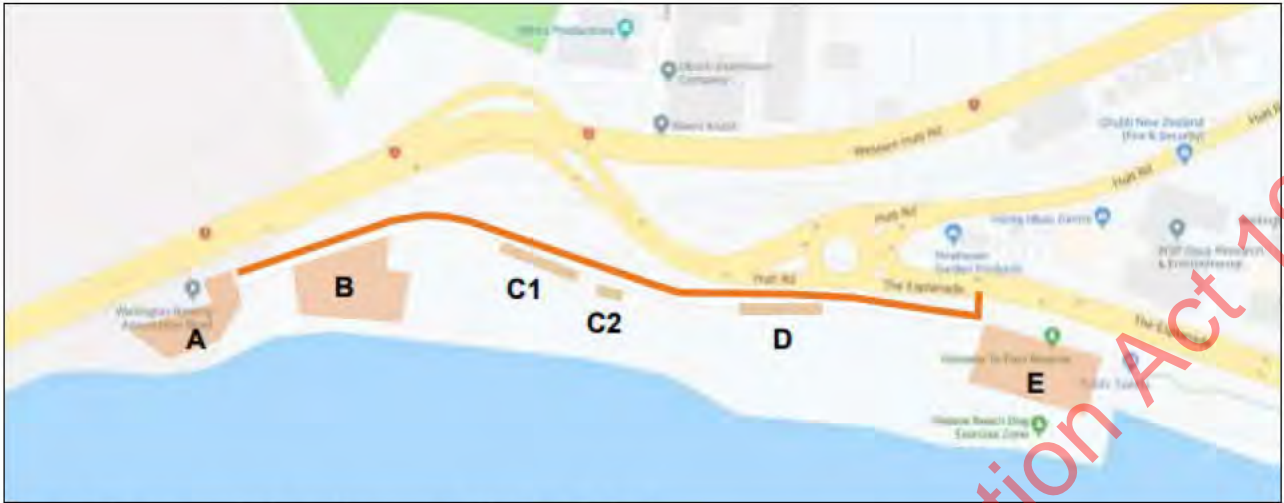
Figure 5: Current available parking areas at Honiana Te Puni.

The Honiana Te Puni Reserve currently has approximately 103 car park spaces across six parking areas, as shown in Figure 5. The ITA Report states the current peak parking demands on a typical weekday is approximately 45 vehicles. On typical sunny weekends the parking demand is approximately 85 vehicles, increasing to 110 vehicles on Sundays when the boating club is operation. Item 25.1 states “there will be 66 parking spaces in the Reserve post construction of the shared path, it is likely that parking demand at the Reserve will exceed supply throughout the year after the shared path is open.” It is proposed that overflow parking will be directed to the Petone Train Station parking area.

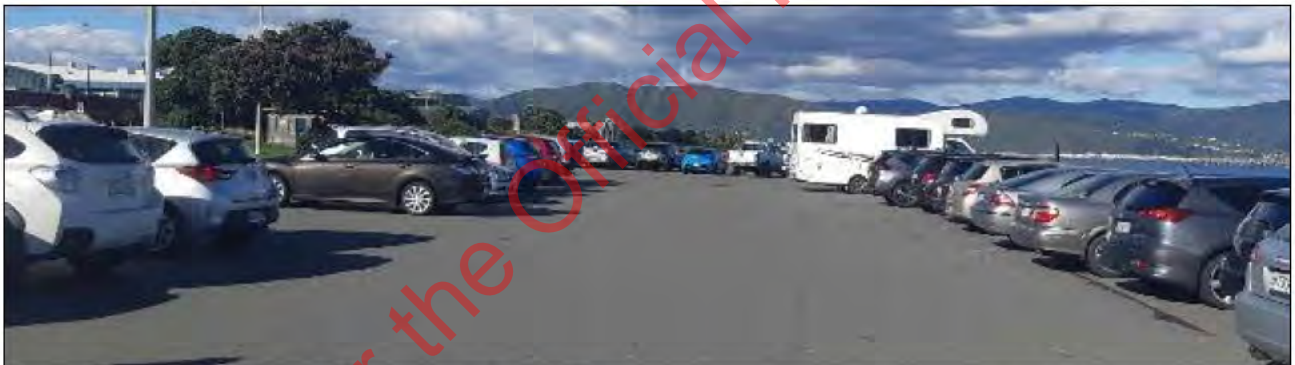
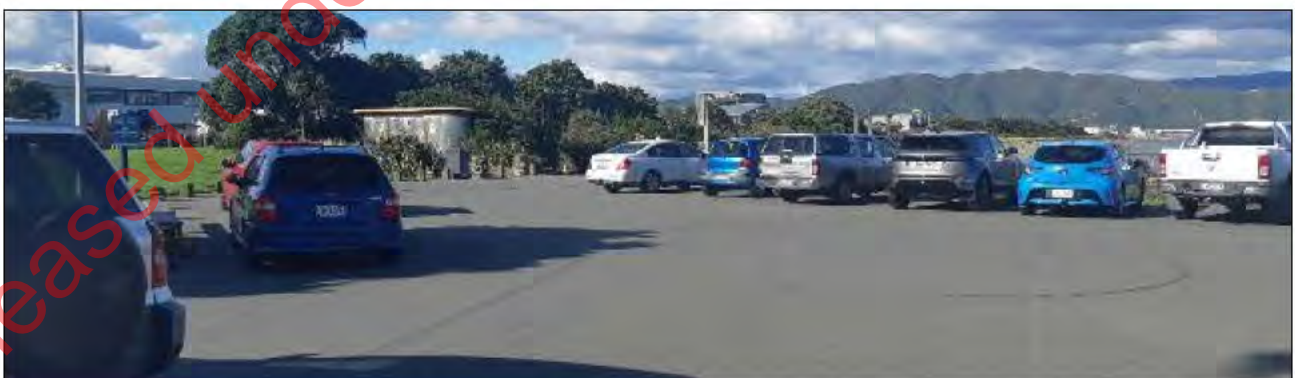
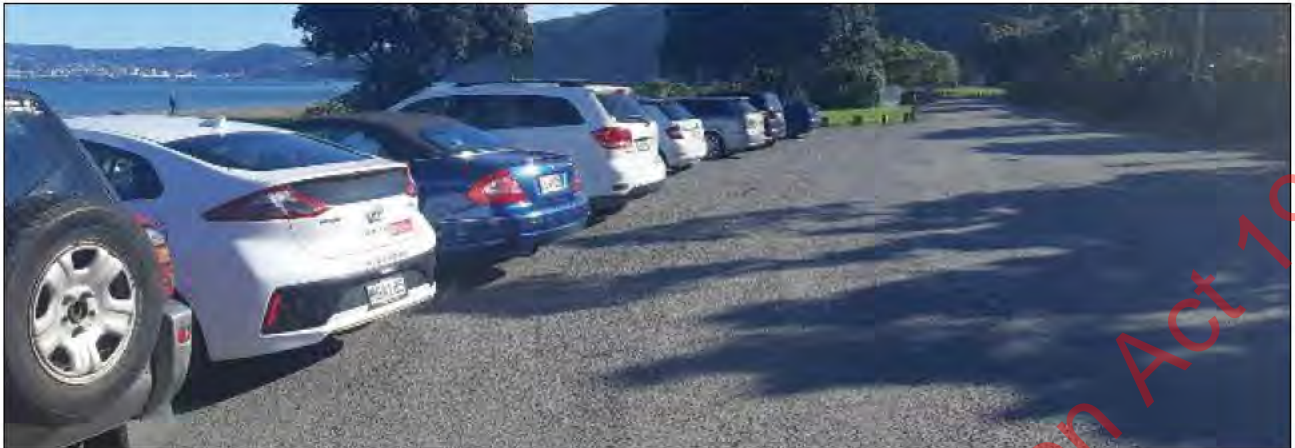
During the site visit, it was noticed that the parking provided at Honiana Te Puni was almost at capacity as shown in Figure 6, Figure 7, and Figure 8. With consideration of increased demands post construction, we believe the parking demands have been underestimated. Inadequate parking will lead to increased congestion and conflicts within the carpark as traffic circulates in search of vacant parks, and with vehicles potentially parking in less safe locations as a result.

Figure 6: Carpark occupancy in Section E during site visit.

Figure 7: Carpark occupancy in Section E continued.

Figure 8: Carpark occupancy in Section B during site visit

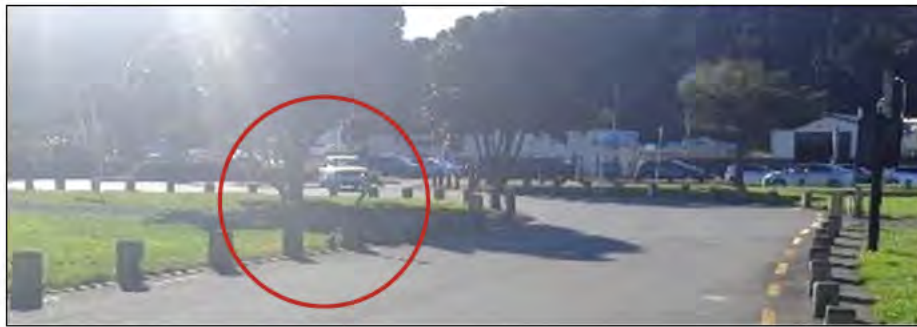
Figure 9: Mobility scooter left at Honiana Te Puni

During the site inspection we noted electric scooters deserted near the grassed areas in the reserve as shown in Figure 9. The ITAR anticipates 181 Transport device users across the shared path on weekdays and 272 on weekends in 2025. Therefore, a designated area should be provided to park these devices to avoid obstructions to walkers, cyclists and vehicles.

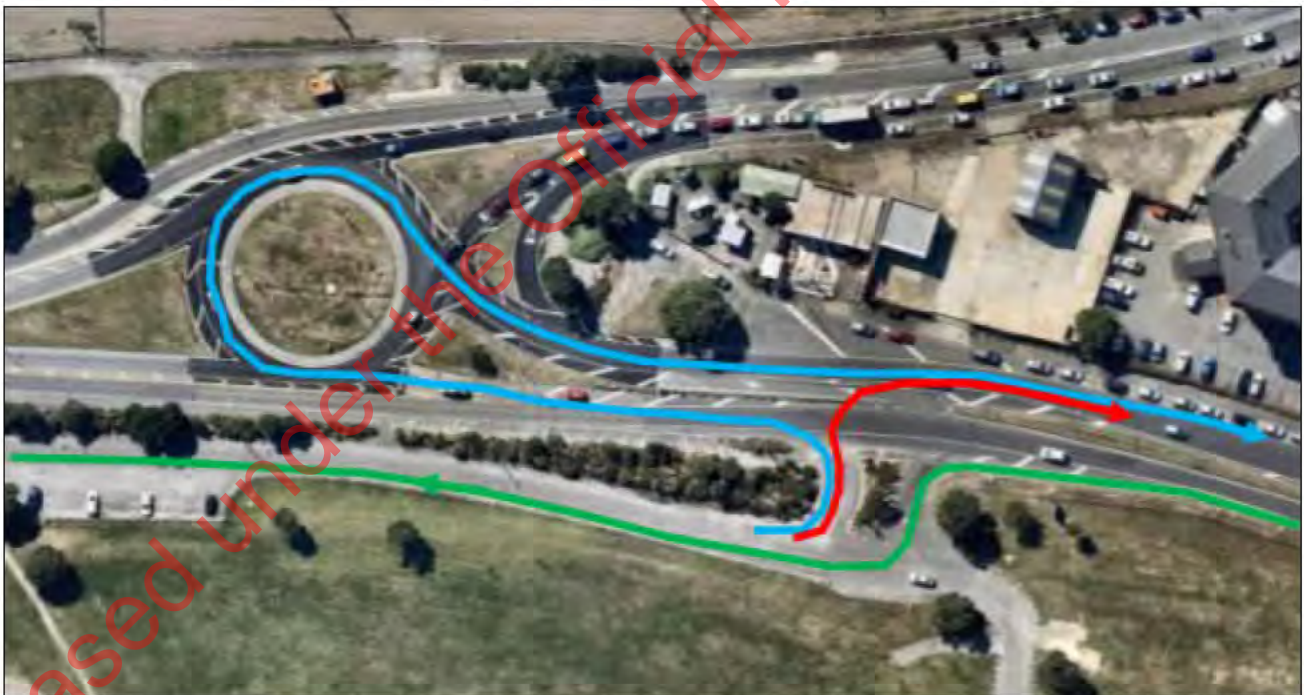
Figure 10: Cyclists connections to The Esplanade

Figure 10 shows the proposed cyclist connections as suggested by ITA report.

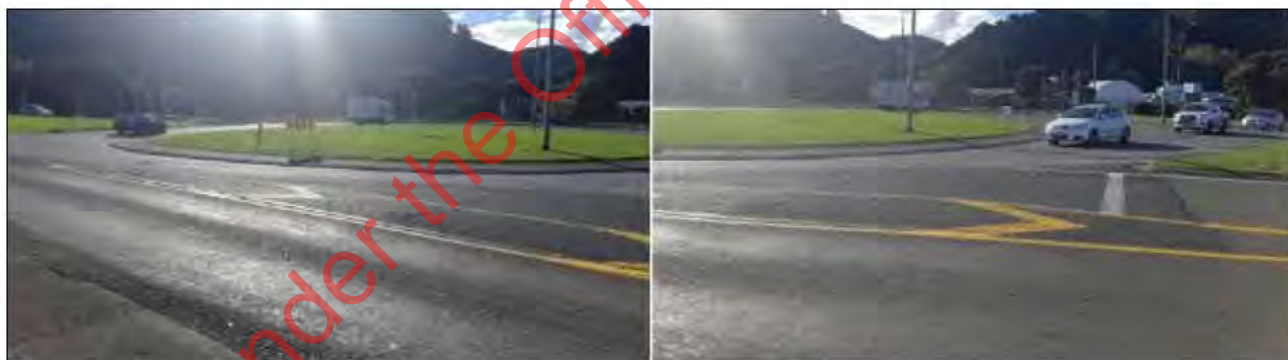
Figure 12: Conflict zone for cyclists at roundabout.

Commonly, cyclist crashes at roundabouts involve circulating cyclists being struck by entering vehicles who fail to see the cyclist<sup>5</sup>. The suggested legal movement from the Reserve to the Esplanade is a difficult movement which puts cyclists in a considerably long conflict zone. This reduces cyclist safety and increases the risk of cyclist crashes. Figure 12 shows the long conflict zone.

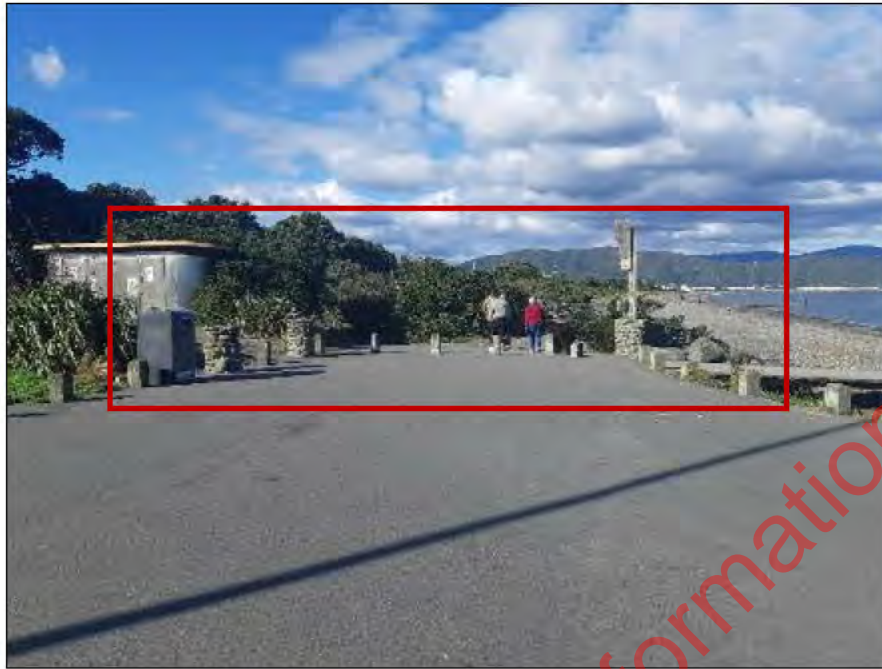
Figure 13: Beginning of Remutaka Cycle Trail at Section E carparking area.

The Petone Foreshore path that connects to the Remutaka Cycle Trail at the eastern end of the foreshore, begins within Section E carpark area as shown in Figure 13. During the site visit it was observed that cyclists were cycling through the existing car park to access the Petone Foreshore path as shown in Figure 14. With expected increases in parking demand and traffic through the car park areas, cyclists will have greater exposure to manoeuvring vehicles increasing the risk of cyclist crashes within the carpark.

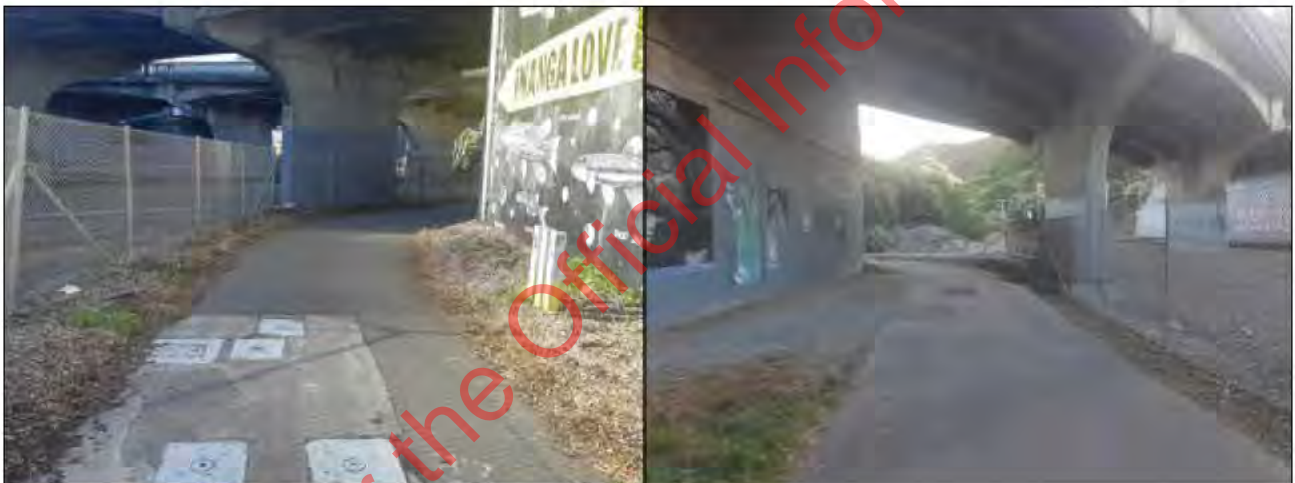
Figure 15: Limited sight distance at the Bridge underpass.

There is limited sight distance around the corner to and from the Reserve to Petone via the Petone Bridge underpass as shown in Figure 15. The underpass is currently unlit limiting sight distance and visibility. The space also poses a personal safety risk for walkers and cyclists, especially at night as shown in Figure 16 and Figure 17.

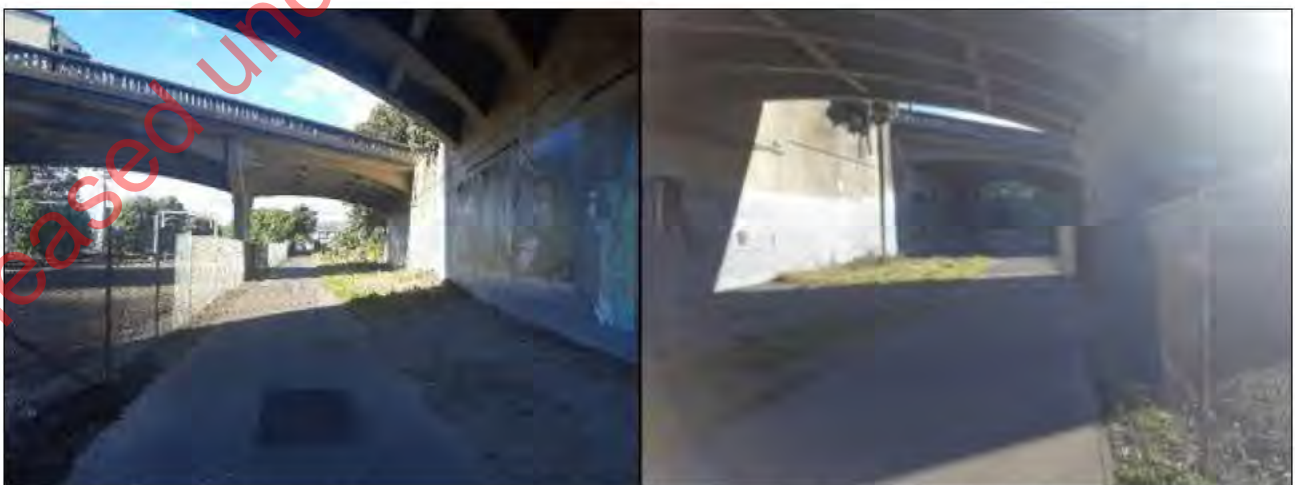
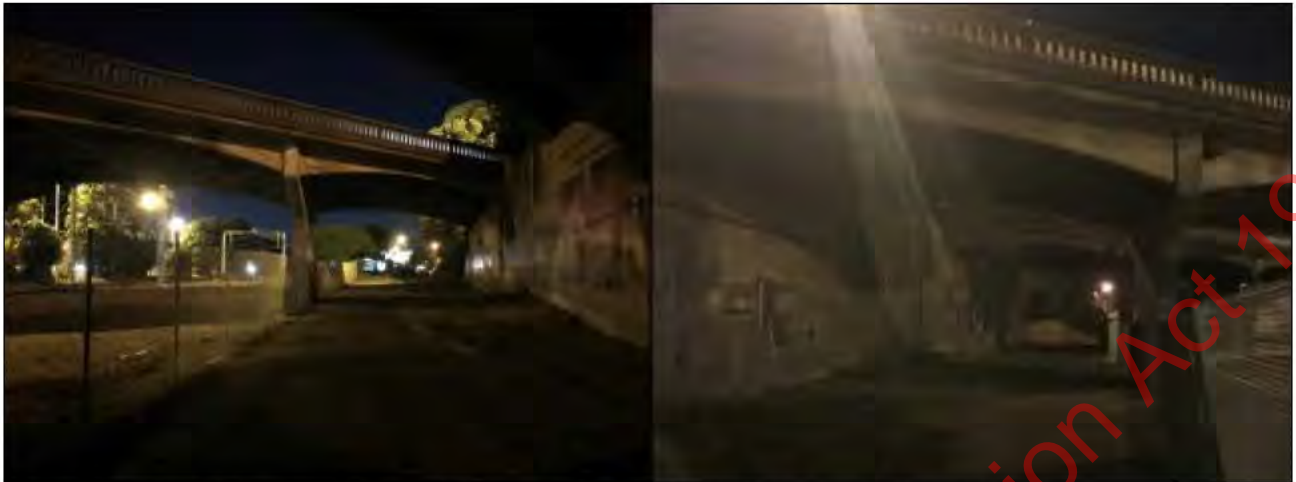
Figure 16: Personal safety risk in the space of the Petone underpass. Facing Petone (left), facing the Reserve (right).

Figure 17: Limited visibility and increased personal safety risk beneath the unlit Petone underpass.

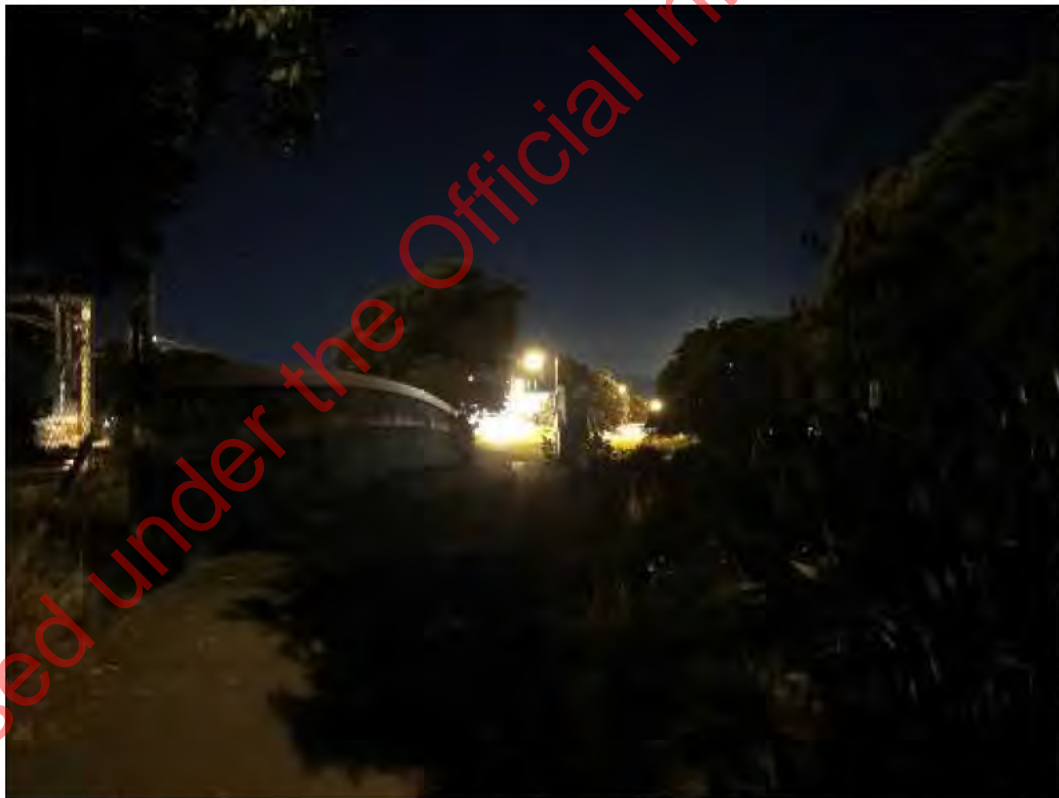
Figure 18: Limited visibility over the Korokoro stream bridge. (Looking towards the Petone roundabout)

During dark hours, the unlit bridge over the Korokoro Stream at the Petone underpass limits visibility and sight distance. This increases difficulty for walkers and cyclists to identify oncoming foot traffic or cyclists as shown in Figure 18. Cyclists at speed are also unlikely to see the vertical crest of the bridge. The dark area also poses a personal safety risk for those using this path.

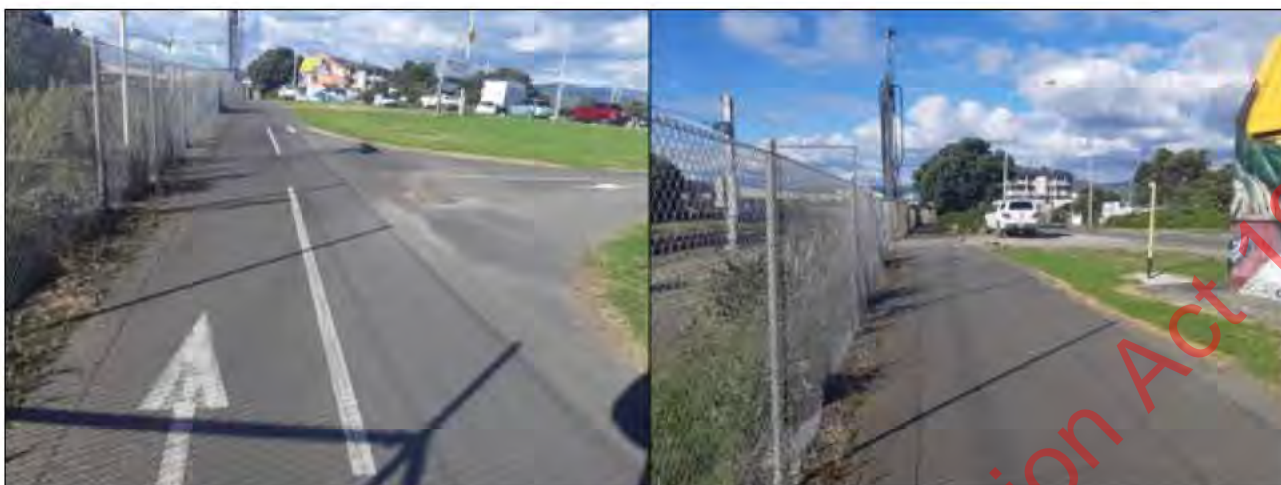
Figure 19: Current connection from the underpass to the Petone to Melling cycle path.

The Petone underpass connects to the shared path on the Hutt Road, Petone as shown in Figure 19. The Petone to Melling shared path is to be constructed from this point. Although it is stated that Te Ara Tupua is to connect with the Petone to Melling shared path, there is no explicit design of how the two shared paths will connect.

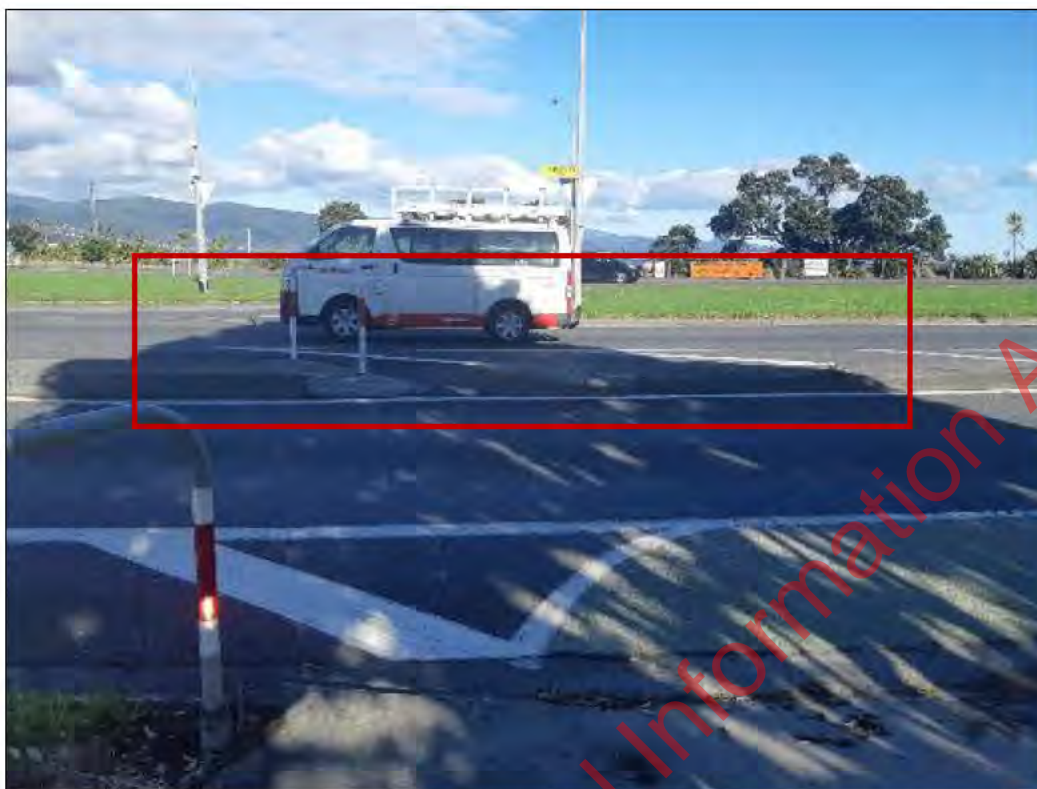
Figure 20: Current cyclist facilities for cyclists on the Petone off ramp who want to access The Esplanade or the Reserve

Cyclists who will continue to travel along the northbound shoulder of SH2 and use the Petone off ramp will require a path to connect to Te Ara Tupua. The current connectivity provided for Te Ara Tupua is relatively unclear. Currently cyclists wanting to travel to the Esplanade must cross the Hutt Road slip lane to the refuge before re-entering the roundabout traffic lane as shown in Figure 20. As the most common cyclist crash at a roundabout involves circulating cyclists being struck by entering vehicles who fail to see the cyclists<sup>6</sup>, this manoeuvre reduces cyclist safety.

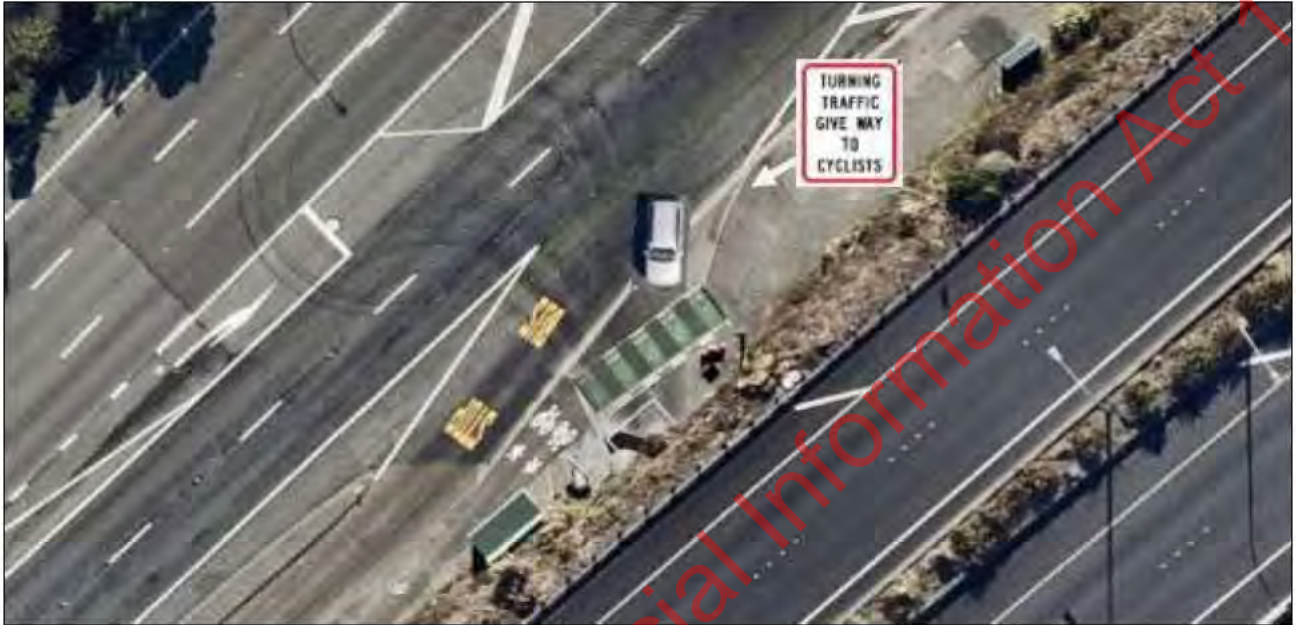
Figure 21: Proposed road markings and additional signage at Hutt Road Tunnel to mitigate increased conflict.

The proposed road markings and additional signage to mitigate conflict arising at the entrance to the Hutt Road Tunnel can be seen in Figure 21, as taken from the ITA report.

The entrance of the Hutt Road tunnel will become a major point of conflict as the number of tunnel users, cyclists and pedestrians increase. Vehicles turning right from the northbound lane on Hutt Road must cross two live traffic lanes, the bus lane and two cycle paths (the on-road cycle path as well as the off-road cycle path.) Left turning traffic from the Hutt Road southbound lane will be required to navigate safely across two cycle paths. A vehicle waiting to turn as shown in Figure 21, will also obstruct a bus from entering the bus path and thus block the on-road cycle path and traffic lane leading to increased congestion in this area.

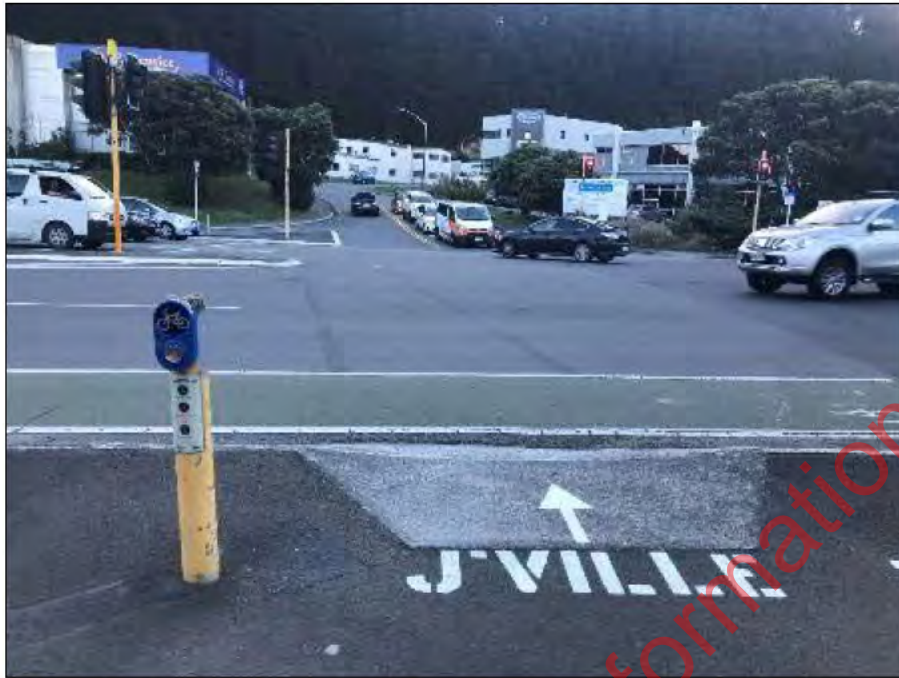
Figure 22: Only cyclist crossing facilities provided at the Hutt Road intersection.

Those who park on Jarden Mile, when parking at Ngauranga Train Station and Hutt Road are at capacity, will need to cross the Hutt Road intersection to access the shared path. Currently there are no pedestrian facilities at this intersection as shown in Figure 22. During the site inspection it was noted that pedestrians are regularly crossing prior to and at the intersection at current to access the bus stops and footpaths in the vicinity as shown in Figure 23 and Figure 24.

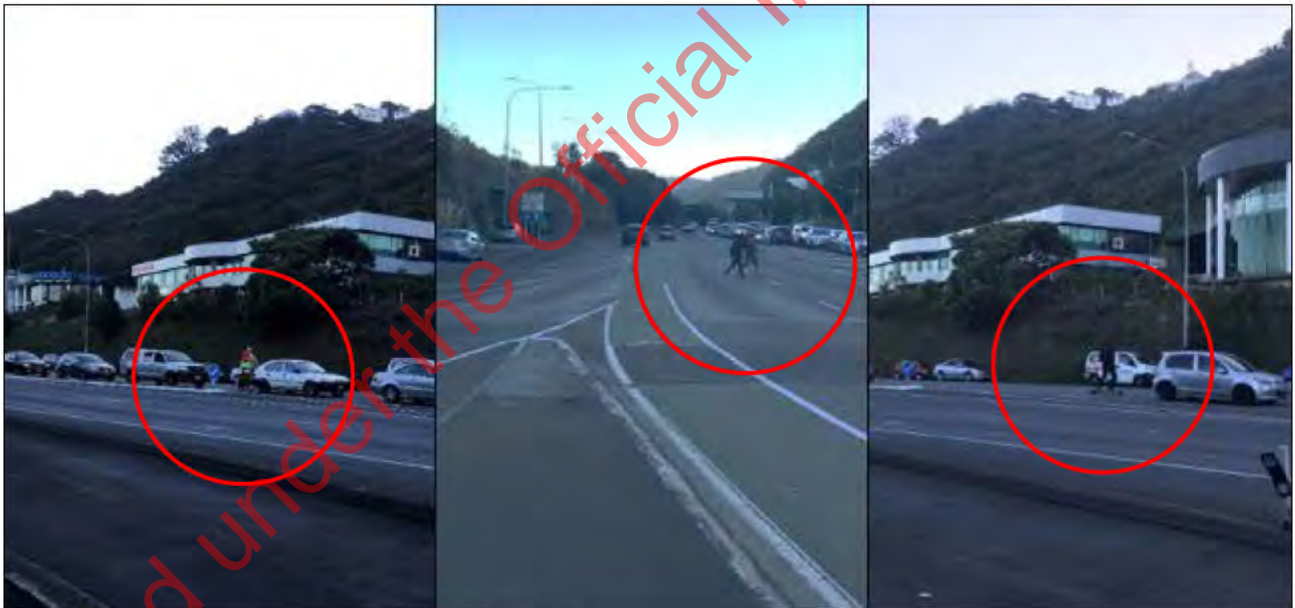
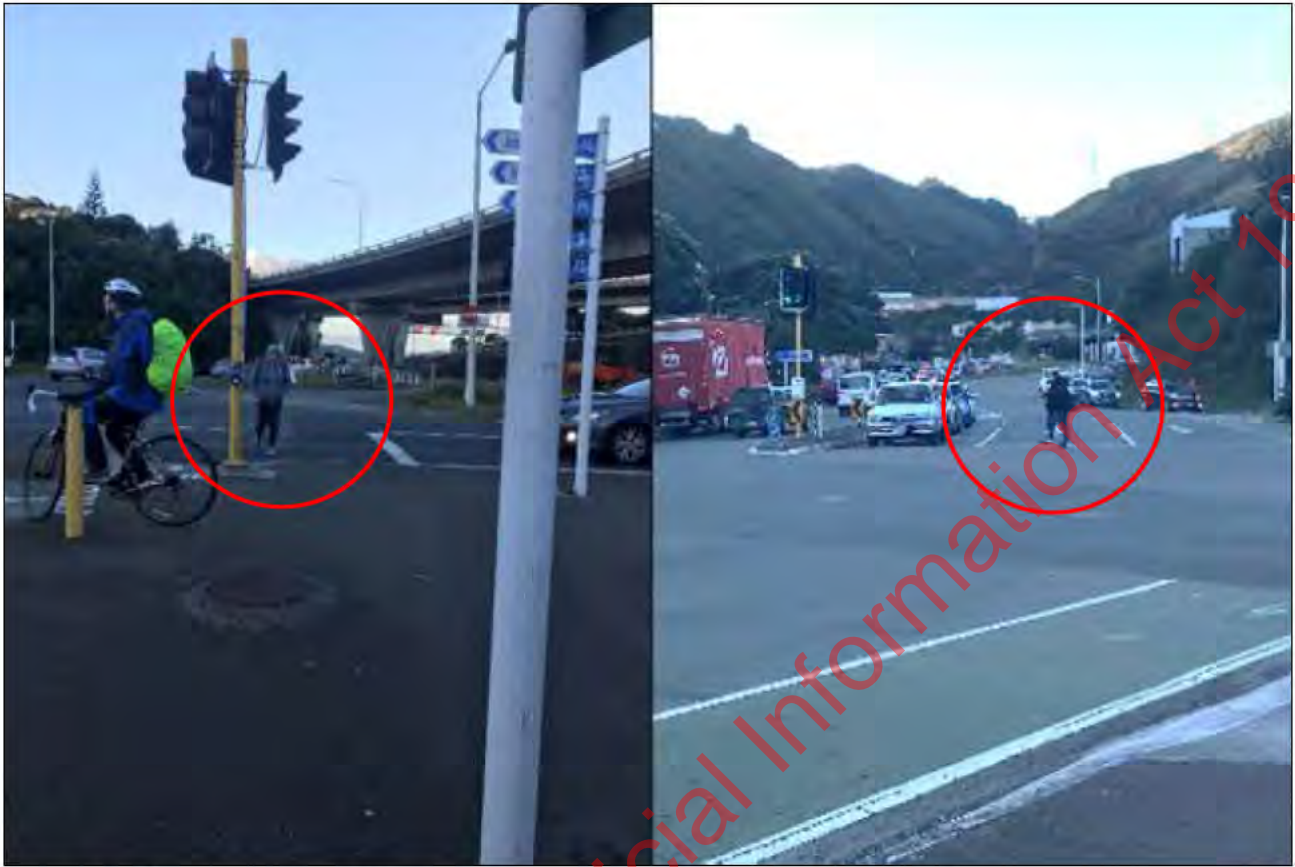
Figure 23: Pedestrians and cyclists crossing Hutt Road

Figure 24: Pedestrians crossing across Centennial Highway, to get from and to the bus stops

With increased pedestrians and cyclists post construction pedestrian facilities need to be catered for to ensure the intersection can be navigated safely. These pedestrian facilities will especially be required by the elderly, small children and mobility impaired users who may not be able to weave through traffic or cross at speed.

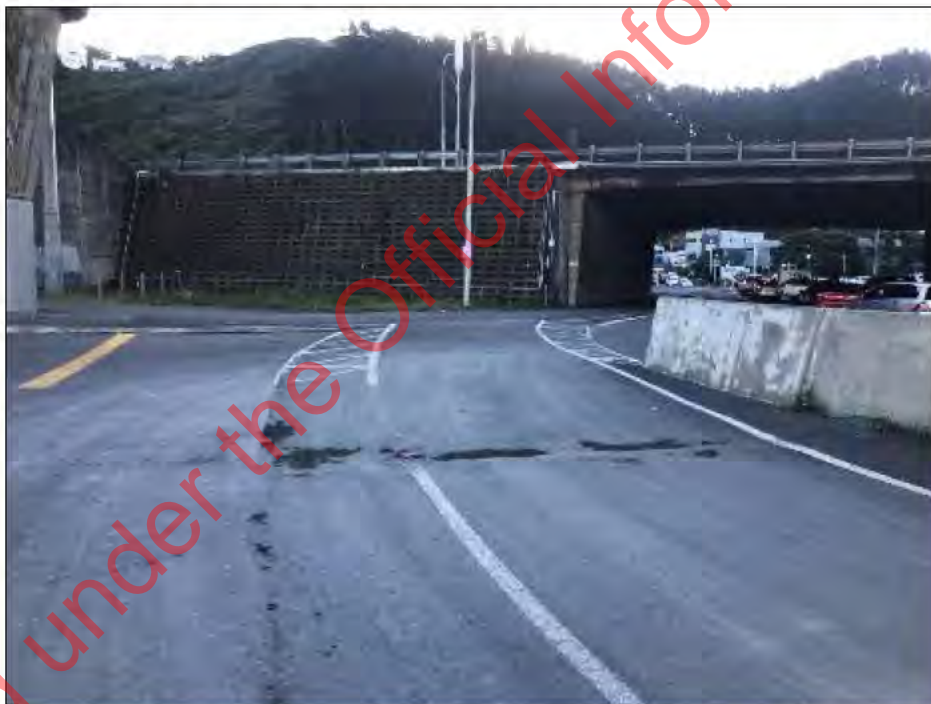
Figure 25: Yellow stop line and raised table for the existing shared path.

With expected increases in parking demand and shared path users, this area will become a major conflict zone, decreasing safety for cyclists and walkers on the path as they must manoeuvre past vehicles.

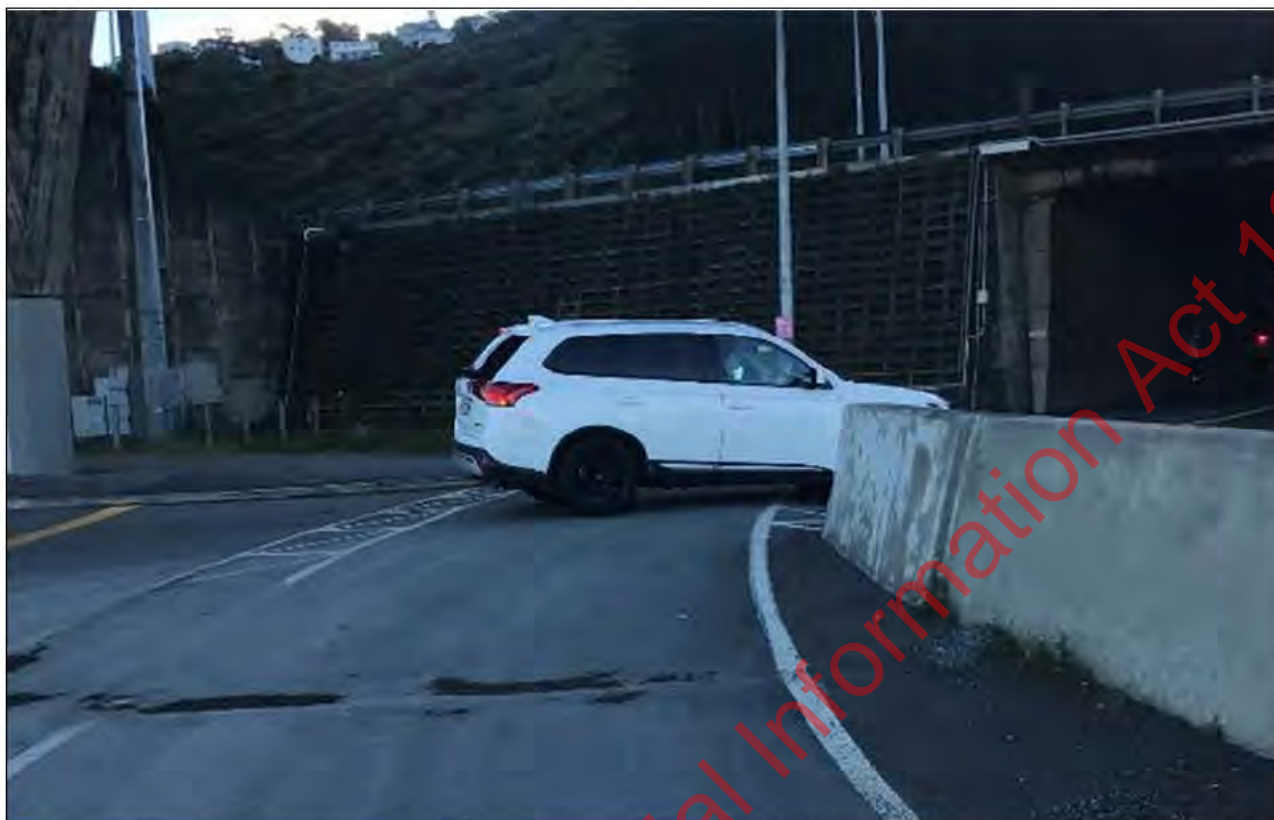
Figure 26: Vehicle exiting Train Station/ Stock Effluent Disposal waiting on the raised table to turn into traffic lane.

It is also important to note that during the site inspection we witnessed several cars queue jumping from this area. It was assumed that vehicles were turning into the Hutt Road Tunnel to join SH2 off ramp traffic and skip the red traffic signals on Hutt Road.

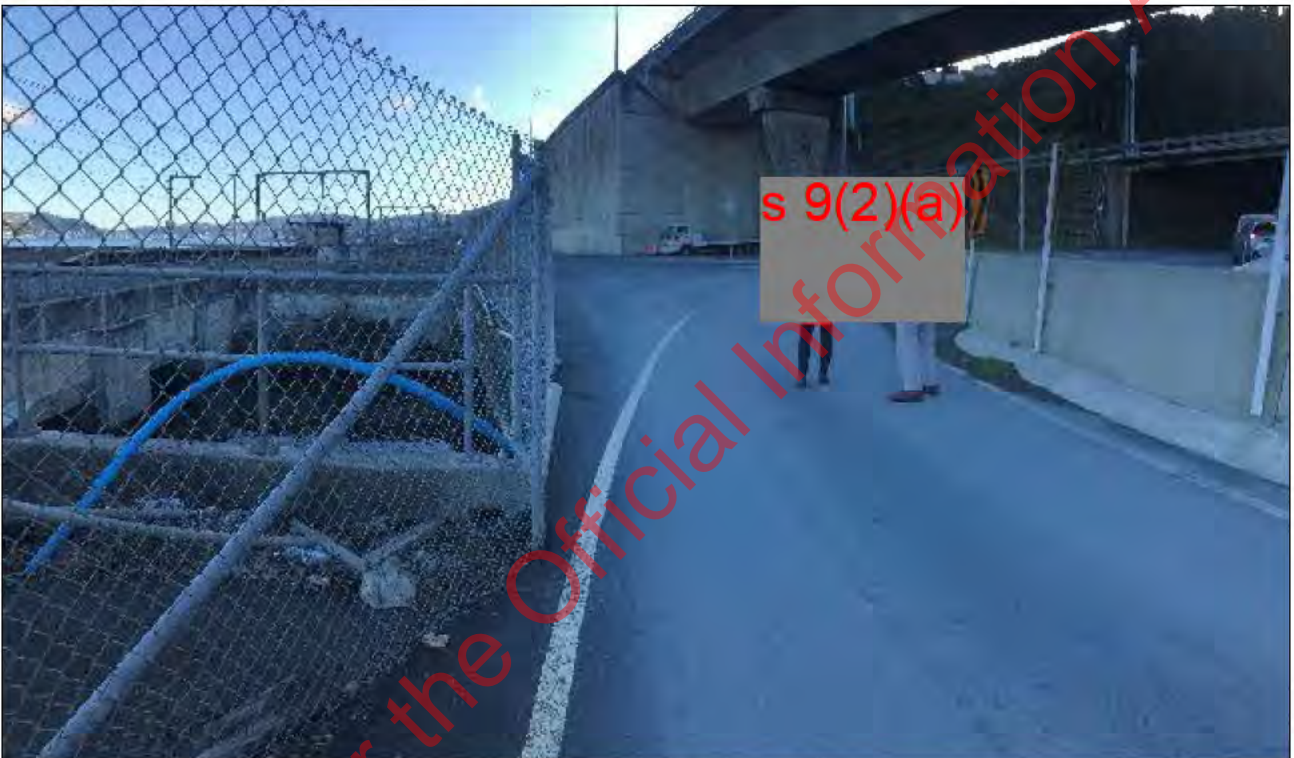
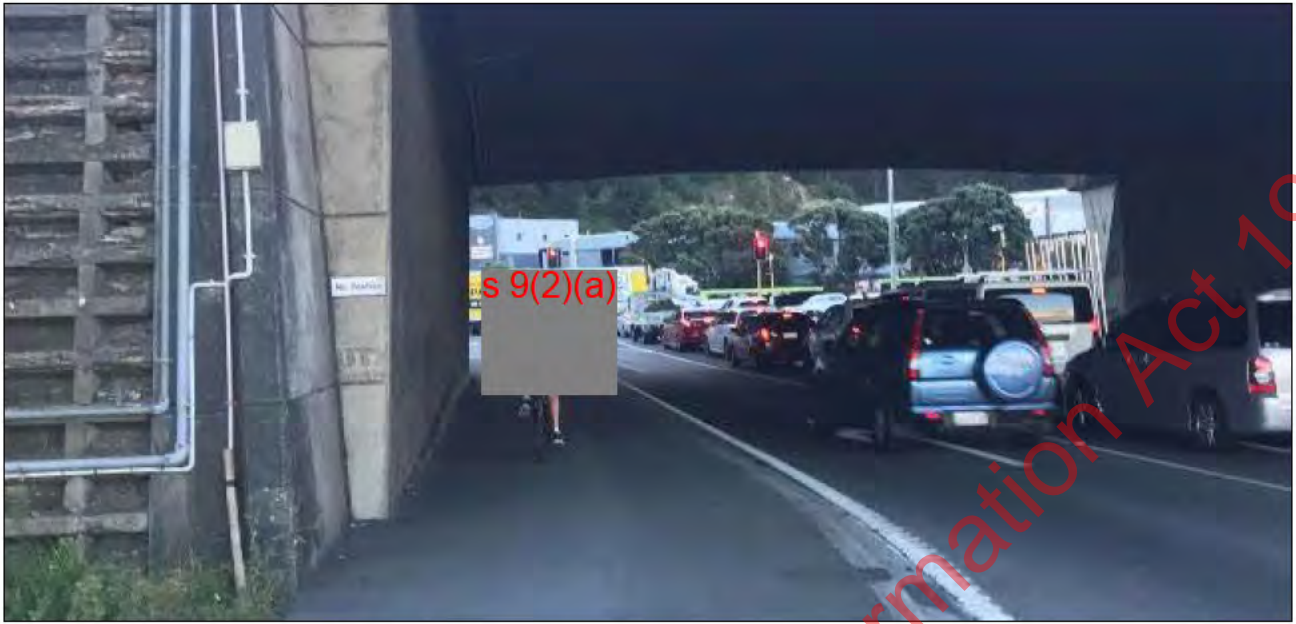
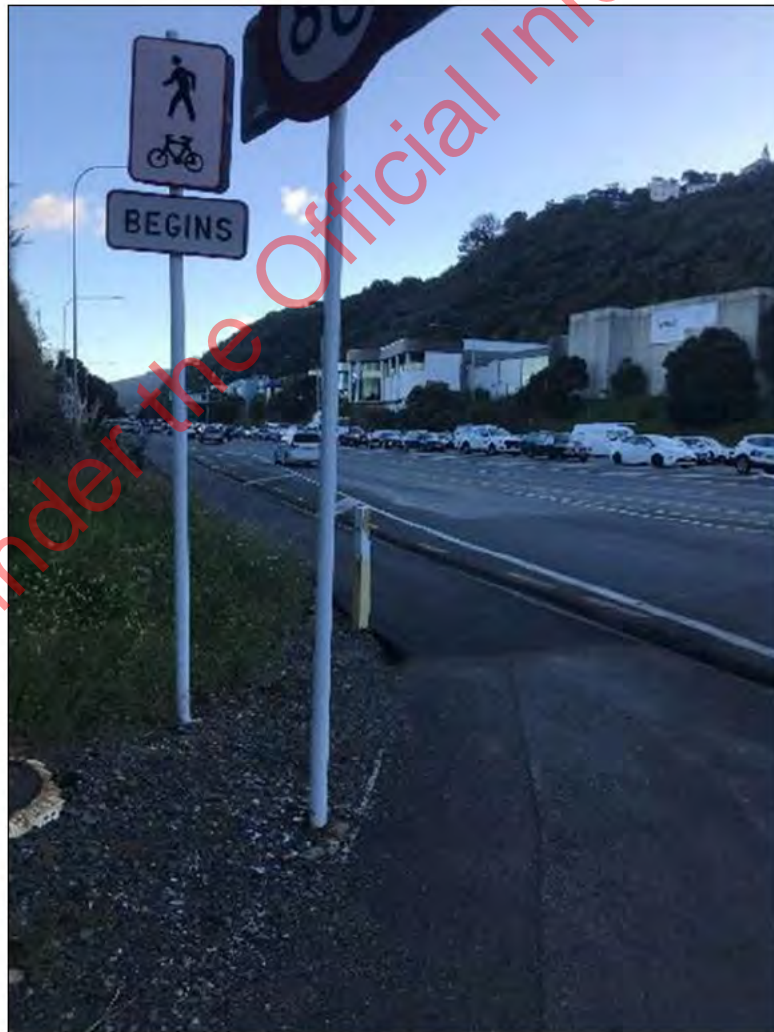
The shared path has pinch points at the motorway underpass, within the motorway underpass tunnel, and at the connection to the Hutt Road shared path as shown in Figure 27, Figure 28, and Figure 29.

Figure 27: Shared path pinch point at the start of the urban motorway underpass.

Figure 28: Narrow path through the motorway underpass tunnel.

Figure 29: Narrow path at the connection to the Hutt Road shared path.

The narrow sections of the shared path may become an area of conflict when the number of path users increases. The increased conflict at this point will increase the risk of crashes between cyclists and collisions between pedestrians and cyclists. The ITA suggests the following road markings, as shown in Figure 31, Figure 32, and Figure 33, be installed to mitigate the increased conflict.

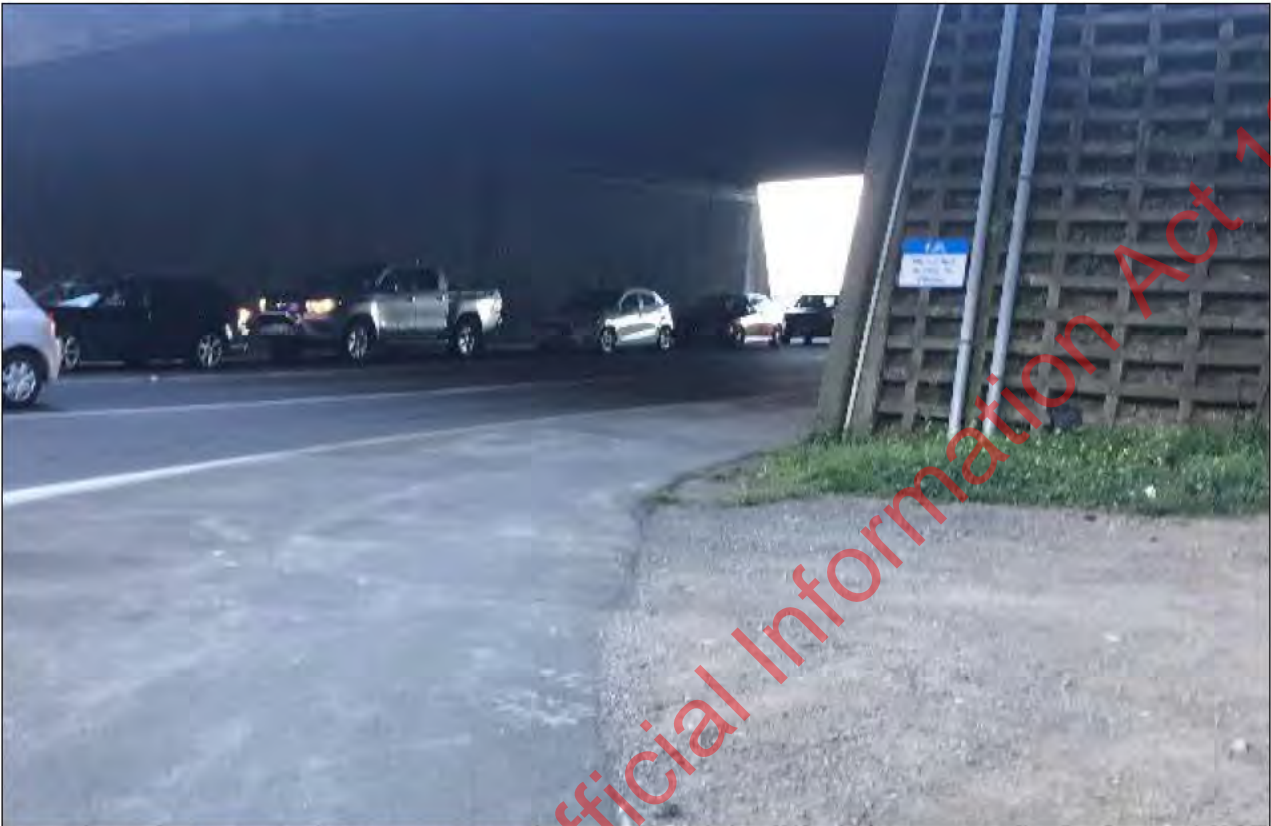
Figure 30: Limited forward visibility from the Hutt Road through the motorway underpass tunnel.

Some regions at this connection also have limited forward visibility, as shown in Figure 30, increasing the risk of collisions at these points.
