Project Number: 5-C3532.00

# Te Ara Tupua

## Concept Design Road Safety Audit

26 July 2021

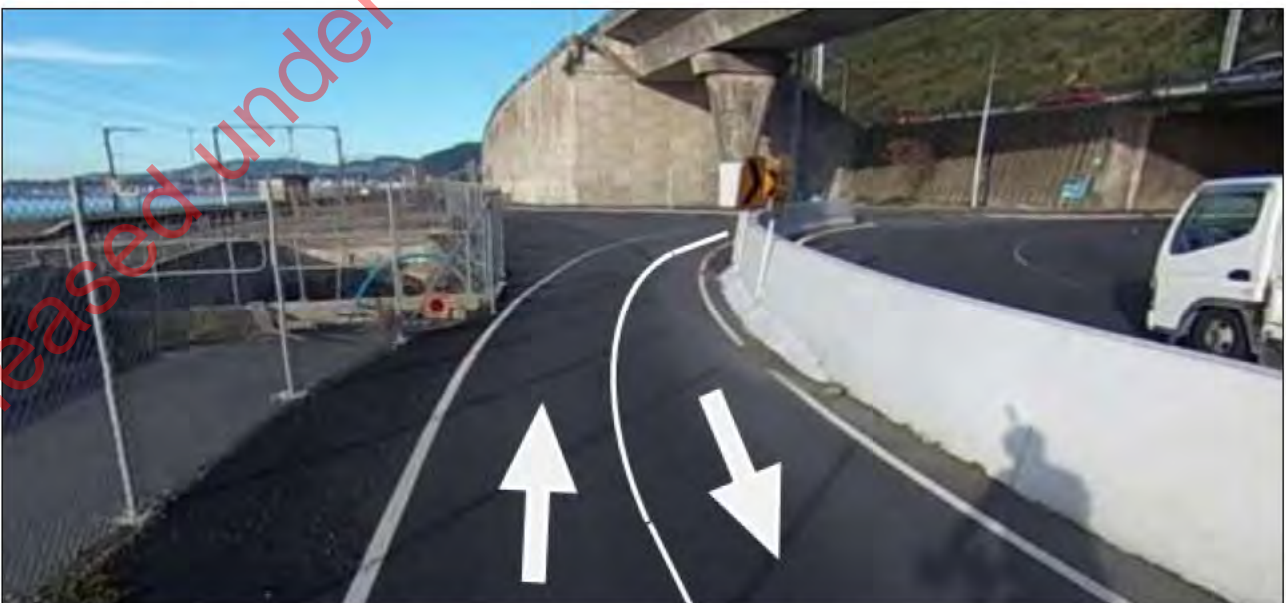
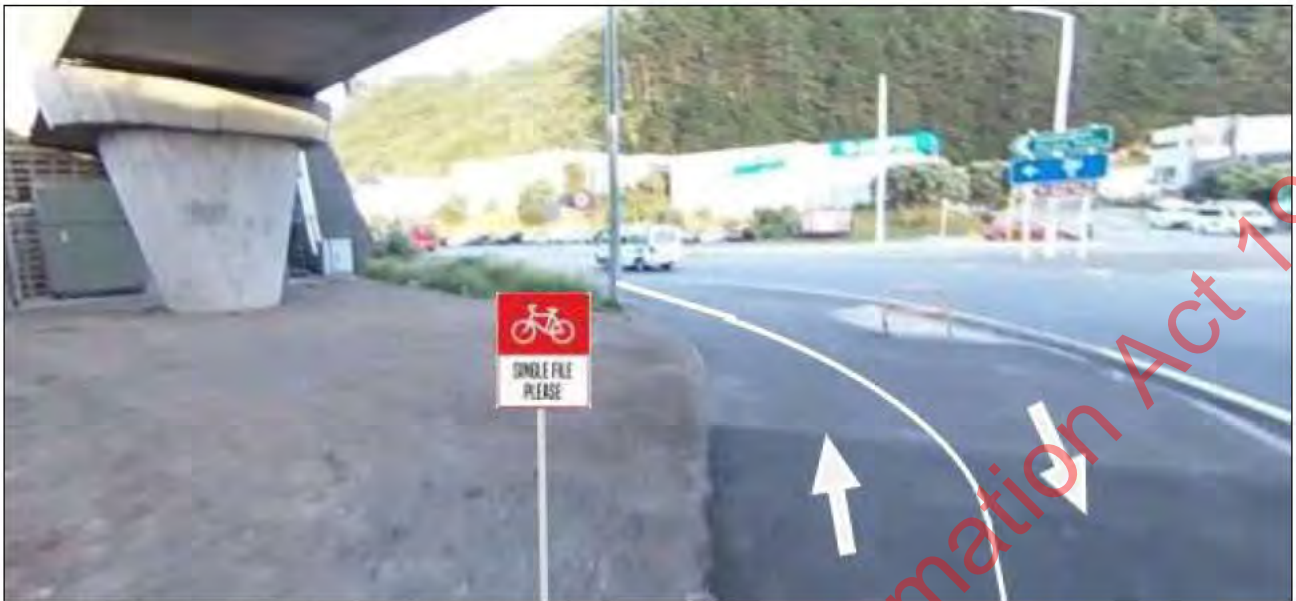
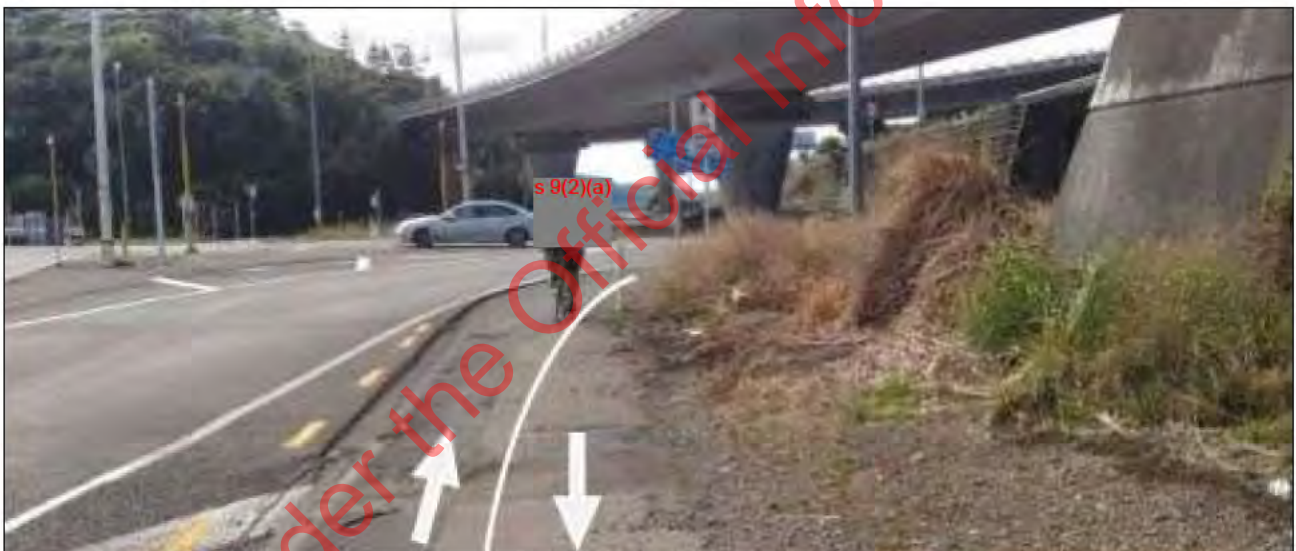
Figure 31: Shared path markings at narrow section of shared path at the motorway underpass.

Figure 32: Shared path markings as suggested by the ITA.

Figure 33: Shared path marking at the connection to Hutt Road shared path as suggested by the ITA and area of vegetation to be removed.

Installing these markings can often give cyclists a false sense of priority and fails to mitigate congestion issues on the path.

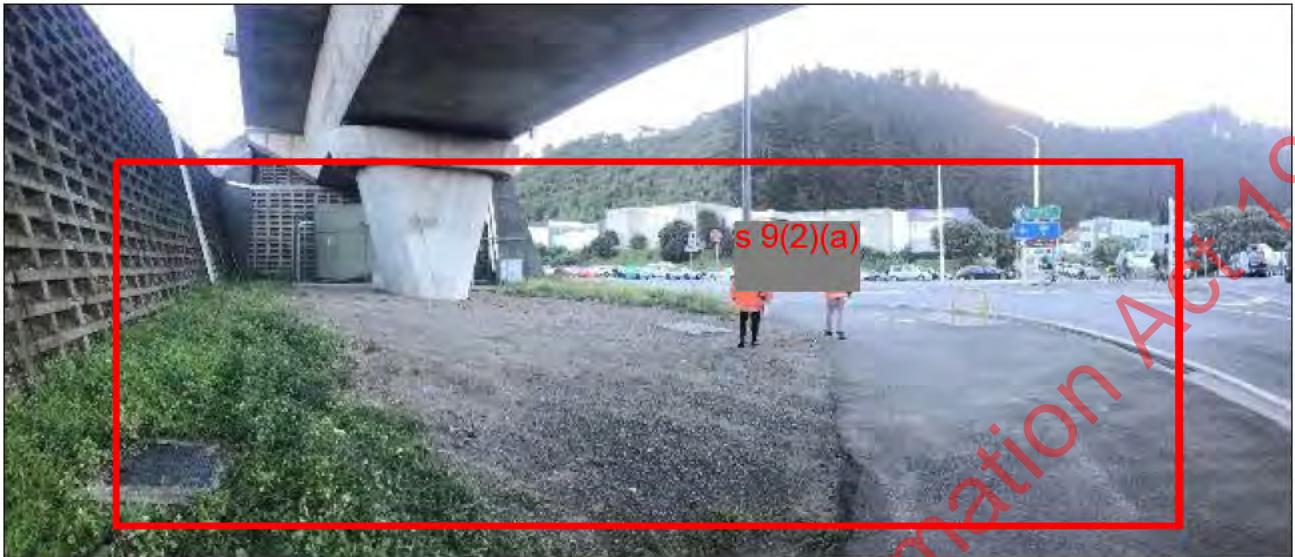
Figure 34: Underutilised land at the Ngauranga connection.

During the site visit it was noted that there are areas of land being underutilised as shown in Figure 34. These areas could undergo vegetation removal and be used to widen the shared path to minimise conflict.

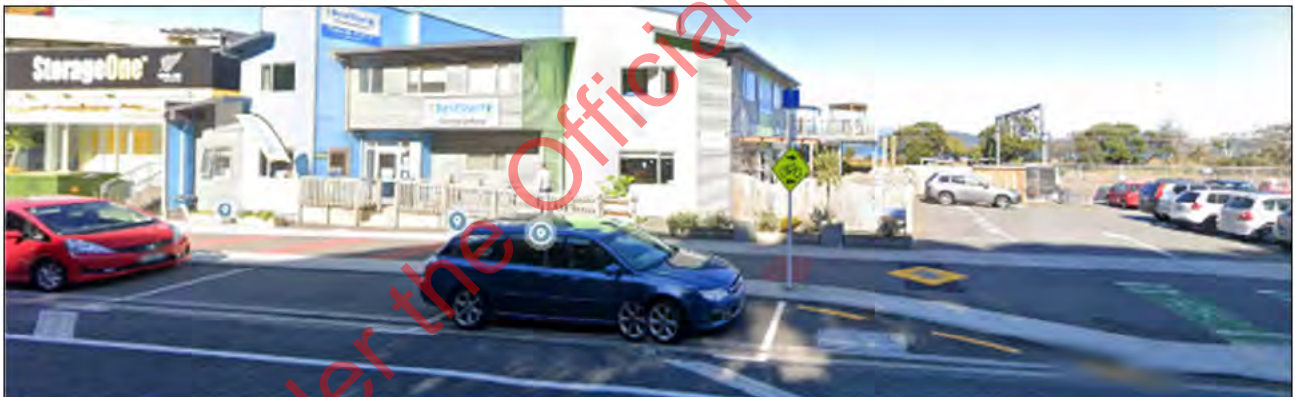
Figure 35: Existing red coloured surfacing bars at conflict zone along the Hutt Road

In the sections of shared path which cannot be widened, red coloured bars, as shown in Figure 35, could be marked on the pathway to indicate users of the conflict zones to be consistent with treatments of other conflict areas on shared paths and cycle paths around Wellington.

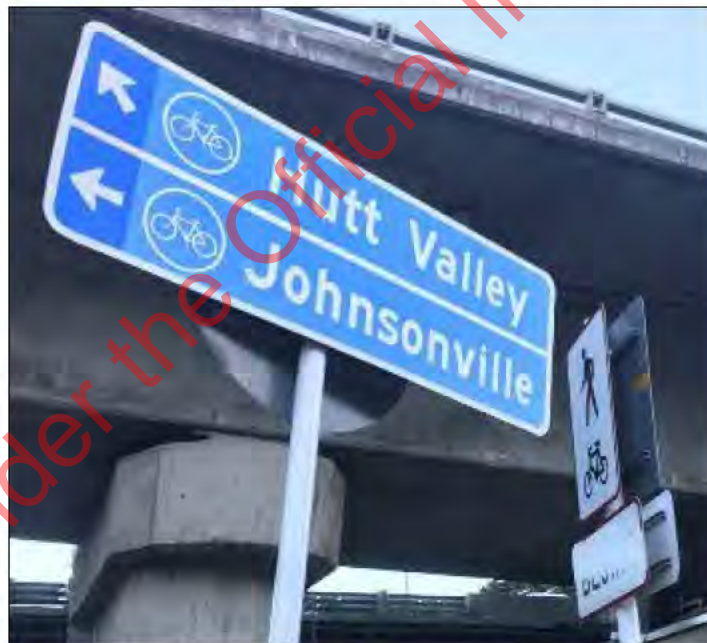
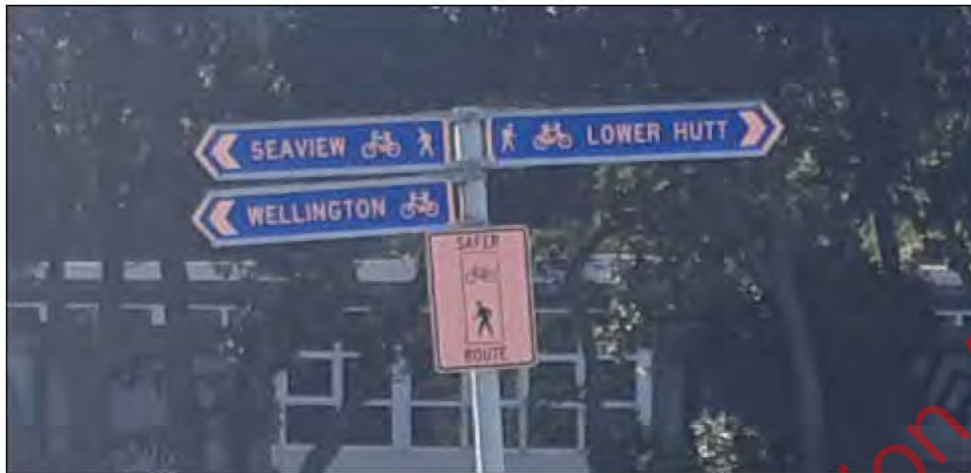
To improve user experience appropriate wayfinding signs should be installed encourage to new users to use the shared path and connected paths. The wayfinding signs should be consistent with current wayfinding signs found at Ngauranga and Petone. Some examples are shown in Figure 36 and Figure 37 to allow users to navigate easily.

Figure 36: Ngauranga wayfinding signs.

Figure 37: Petone way finder signage.

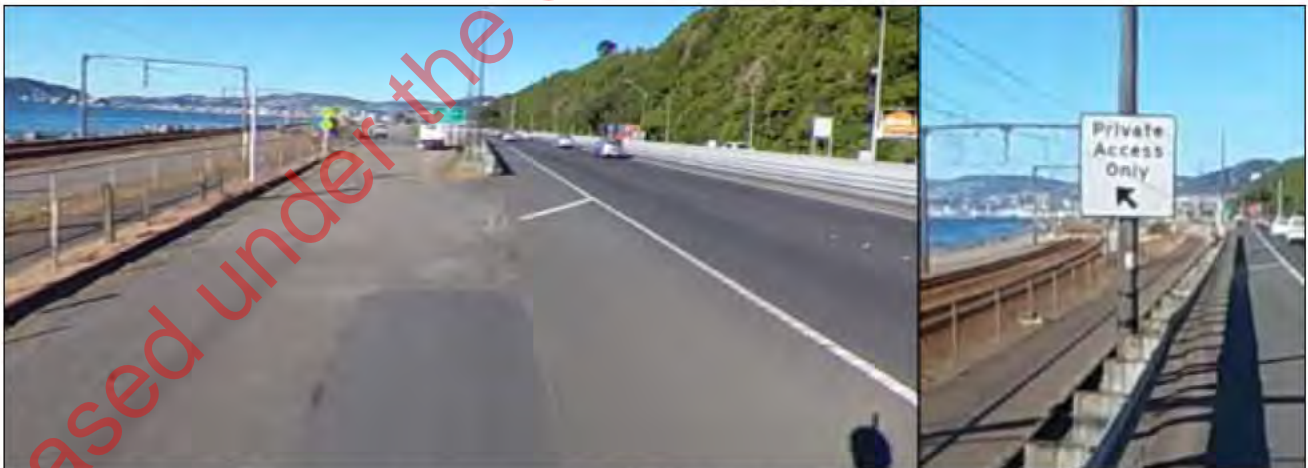
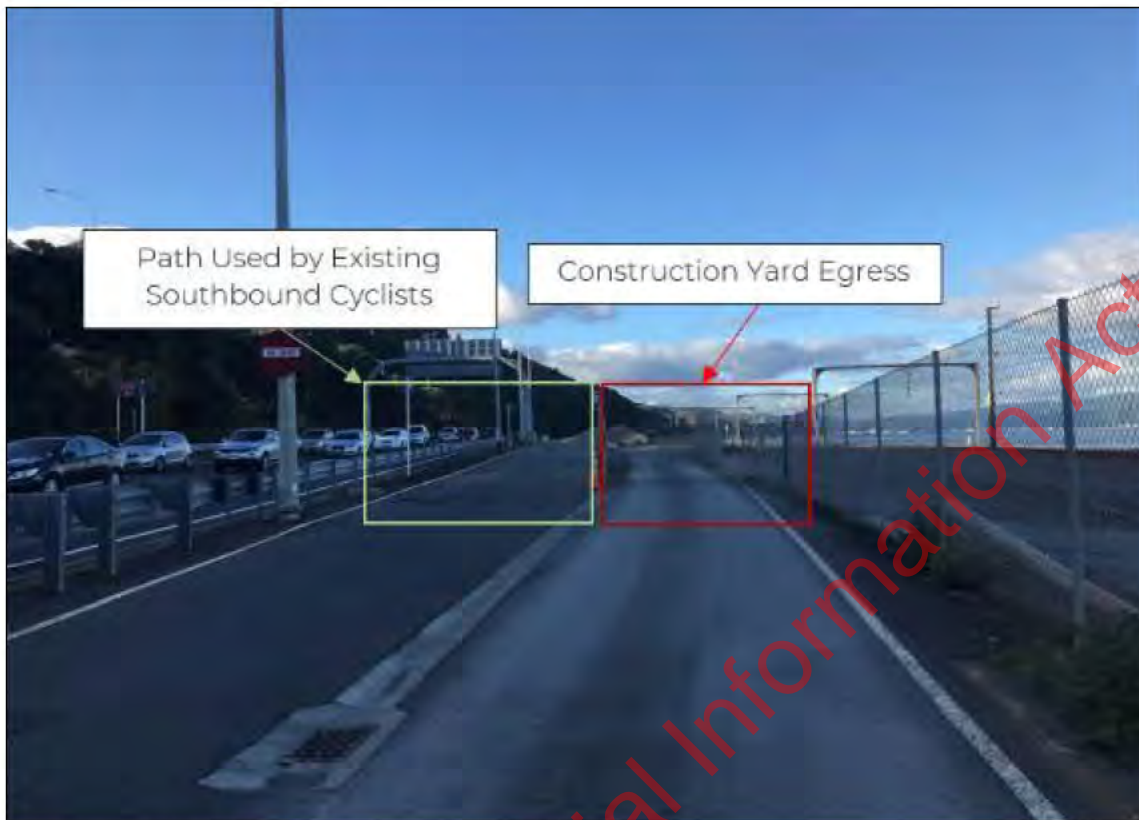
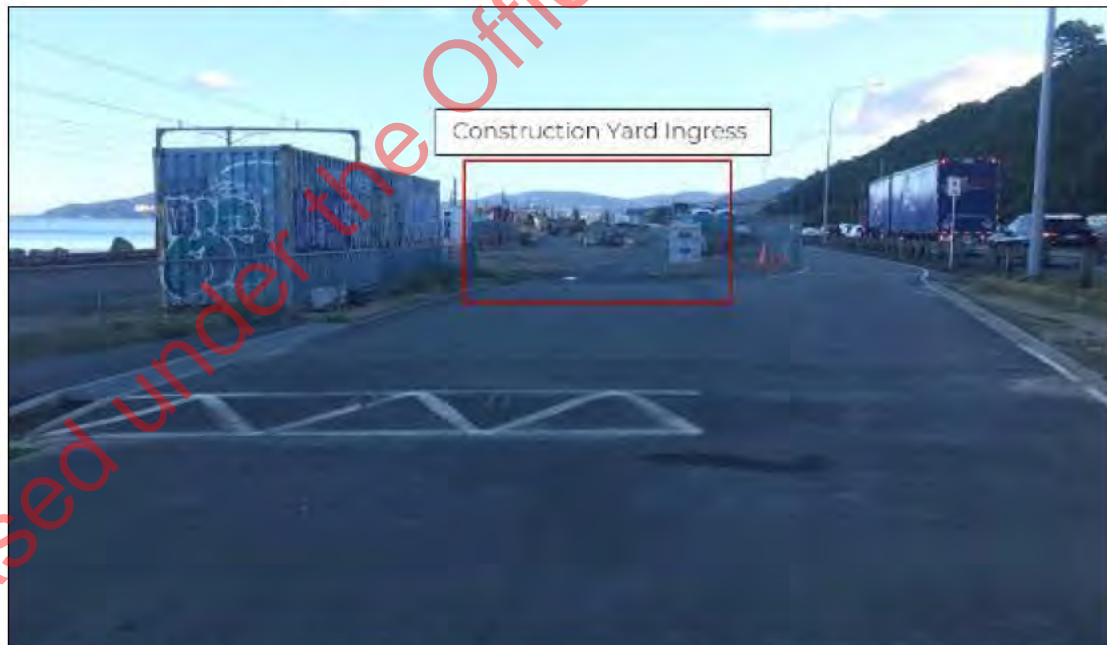
Figure 38 and Figure 39 show the current Kiwi Rail access points which will be used as the ingress and egress to the construction yard for the duration of the Te Ara Tupua project. The accessway is also used by off road and on road cyclists. The ingress is via a private access way and has a raised table prior to the construction yard entrance gate as shown in Figure 40.

Figure 38: Construction yard ingress from southbound lane on SH2 and signage prior to the access way.

Figure 39: Construction yard egress and current shared path.

Figure 40: Construction yard ingress and raised table at the connection point of on road and off-road riders.

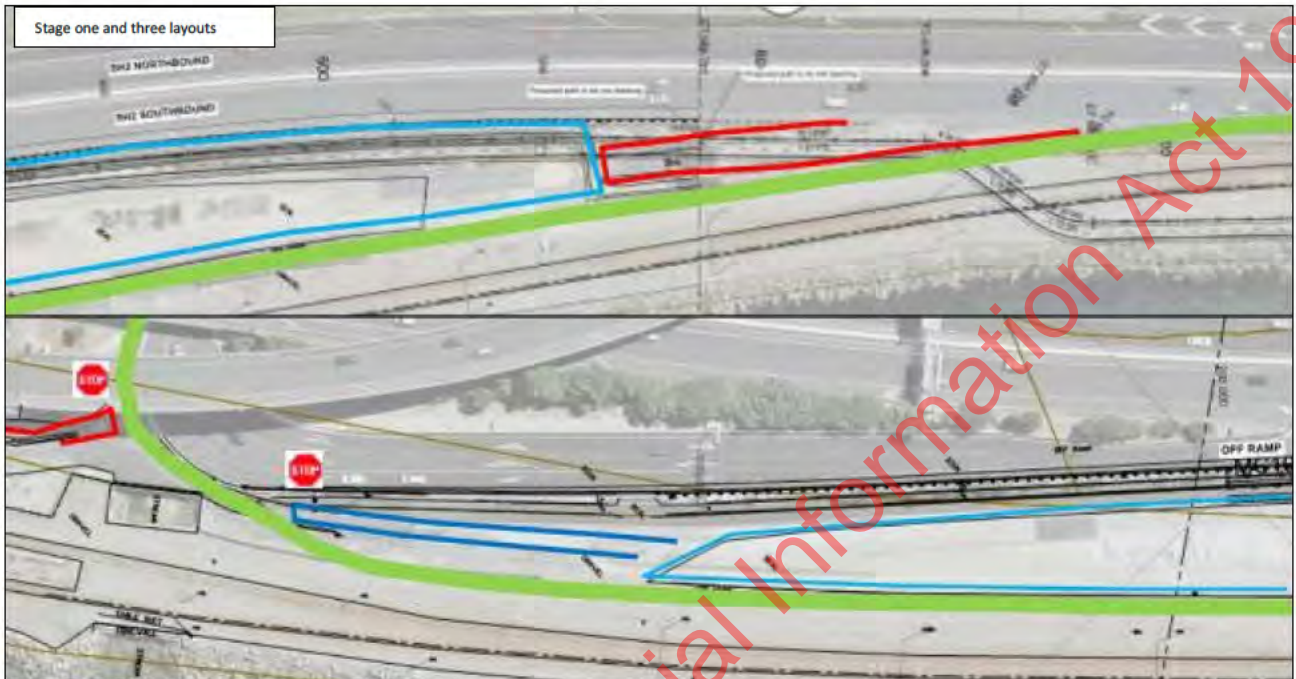
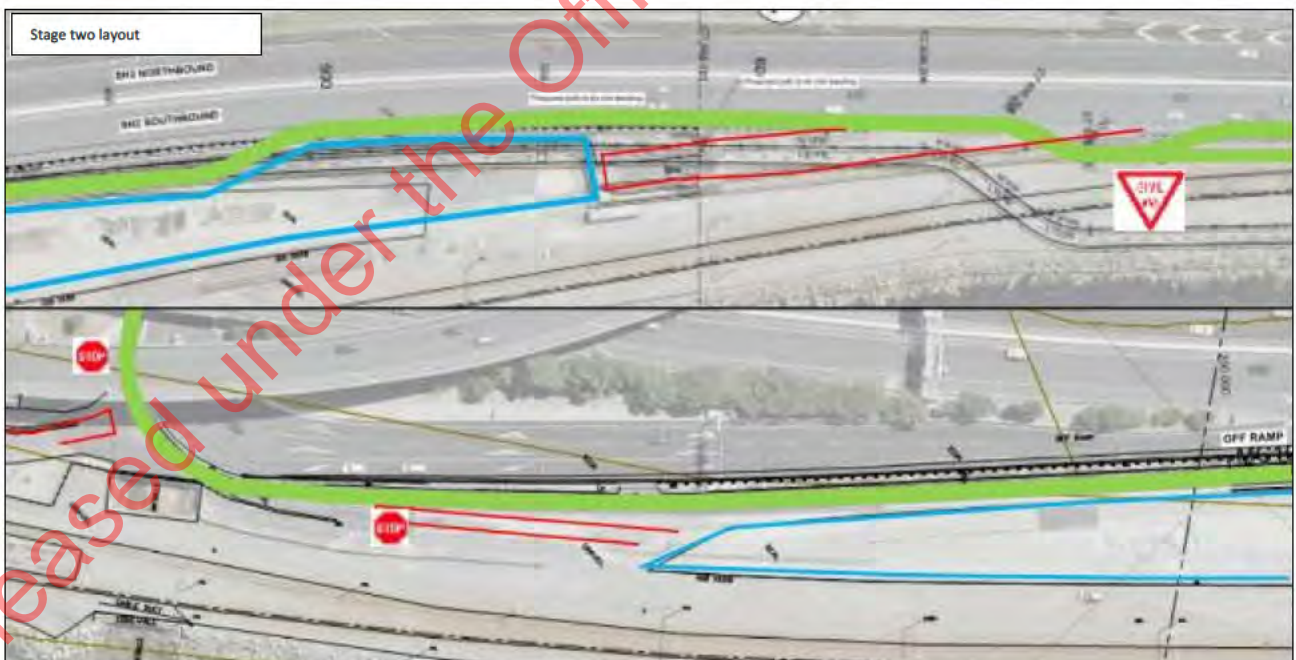
Construction from the Ngauranga side has been split into three stages. The suggested cycle path layouts during stage one, two, and three of construction are as shown in Figure 41 and Figure 42. The green is the active user path, the red boundary shows the private access to be used by trucks, the light blue boundary indicates the construction yard, and the dark blue shows the egress from the construction yard.

Figure 41: Stage one and three layout of construction yard and active user path.

Figure 42: Stage two layout of construction yard and active user path.

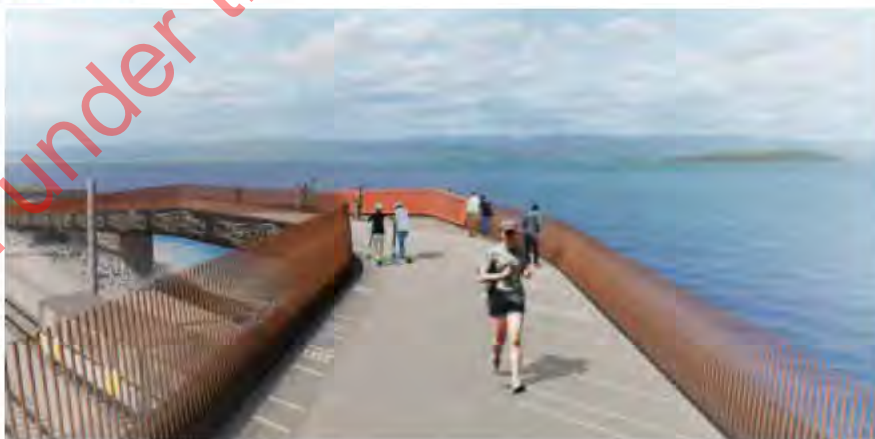
Figure 43: Shared path bridge fencing design.

The design for the fence line for the overbridge bridge is as illustrated in Figure 43 from the Cultural and Environmental Design Details. Further consideration should be taken to determine if the fencing design of the bridge will be a snagging hazard and limit sight distances.

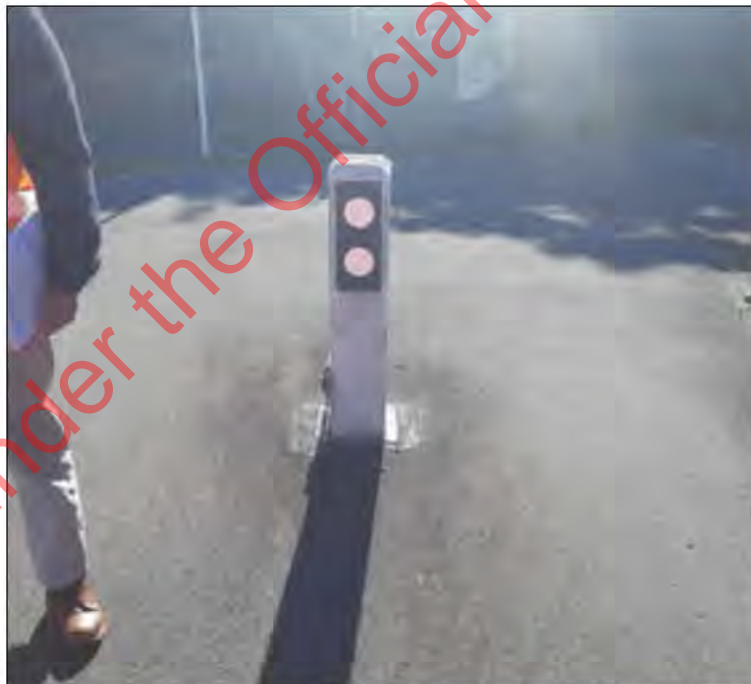
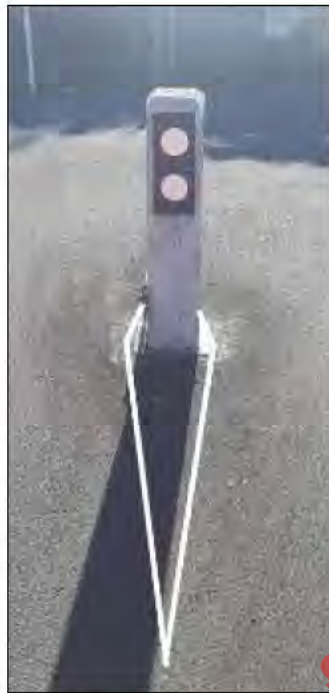
Currently there are single bollards present at the beginning of the connection from Honiana Te Puni to the Petone SH2 onramp as shown in Figure 44. When multiple cyclists are travelling behind one another, typically only the first cyclist will see and manoeuvre around the bollard in time, sending cyclists behind straight into the bollard. Surface markings prior to bollards, as shown in Figure 45, should be used to decrease the risk of this hazard.

Figure 44: Bollards present at the connection from Honiana Te Puni to Petone SH2 onramp.

Figure 45: Surfacing markings on approach to single bollards.

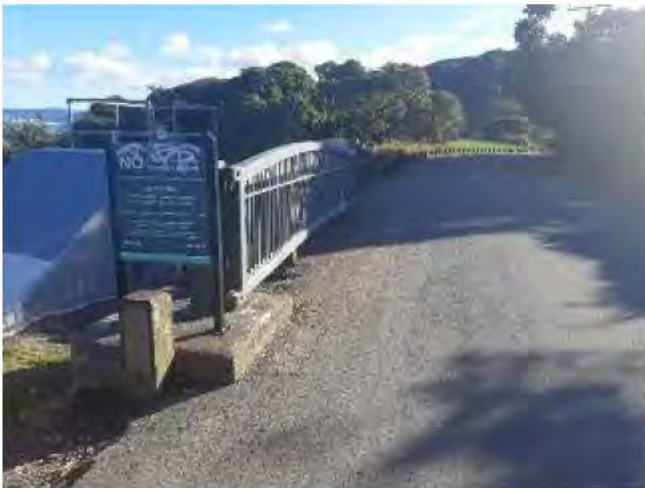
Figure 46: Hutt City Council owned and operated gate

It should be noted that the shared path will likely be used by commuters who travel to and from work therefor would require access to the path prior to 7:00 am and past 6:00 pm.

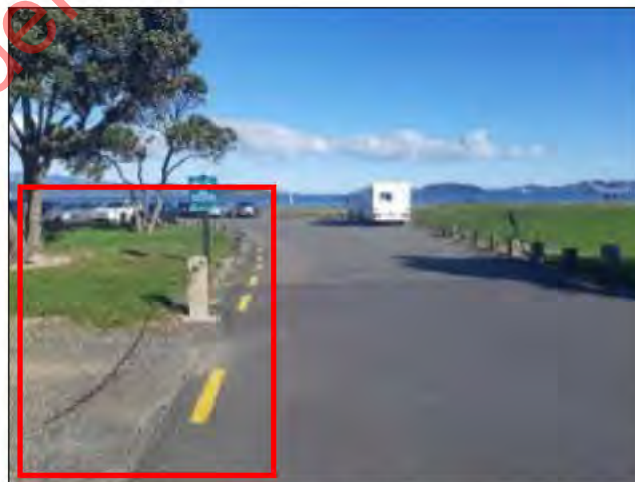
Figure 47: Access way restricted by chain at Honiana Te Puni Reserve.

During the site visit it was noticed that there were several accesses restricted with chains as in Figure 47. During dark hours, the lighting at Honiana Te Puni Reserve does not allow cyclists and micromobility device users to see the chains from afar. This may result in users riding straight into the chain causing them to be thrown off their transportation device and seriously injured.

- 1 Consider installation of removal bollards instead of chains to restrict accessways.
- 2 Improve the lighting conditions around Honiana Te Puni Reserve so cyclists, micromobility users and pedestrians are aware of the chains at the restricted accessways.

Frequency:	Severity:	Rating:
Crashes are likely to be Common	Death or serious injury is Likely	The safety concern is Significant
Designer Response:	Acknowledged. Lighting through the reserve path is to be provided to P3 standard. The hazards identified will be raised with the landowners and operators of the reserve	
Safety Engineer:	Agree with Designer comments.	
Client Decision:	Agreed	
Action Taken:	[

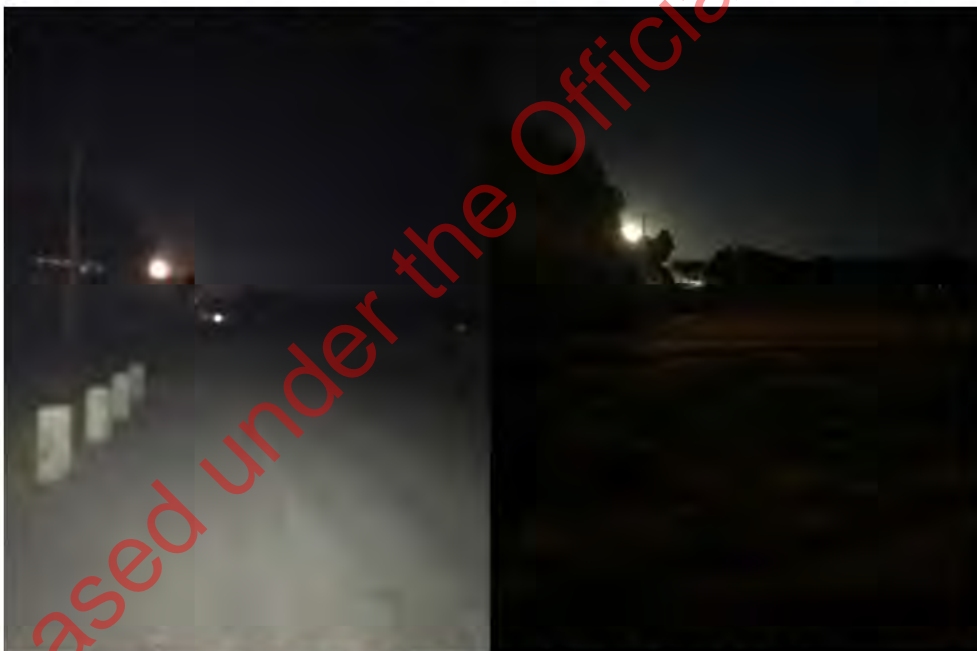
Figure 48: Honiana Te Puni with flash on left and without flash on the right

During the site visit it was noticed the lighting at Honiana Te Puni Reserve was insufficient, as shown in Figure 48. This limits user visibility and increases the risk of collisions with bollards and other objects.
