From: [Richard Williams](#)
To: [James Luty](#)
Cc: [James Snowdon](#); [Rubie McLintock](#); [Paul Gardiner](#)
Subject: RE: BURST WASTEWATER RISING MAIN - SH1 Paremata
Date: Thursday, 23 September 2021 5:05:13 pm
Attachments: [image002.png](#)
[Paramata Water Quality Monitoring - To GWRC.xlsx](#)
[Emergency Works - Paremata Wastewater Pipe - 17 July 2021 - Final to GWRC.pdf](#)
[Paremata Wastewater Riser Break - emergency works notification \(s.330A\(1\)\).msg](#)

Emergency Works

RMA s330 and s330A Emergency Works Report

- This report provides information related to a ruptured pressure wastewater pipeline in Porirua.
- The report describes the work completed in the context of s330 and s330A of the Resource Management Act.
- The report is prepared for Greater Wellington Regional Council.

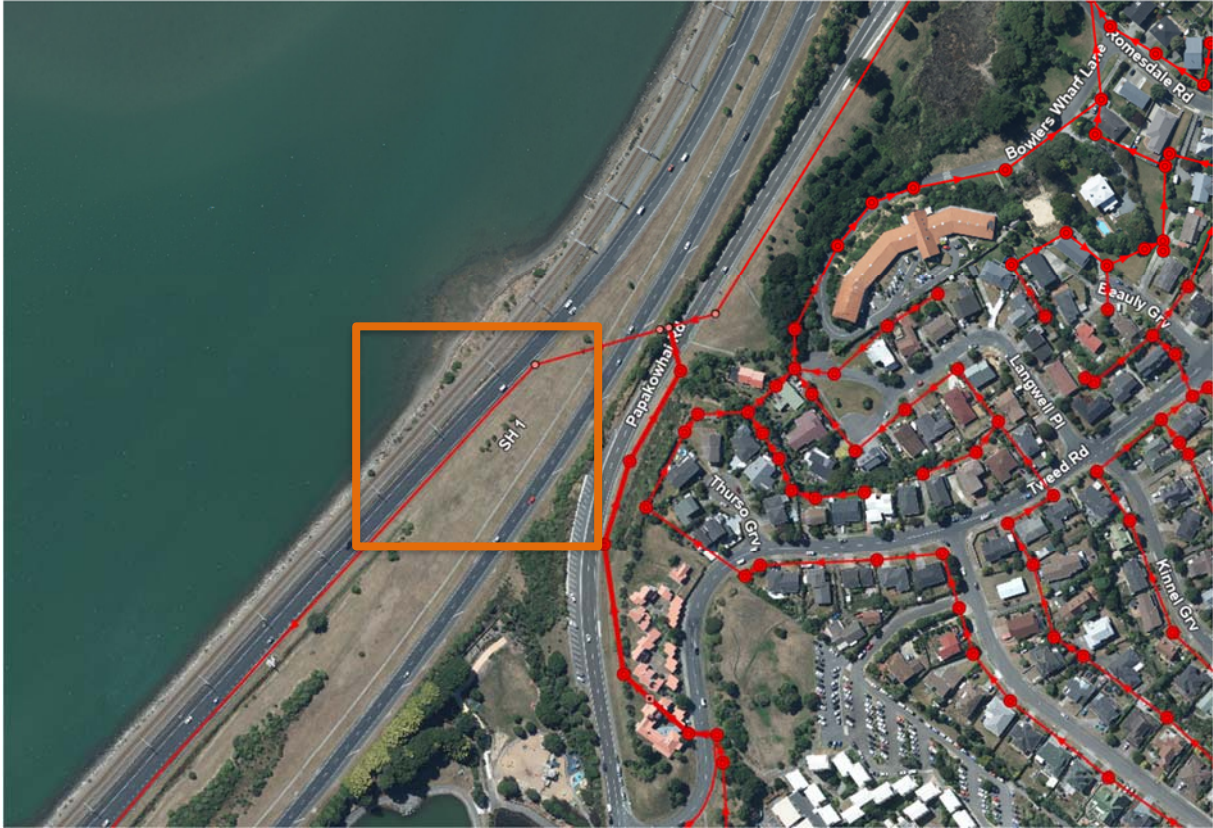
Figure 1: Pipeline Failure (shown in orange)

- The pipeline failed (ruptured) between the carriageways on State Highway 1, approximately 600m north of Whitford Brown interchange. (See Figures 1 and 2 in Attachment A)

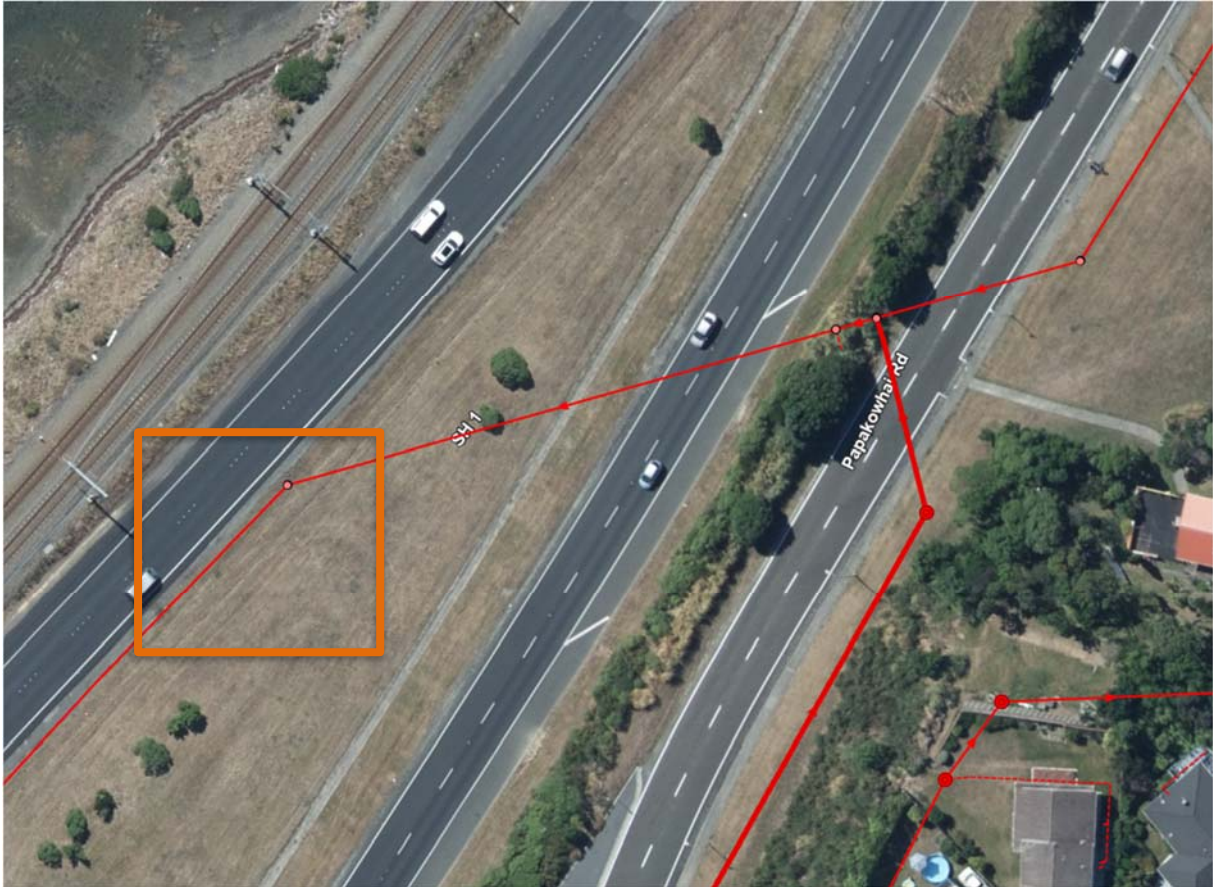
Figure 2: Pipeline Failure (shown in orange)

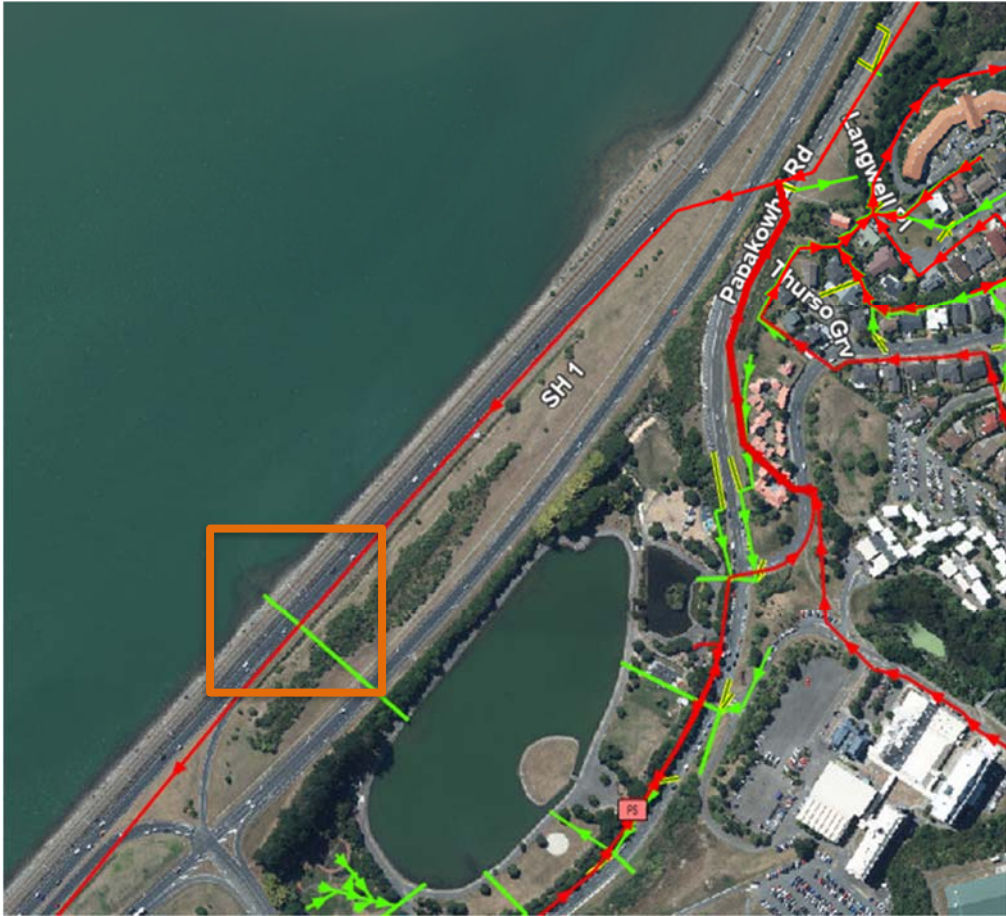
Figure 3: Aotea Discharge Location (shown in orange)

- Wastewater from the break (rupture point) travelled southwest along the State Highway 1 median and entered a stormwater culvert approximately 400m from the pipe failure. The wastewater then discharged to Te Awarua-o-Porirua Harbour (See Attachment B, Figure 3).

<p>July 2021 and approximately 4.00 pm to 5.00 pm on 22 July 2021 at Aotea (See Attachment B, Figure 3). These discharges are a result of the initial and subsequent pipeline ruptures. These ruptures and associated discharges are a result of an unanticipated failure of the pipeline that could not have reasonably been provided against. Wellington Water acted immediately to mitigate the effects of the discharge by deploying vacuum (sucker) trucks and making requests to the public to minimise water use in order to reduce the volume of wastewater being discharged. Wellington Water also sought to minimise the effect of the discharge by shutting pump stations to move the discharge point closer to open water to increase dispersion of potential contaminants. Repairs were completed and normal operation resumed as soon as was reasonably practical.</p> <p>2. Wastewater (contaminant) discharge approximately 10.30 am on 17 July 2021 to 10.00 pm on 18 July 2021 at Paremata via overflow through the stormwater system (See Attachment B, Figure 4). Approximate volume of discharge – 7,740m³. This wastewater discharge is associated to the decision to restrict wastewater flowing through the pipeline by redirecting the wastewater to the Paremata stormwater network which overflowed and was in some cases pumped into the Te Awarua-o-Porirua Harbour at Paremata. The decision to stop the pumps at Station Road and Paremata Pumping Stations backed up the wastewater network until it flowed into the stormwater network. In addition, mobile pumps were deployed to pump the overflowing wastewater into the stormwater network. This decision ensured that wastewater did not pond on State Highway 1, Station Road and Paremata School which would cause a traffic and health hazard, property damage and ensured the safety of our response crews working to repair the pipeline at Aotea. Vacuum sucker trucks were also</p>

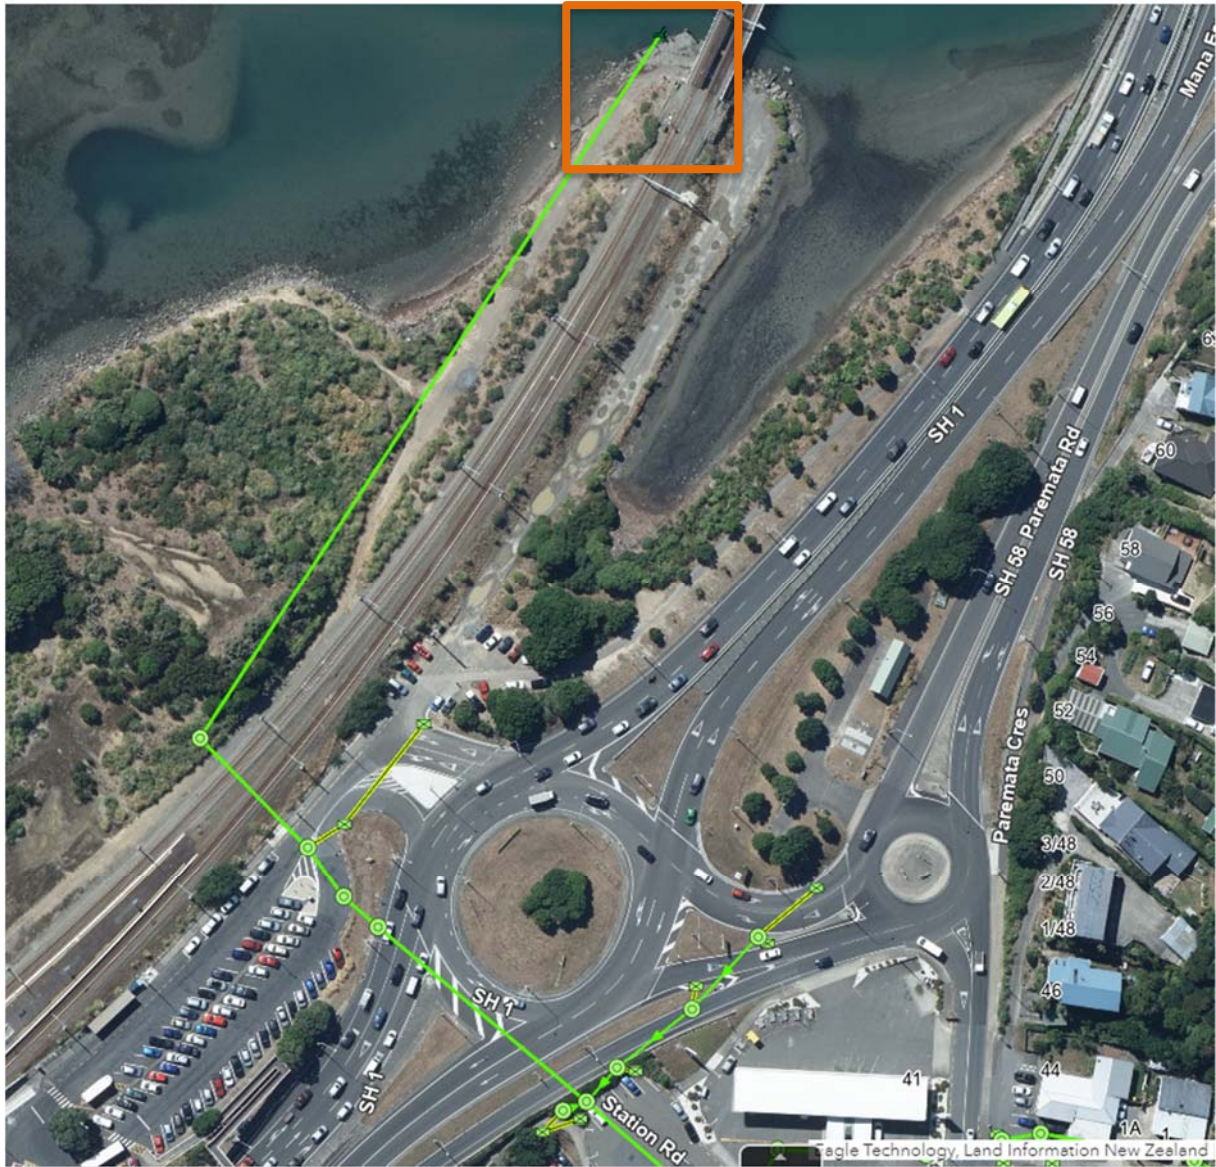
Figure 4: Paremata Discharge Location (shown in orange)

- The wastewater also flowed onto the two north bound State Highway 1 lanes.
- In order to avoid damage to property, avoid creating a traffic and health hazard, and to facilitate the repair work of the ruptured pipeline in a safe manner, the Pumping Stations in Paremata were turned off. These pump stations are directly 'upstream' of the rupture, and intercepts all the wastewater from the surrounding communities that flows through the main trunk pipeline towards the city centre. The wastewater then backed up within the wastewater system and overflowed at Station Road and Paremata Crescent into the stormwater system which then flowed into Te Awarua-o-Porirua Harbour at Paremata (See Attachment B, Figure 4).

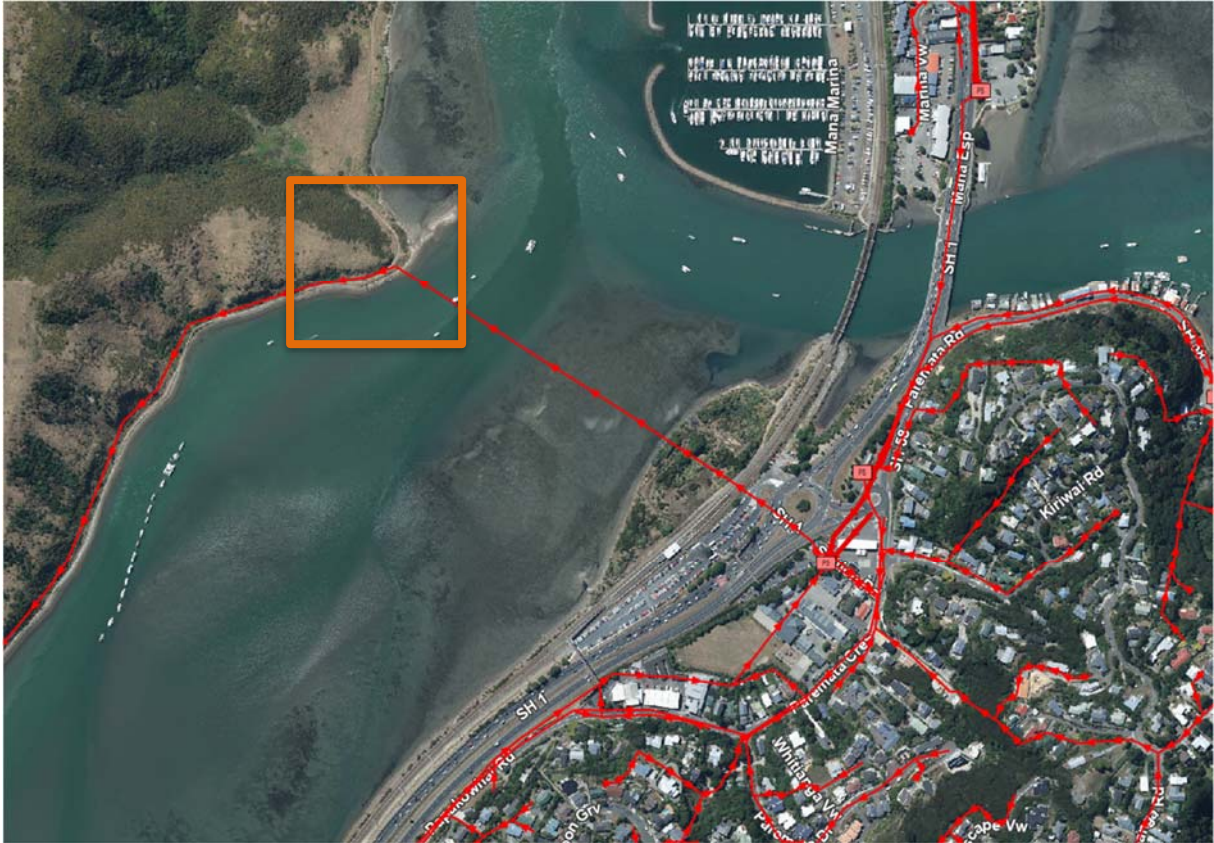
Figure 5: Whitireia Park Reserve Discharge Location (shown in orange- approximate)

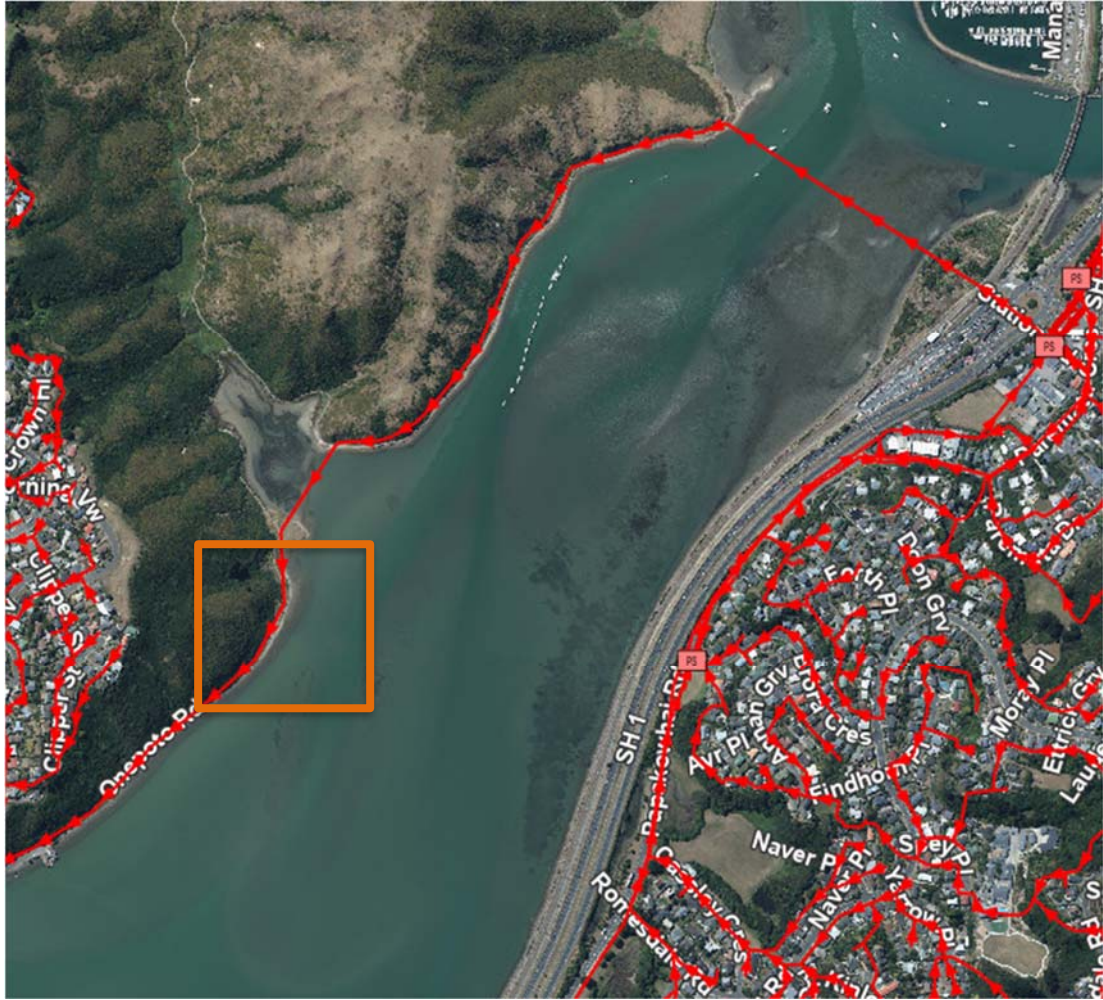
Figure 6: Onepoto Discharge Location (shown in orange - approximate)

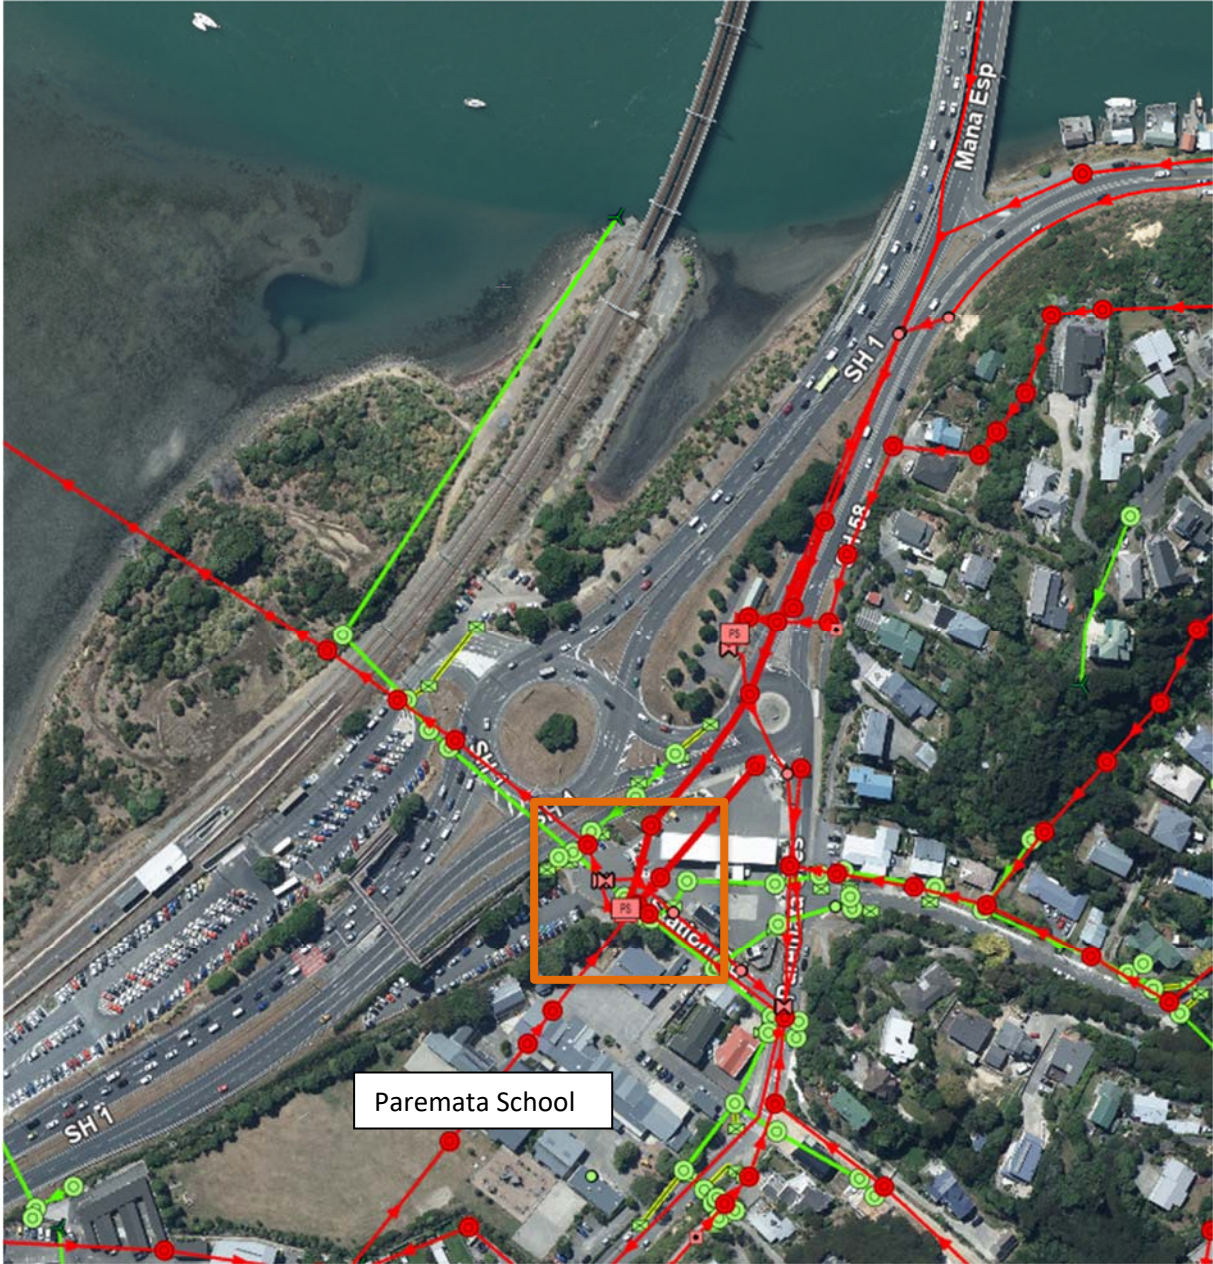
Figure 7: Station Road Pump Station (shown in orange)

- In addition, due to the capacity of the stormwater system, some wastewater ponded onto Paremata School until additional mobile pumps could be deployed. These pumps transferred the overflowing wastewater to the stormwater network, which then flowed into Te Awarua-o-Porirua Harbour at Paremata (See Attachment C, Figure 7).
- To protect property and avoid creating a health hazard, the cross harbour pipeline between Paremata and Whitireia Park Reserve was utilised to convey wastewater (See Attachment C, Figure 8). This pressure pipeline had previously been inspected through creating small openings at Onepoto and Whitireia Park Reserve, and unbeknown to Wellington Water, these inspection points remained open when the pipeline began to convey wastewater under pressure. These openings resulted in discharges of wastewater to Te Awarua-o-Porirua Harbour at Onepoto and Whitireia Park Reserve.

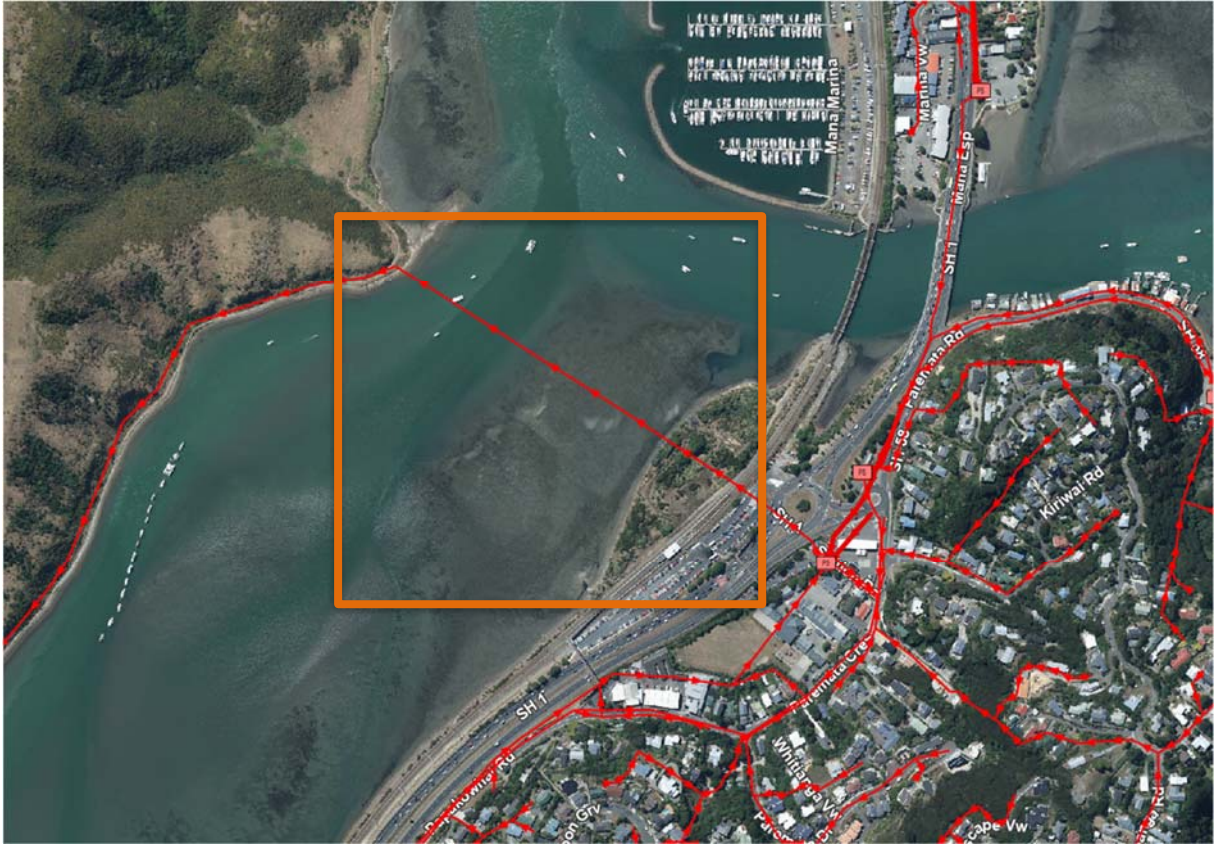
Figure 8 Cross Harbour Pipeline (shown in orange)– Paremata to Whitireia Park Reserve

- Wellington Water organised vacuum trucks to Paremata School and Station Road pump station to reduce wastewater entering the pipeline and property.
- To repair the failed pipe adjacent to State Highway 1, the wastewater was diverted to the cross harbour pipeline that directly connects Paremata to Onepoto. (Note: cross harbour pipeline did not convey wastewater as drain valve in pipeline was inadvertently opened).

- On Tuesday (20 July 2021), wastewater diverted through cross harbour pipeline. On site observation notes a leak in the pipe and wastewater entering Porirua Harbour. Commenced dye testing to confirm location. Wastewater leak detected in Onepoto Road. Cross harbour pipeline repaired and pressure tested with drinking water.
