**RE: REGINA -v- DAVID EDWARD TURNER - SENTENCING**

Crash scene examination by myself on the 16<sup>th</sup> March 2008  
Photographs taken at the scene of the crash.  
Photographs taken of the vehicles at salvage.  
Forensic Mapping and prepared scale plans.  
Statements obtained from witnesses to this crash and drivers involved.  
Reports prepared by specialists.
- 1.3 This report will not include any recommendation regarding criminal liability or possible charges.
- 1.4 This report was commissioned as per General Instruction T004 and Waikato Serious Crash Investigation Protocol.

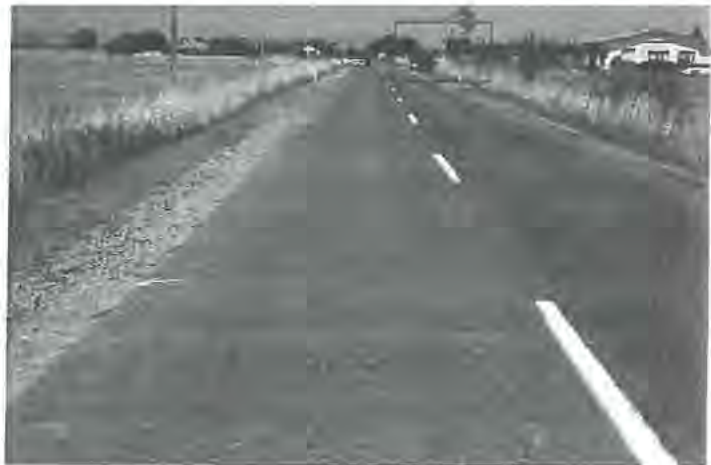
**Fig 2** View east of Bush Road, 108 Bush Road is at top right corner of view with driveway in boxed area.

- 4.1 The section of Bush Road where the crash occurred runs approximately southeast to northwest, for the purposes of this report is referred to as running east to west with State Highway 25 located to the west. The road is rural in nature providing access to local farms and residential properties.
- 4.2 The crash occurred on a straight section of road that has its nearest curve located approximately 190 metres east of the immediate crash scene. This curve is moderate and is a left curve for westbound traffic.
- 4.3 Bush Road is marked into two lanes, the lanes being formed by a broken white centreline. No marking is provided to delineate the lane outer boundaries. Reflecting marker posts are positioned along the road edges.

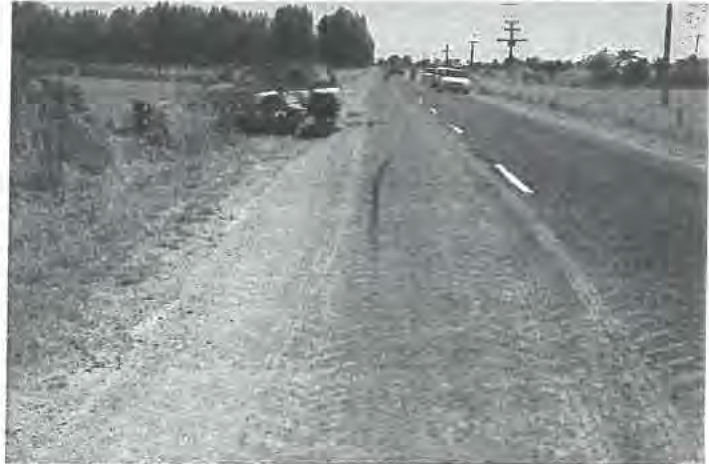
**Fig 3** Tyre friction mark at eastern end of scene in centre of view. [Image digitally altered due to sensitive material]

- 5.1 The physical scene evidence observed will be described moving from the east to west and described in sequential order.
- 5.2 The first physical evidence located at the eastern end of the scene was a tyre friction mark near the lane centre of the westbound lane. This tyre friction mark was approximately 9.4 metres in length and arced in a clockwise direction. It was faint at its start and became more prominent as it progressed west. This mark is consistent with being left by a locked and sliding wheel.

- 9.6 The single tyre friction mark observed at the eastern end of the scene in the westbound lane curved in a tightening clockwise arc and became darker as it progresses west. This is consistent with it having been made in an east to west direction. It is attributable to the Honda motorcycle rear tyre being locked and skidding. The direction of the arc is consistent with the motorcycle falling on to its right side.

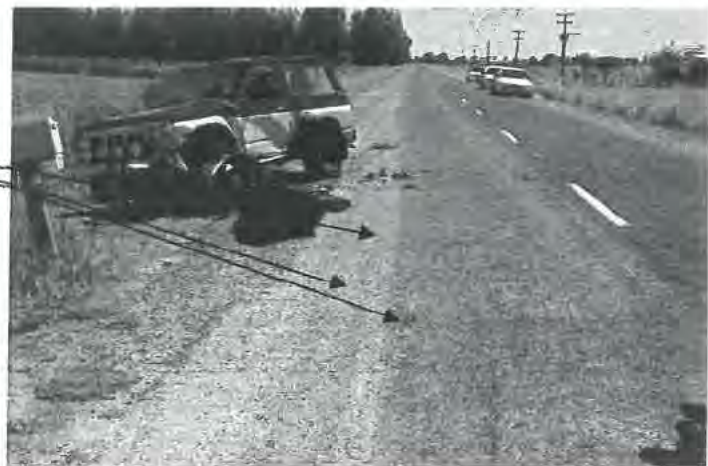
**Fig 4.** Scrape marks located in westbound lane. [Image digitally altered due to sensitive material]

- 5.3 Approximately 0.3 metres west of the eastern end of the tyre friction mark and 0.59 metres south of it a series of scrape marks were visible on the road surface. These scrape marks were fully contained within the westbound lane, and had a coverage area of approximately 6.7 metres by 1.3 metres.

- 9.7 The scrape marks located proceeding west from about the end of the tyre friction mark toward the vehicles' rest positions are also attributable to the Honda motorcycle as it slid westward on its right side. This is consistent with grazing noted on the right side of the motorcycle.

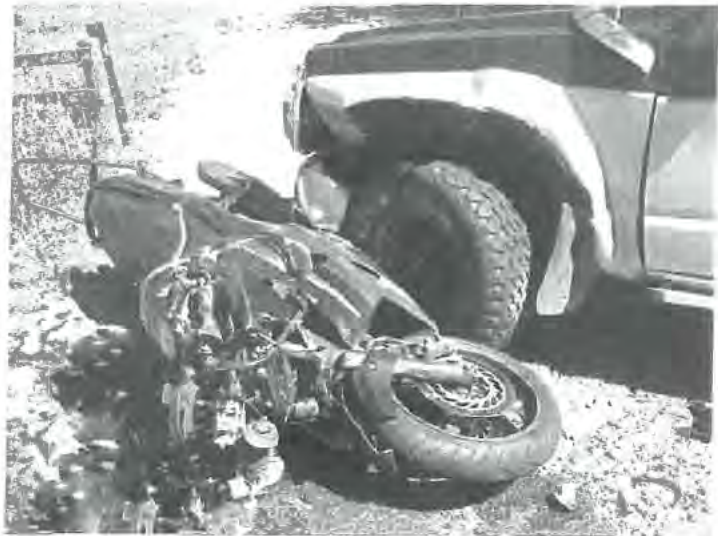
**Fig 5.** Motorcycle in situ against front left guard of Nissan Patrol wagon.  
[Image digitally altered due to sensitive material]

- 5.5 Approximately 0.9 metres west of the head of the deceased male a black Honda CB1000F registered number [REDACTED] was located lying on its right side with its lower chassis hard up against the front left corner of a Nissan Patrol wagon registered number [REDACTED]

- 5.6 The Honda motorcycle had sustained moderate frontal damage and was orientated in an approximate north - south direction with the front wheel pointing.

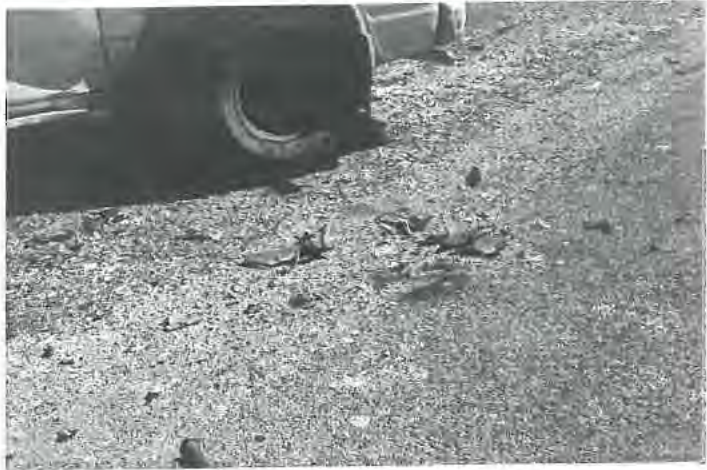
Fig 7. Gouging to westbound lane visible in centre of view and highlighted by orange paint.

- 5.9 Gouging was observed in the road surface of the westbound lane approximately 2.5 metres west of the start of the acceleration mark. It was located approximately 2.1 metres south of the road centreline and measured approximately 0.6 metres in length.

- 9.8 The gouge located in the westbound lane is consistent with an impact gouge and it is probable that it was caused at impact. It is unlikely that a part of the Nissan Patrol was forced down into the sealed surface and it was therefore attributable to the Honda motorcycle. This is consistent with the vehicle impact damage and the evidence of the left sill and chassis rail of the Nissan

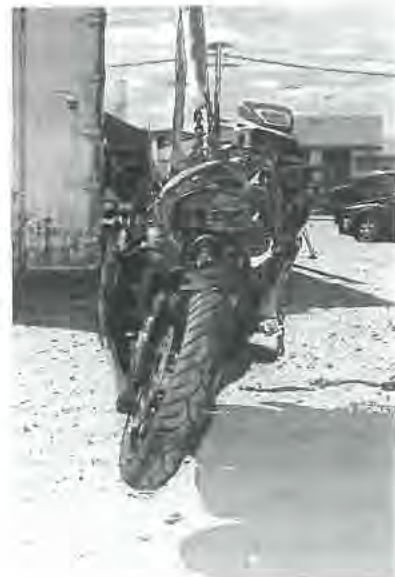
Fig 8.

- 6.2 The front of the fairing, instrument panel and headlight assembly of this motorcycle had extensive contact damage. The right handle bar had snapped off and the left handlebar damaged. The front forks were extensively damaged and the fuel tank exhibited contact type damage demonstrated as denting to both sides.

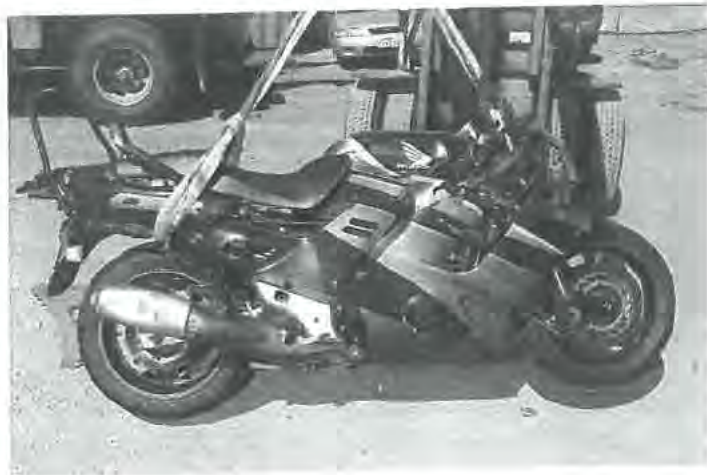
**Fig 9.** Right side view of Honda motorcycle at salvage

- 6.3 The right side of the motorcycle exhibited grazing and denting to the exhaust and grazing of the right side lower engine case cover.

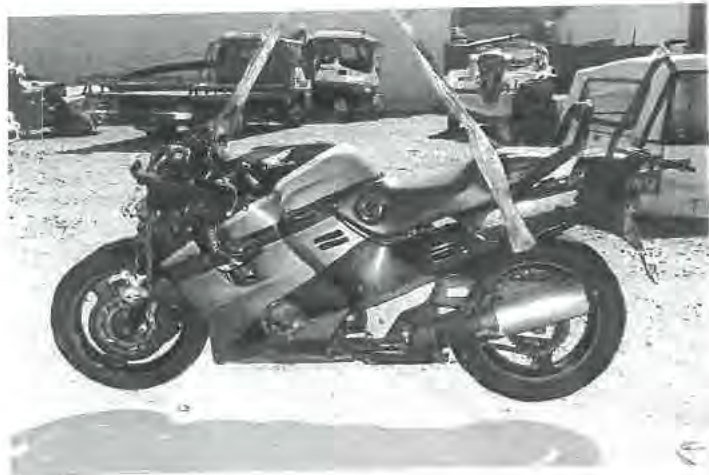
**Fig 10.** Left side view of Honda motorcycle at salvage

- 6.4 The left side of the motorcycle had contact damage evident to the exhaust and the lower engine case cover.
- 6.5 Impact damage to the right side of the front wheel rim was evident in the form of chop marks in the edge of the rim wall.
- 6.6 The tyres fitted were correctly matched for size and type and had sufficient tread depth. Both the front and rear tyre pressure was measured at approximately 32 PSI.
- 6.7 The headlight assembly and switching was destroyed in the crash and inspection of the resultant debris proved inconclusive as to whether the motorcycle forward lighting was being operated at the time of the crash. The motorcycle was found to be in 5th gear when inspected.

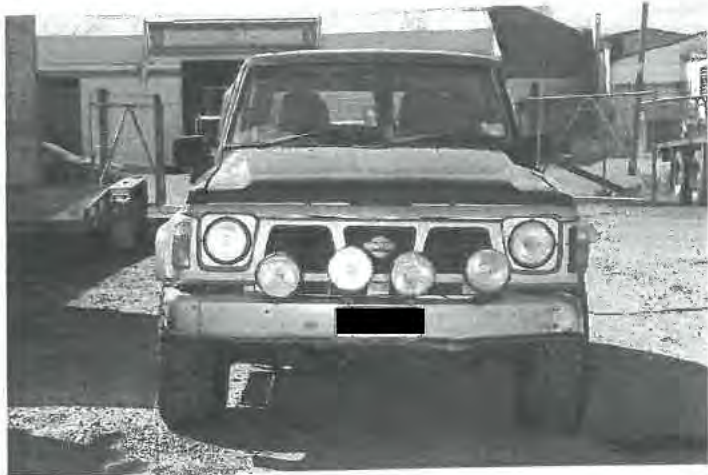
**Fig 11.** Front view of Nissan Patrol wagon at salvage

- 6.9 Damage to this vehicle was of a minor nature and confined to the front left and forward half of the left side of the vehicle.

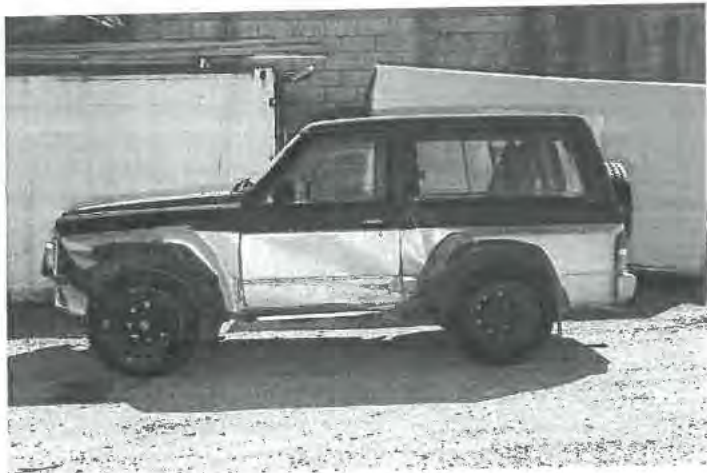
**Fig 12.** Left side view of Nissan Patrol wagon at salvage

- 6.10 The front bumper of this vehicle had contact damage evident to the front bumper assembly which had deformation to the left corner.

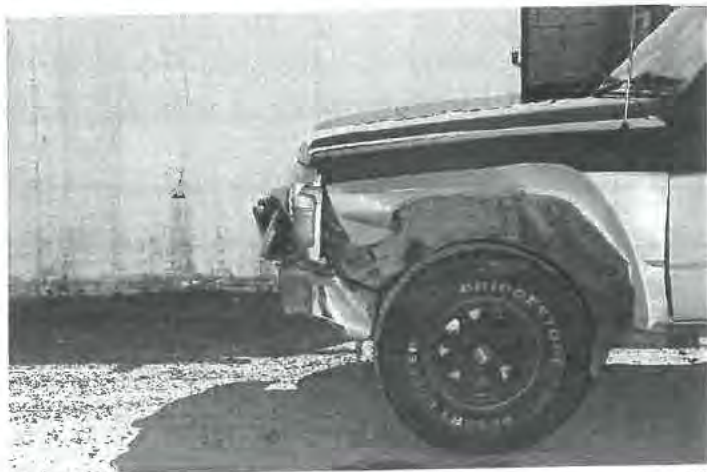
**Fig. 13** View of left front guard of Nissan Patrol wagon at salvage.

- 6.11 The left front guard trim had been pulled free and deformation was visible to the guard lower panel edge. The left front indicator lens had been displaced.

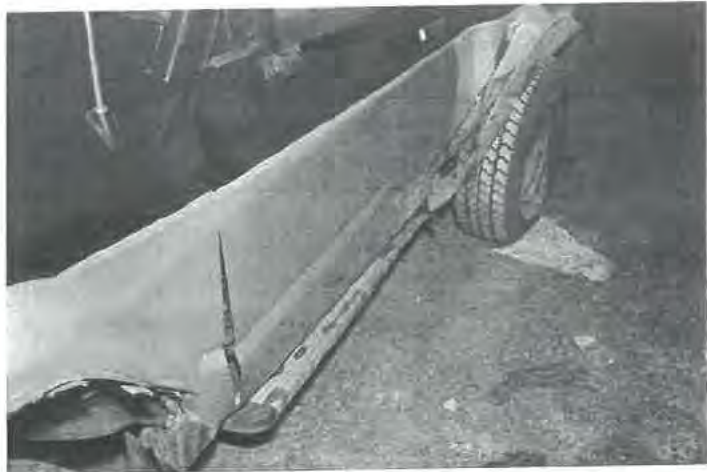
**Fig 14.** View of left side of Nissan Patrol at salvage looking from front to rear.

- 6.12 Further contact damage was noted to the front of the left rear guard and door about the sill intersection. Induced damage was evident as creasing to the rear left guard and door panel emanating from the contact damage area.

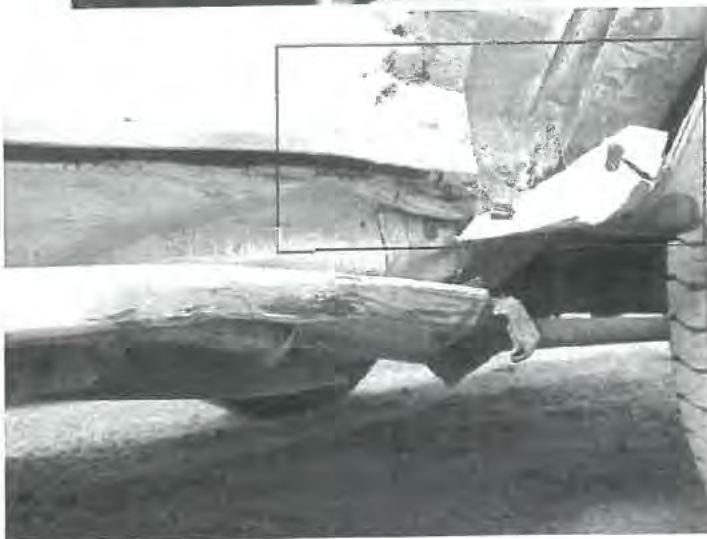
**Fig 16.** Close view of over-ride damage forward of rear left guard.

- 6.13 The left running board was twisted upward and damage to the left chassis rail suggests a partial over-ride occurred during engagement.

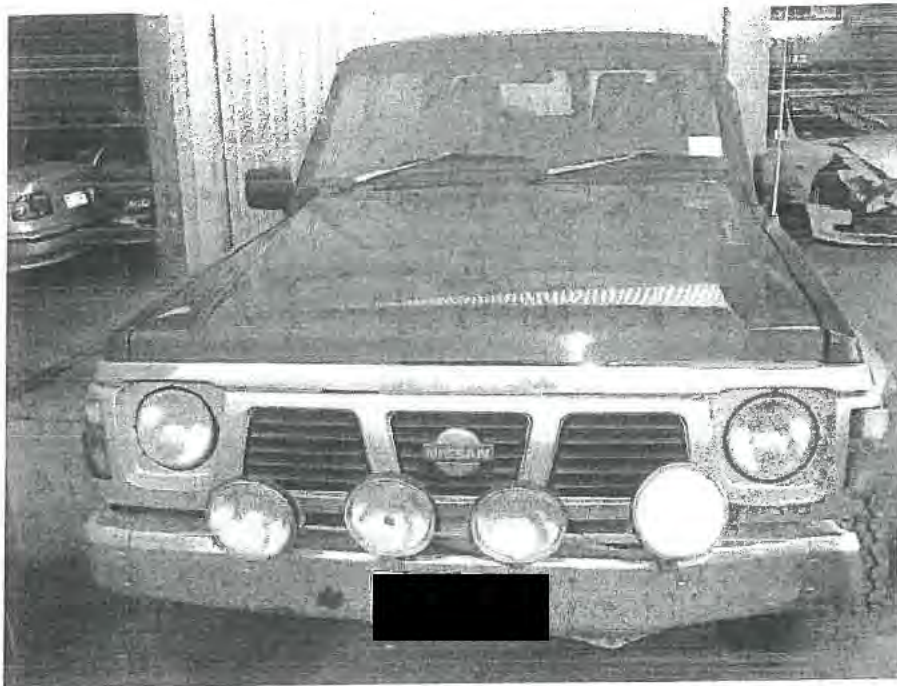
fig.1

Registration No:	[Redacted]	Year:	1989
Make:	Nissan	Colour:	Blue / Silver
Model:	Patrol	Speedometer reading:	325999 km
VIN No:	KY60105498	Motive Power:	Petrol
Engine Capacity:	4200 cc's	Airbags Fitted?	No
		Airbags Deployed?	N/a
Type:	Station Wagon Four wheel drive Right hand drive

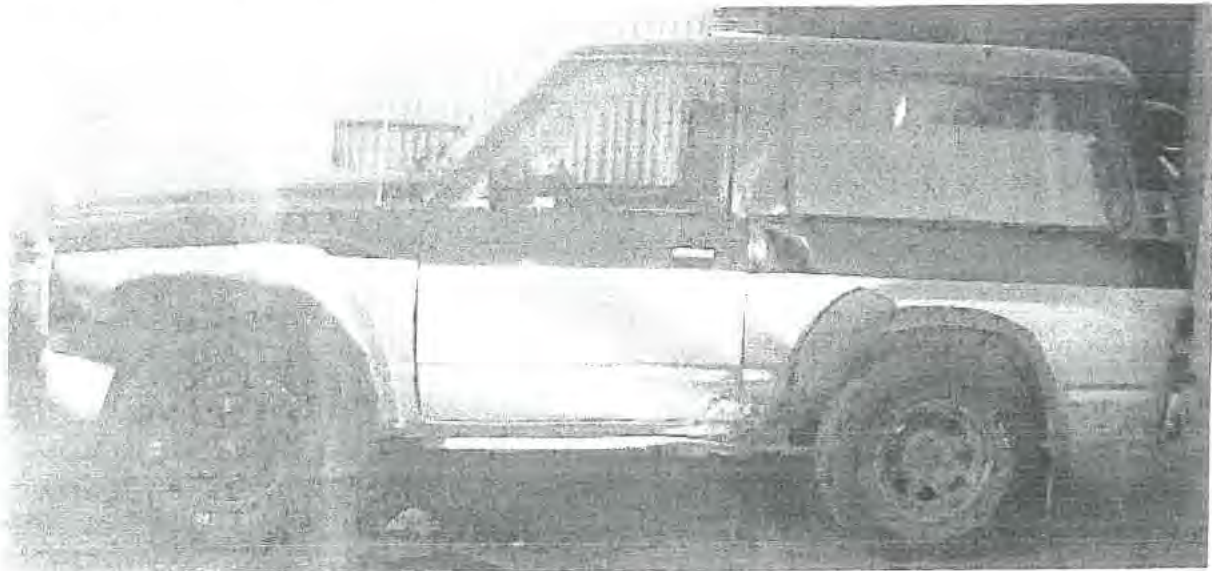
**Damage sustained**

Moderate dents to the left hand front mudguard, door and rear guard

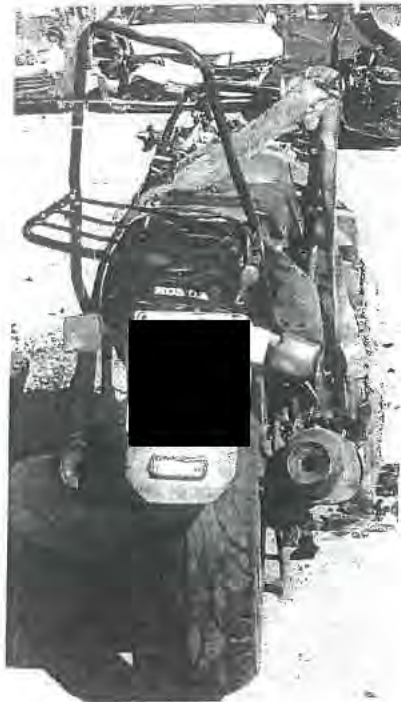
Fig.1

Registration No: [REDACTED]	Year: 1993	
Make: Honda	Colour: Silver	
Model: CBR1000F	Speedometer reading: 46889 km.	
VIN No: JH2SC24UXPM400148	Motive Power: Petrol	
Engine Capacity: 998 cc's	Airbags Fitted? N/A	Airbags Deployed? N/A
Type: Motorcycle

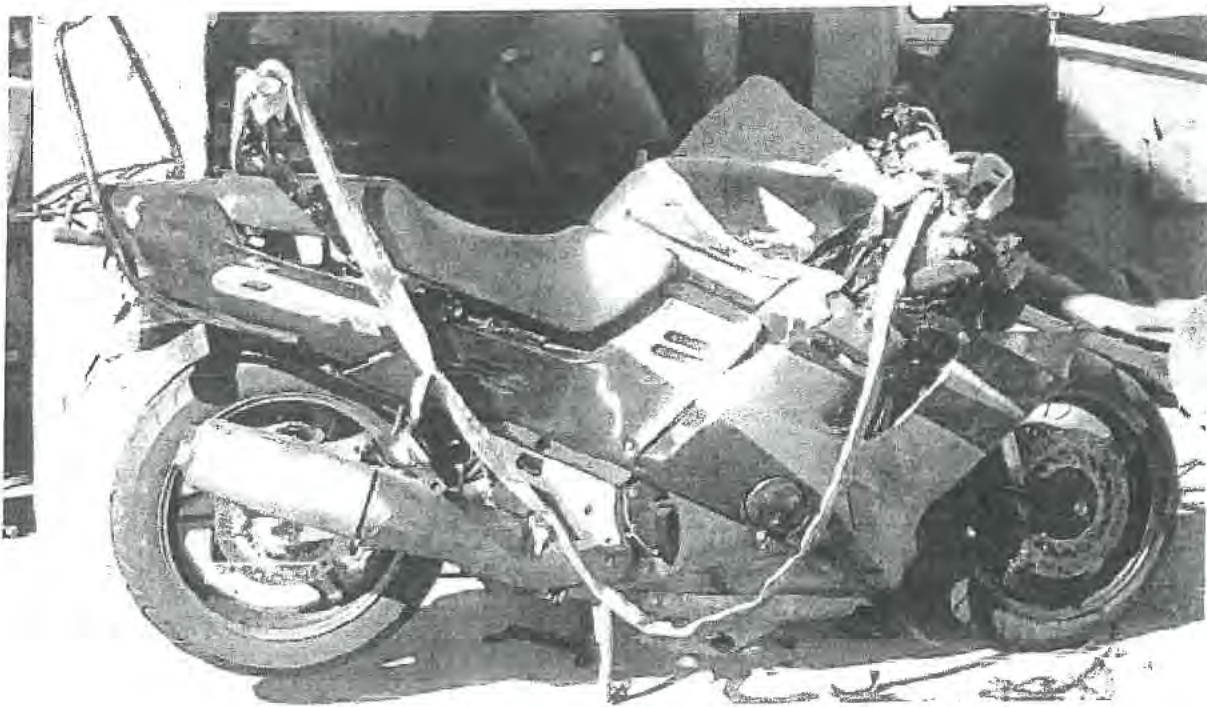
**Damage sustained**

Severe crash damage to both front forks, steering head, fairing, fuel tank, right hand exhaust, front brake controls and master cylinder torn off in the crash.

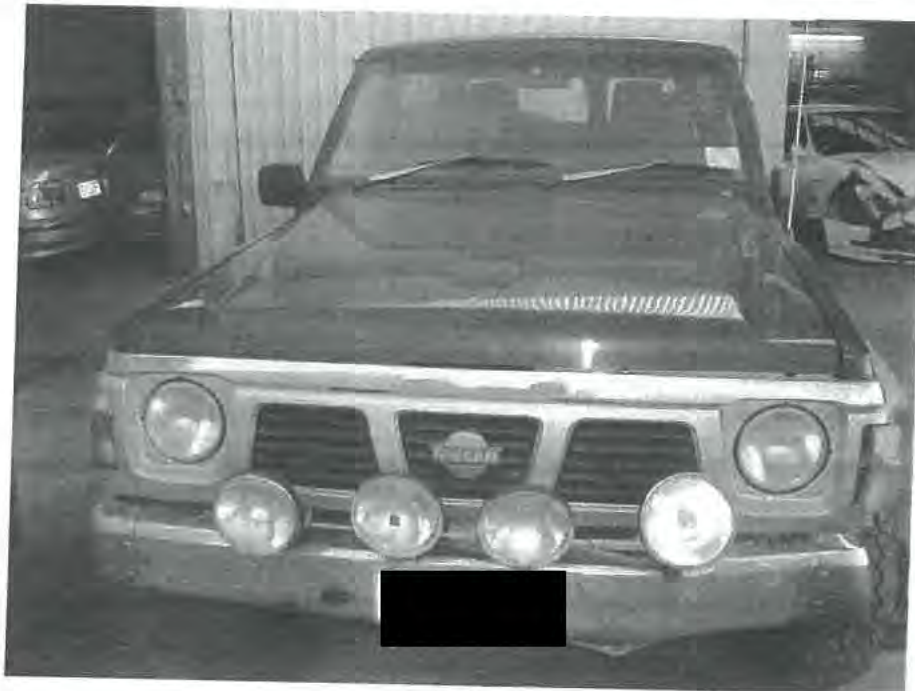
fig.1

Registration No:	[Redacted]	Year:	1989
Make:	Nissan	Colour:	Blue / Silver
Model:	Patrol	Speedometer reading:	325999 km
VIN No:	KY60105498	Motive Power:	Petrol
Engine Capacity:	4200 cc's	Airbags Fitted?	No
		Airbags Deployed?	N/a
Type:	Station Wagon Four wheel drive Right hand drive

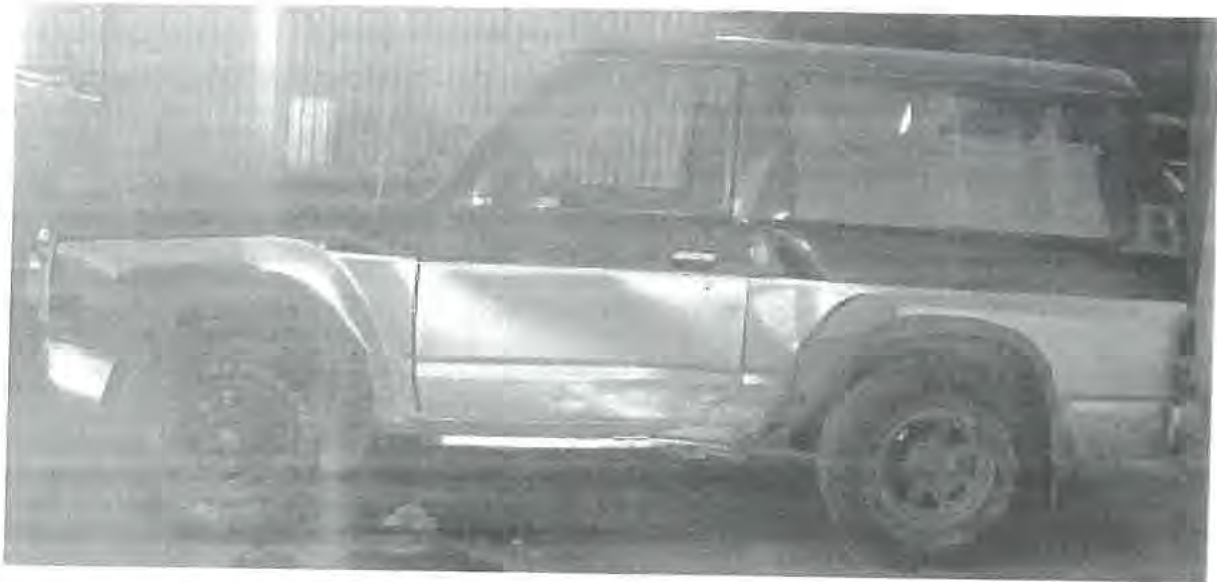
**Damage sustained**

Moderate dents to the left hand front mudguard, door and rear guard

As far as I could inspect the vehicle, I found no defects that in my opinion could have been a contributing factor in the cause of the crash.

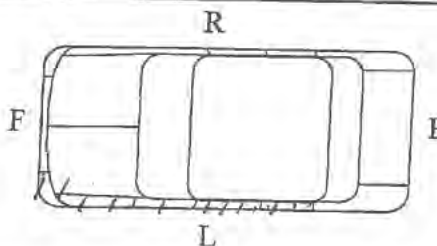
Damage to L/F bumper, F/guard, L/H door & L/R guard

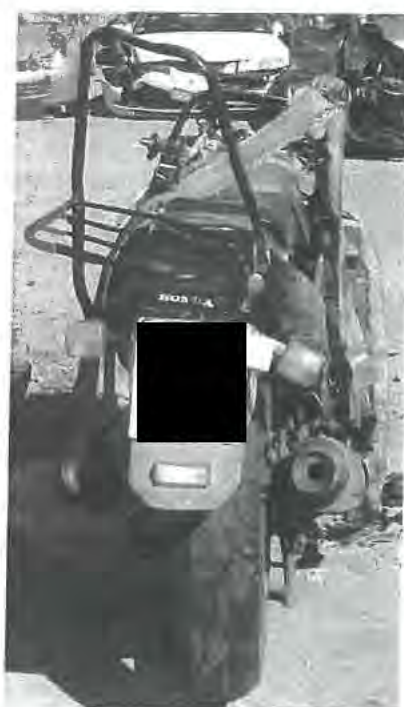
Fig.1

Registration No: [REDACTED]	Year: 1993	
Make: Honda	Colour: Silver	
Model: CBR1000F	Speedometer reading: 46889 km.	
VIN No: JH2SC24UXPM400148	Motive Power: Petrol	
Engine Capacity: 998 cc's	Airbags Fitted? N/A	Airbags Deployed? N/A
Type: Motorcycle

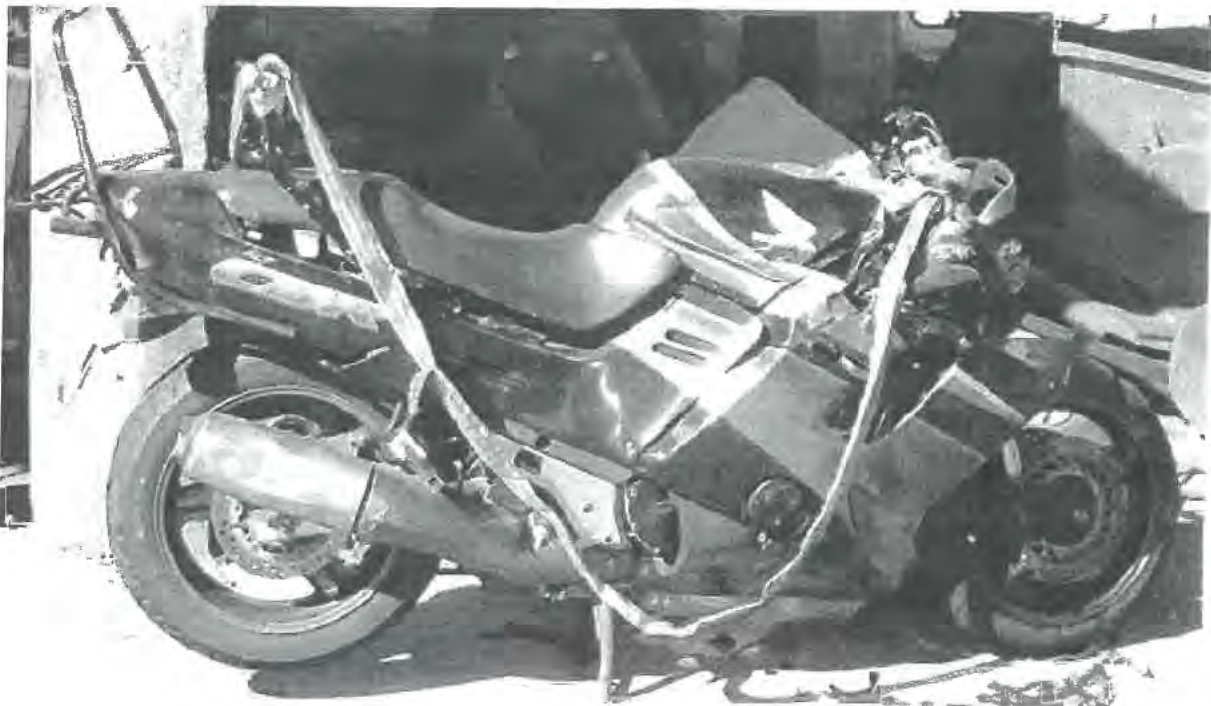
**Damage sustained**

Severe crash damage to both front forks, steering head, fairing, fuel tank, right hand exhaust, front brake controls and master cylinder torn off in the crash.
