PETONE TO NGAURANGA CYCLEWAY

GEOTECHNICAL INVESTIGATION

Prepared For:	Prepared By:	Title:
NZ TRANSPORT AGENCY WAKA KOTAHĪ	OPUS AECOM	Proposed Combined Geotechnical Investigations
Project: Petone to Grenada Link Road & Wellington to Hutt Valley Link		
Scale: 1:1,500	Date: 17 Apr 2014	Project No: Figure: 1

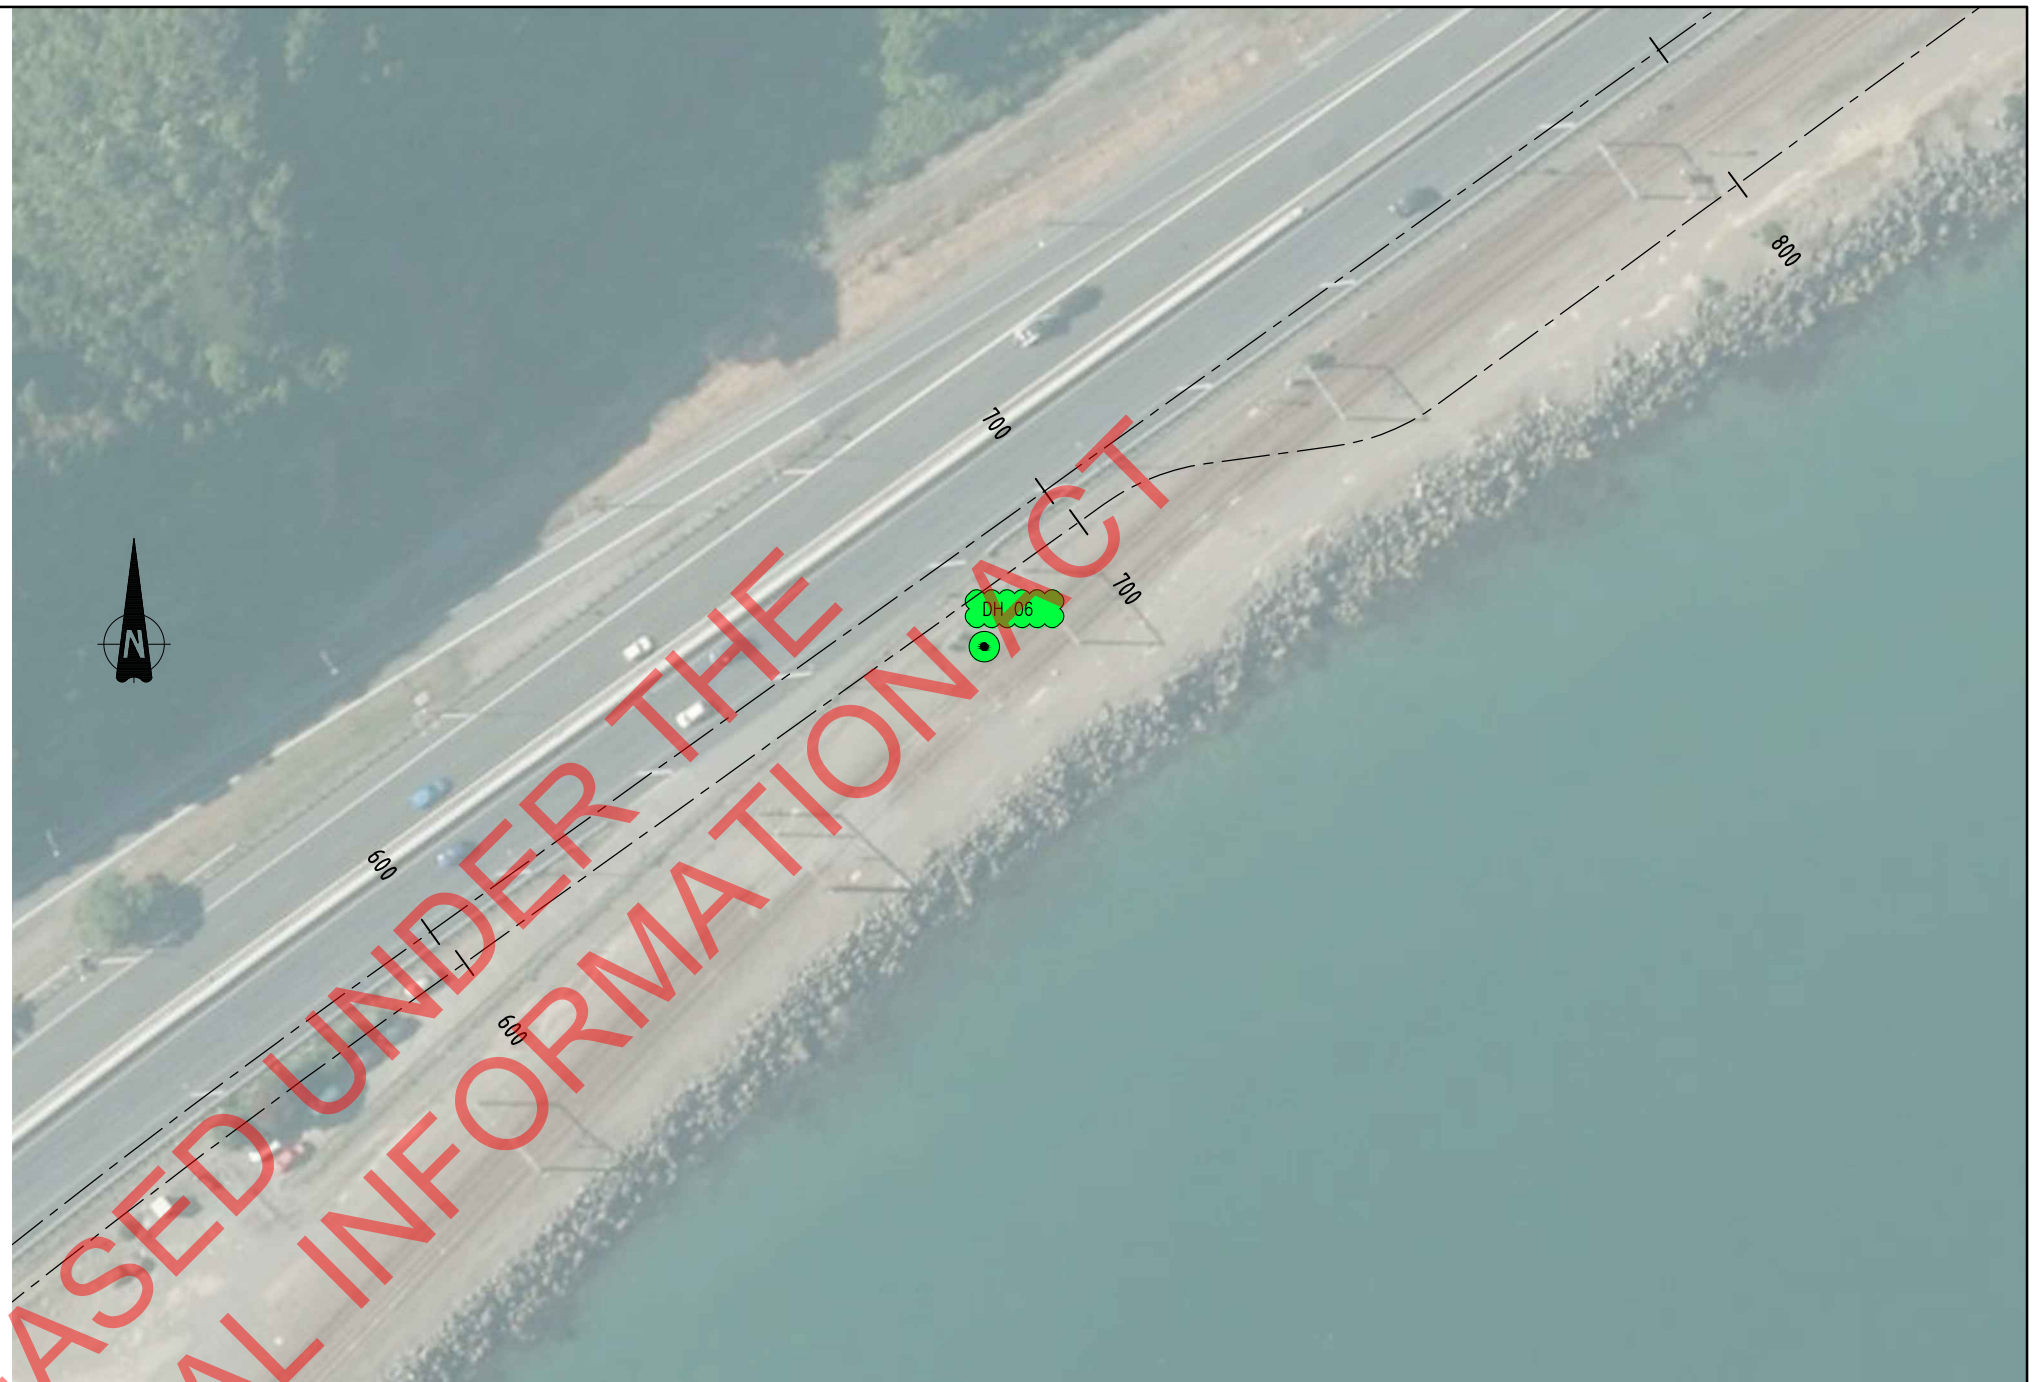
A1	STATUS FOR INFORMATION ONLY	DRAWING NO. SK120	REV.
----	-----------------------------	-------------------	------

GEOTECHNICAL INVESTIGATION TABLE

ID	EASTING	NORTHING	DEPTH	LEGAL DESCRIPTION	LAND PARCEL	OWNERSHIP
DH 06	1752517	5432596	13.5m		RAILWAY PARCEL

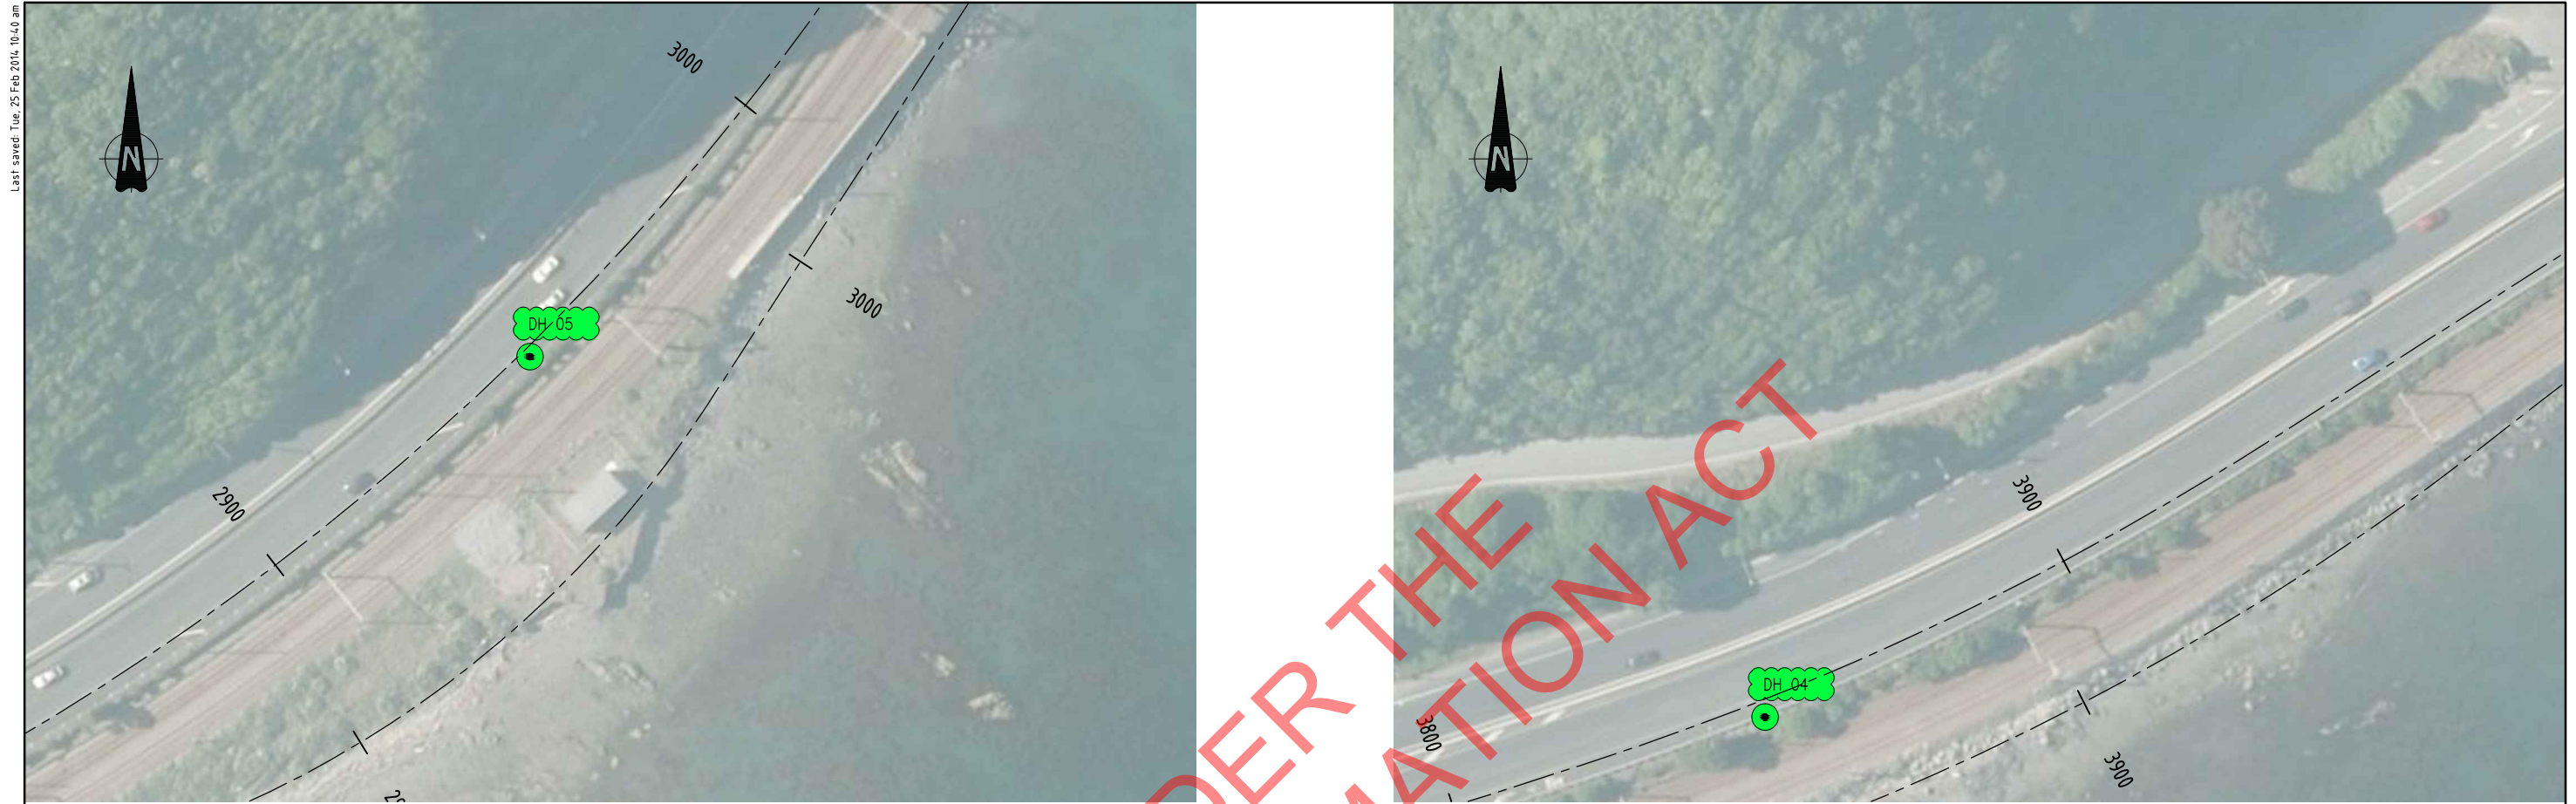
A1	STATUS FOR INFORMATION ONLY	DRAWING NO. SK130	REV.
----	-----------------------------	-------------------	------

GEOTECHNICAL INVESTIGATION TABLE

ID	EASTING	NORTHING	DEPTH	LEGAL DESCRIPTION	LAND PARCEL	OWNERSHIP
DH 04	1755069	5434388	8.1m		ROAD PARCEL	
DH 05	1754304	5433973	2m		ROAD PARCEL

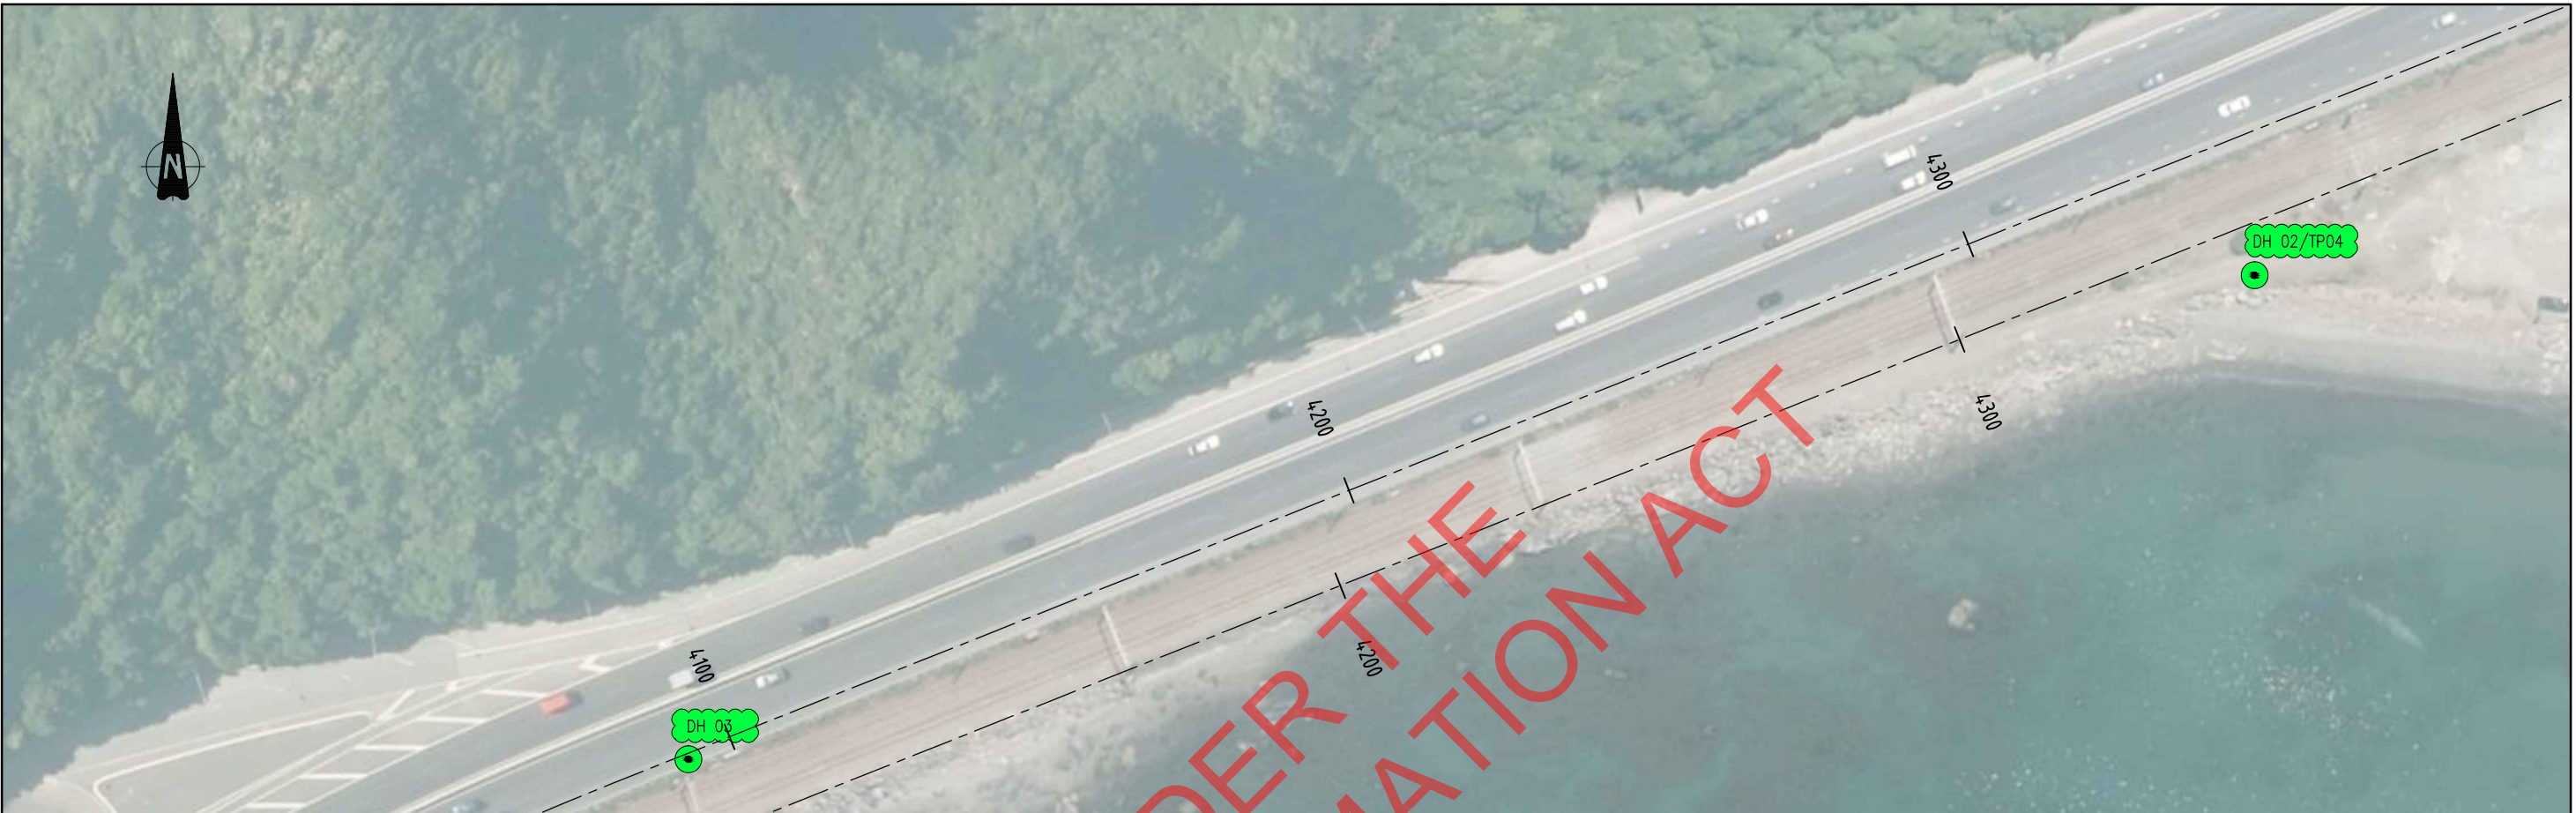
A1	STATUS FOR INFORMATION ONLY	DRAWING NO. SK131	REV.
----	-----------------------------	-------------------	------

GEOTECHNICAL INVESTIGATION TABLE

ID	EASTING	NORTHING	DEPTH	LEGAL DESCRIPTION	LAND PARCEL	OWNERSHIP
DH 02/TP04	1755518	5434577	7.5m		RAILWAY PARCEL	
DH 03	1755283	5434504	10.5m		ROAD PARCEL

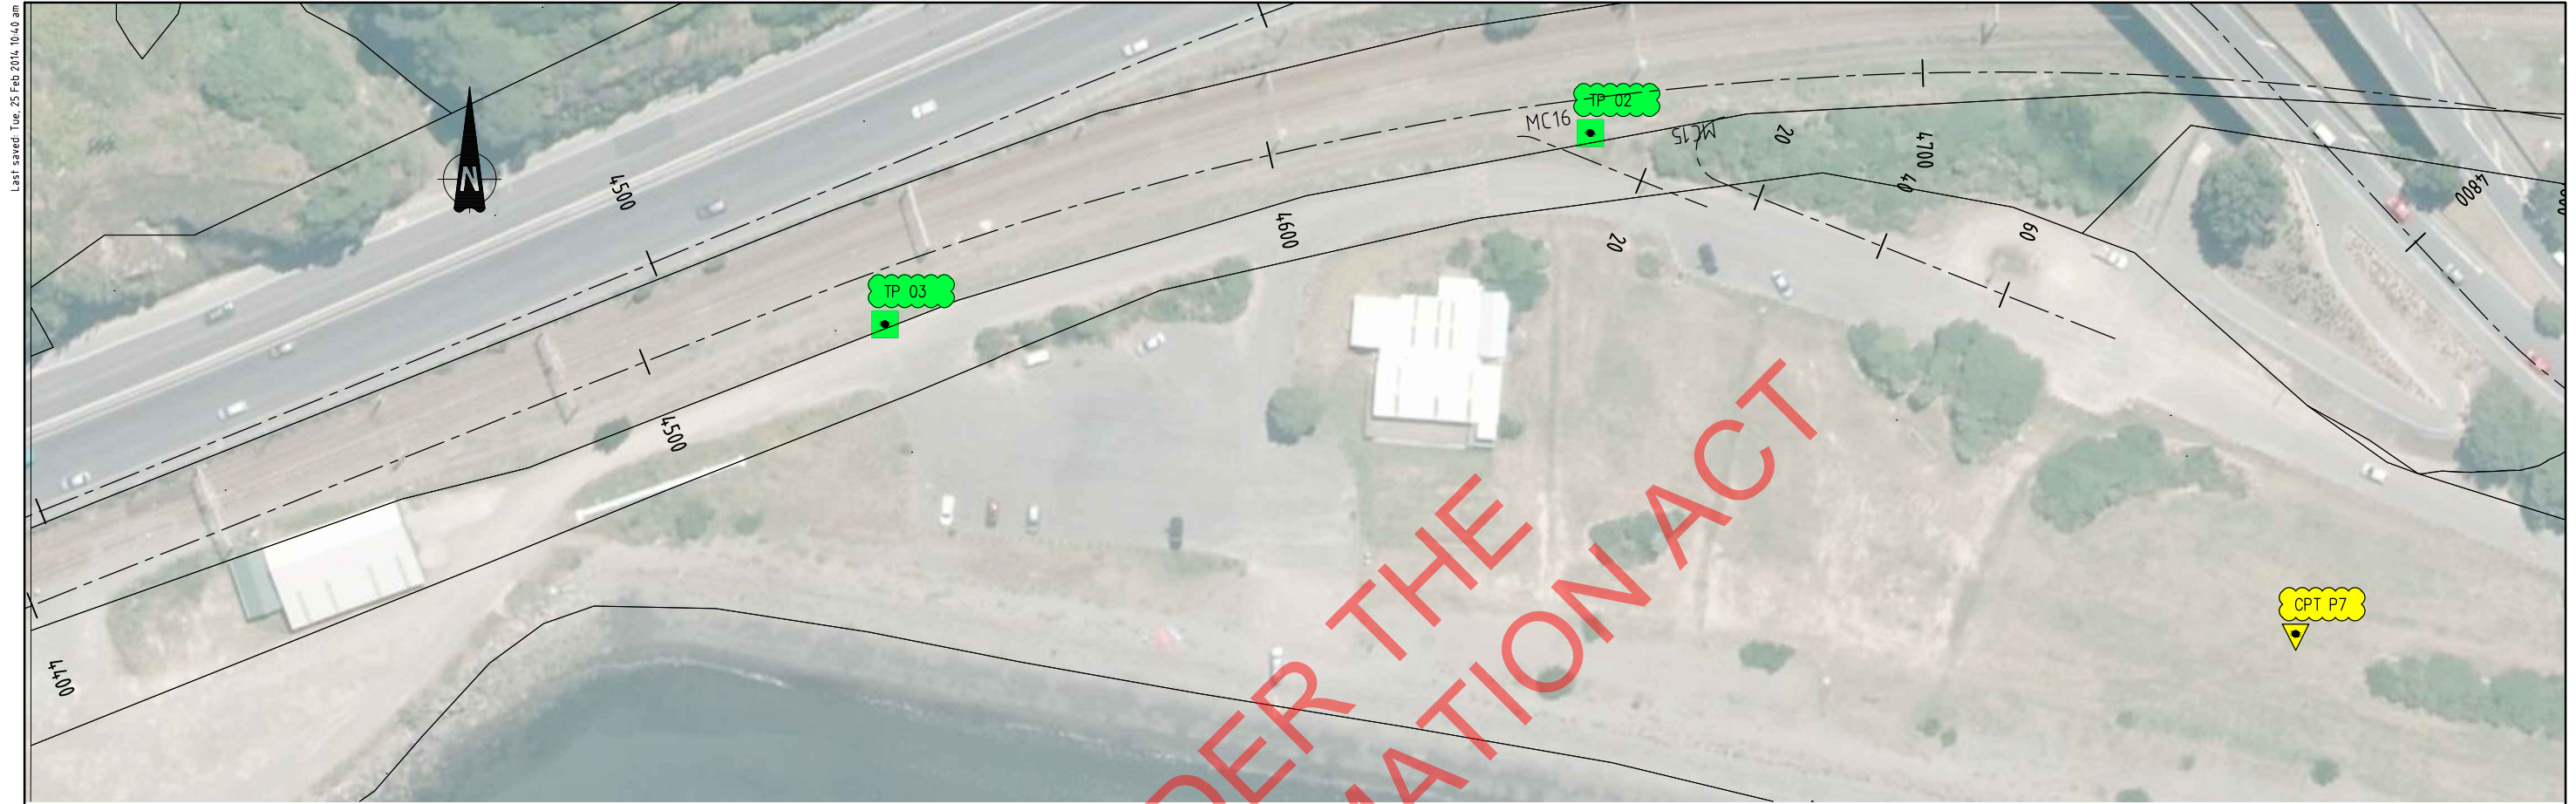
A1	STATUS FOR INFORMATION ONLY	DRAWING NO. SK132	REV.
----	-----------------------------	-------------------	------

GEOTECHNICAL INVESTIGATION TABLE

ID	EASTING	NORTHING	DEPTH	LEGAL DESCRIPTION	LAND PARCEL	OWNERSHIP
CPT P7	1755910	5434600	TBC	SECTION 1 SURVEY OFFICE PLAN 407772		CATHERINE MARIE AMOHIA LOVE, HOKIPERA JEAN RUAKERE, HOWARD KEVIN TAMATI,
TP 02	1755803	5434676	2.0m		RAILWAY PARCEL	
TP 03	1755696	5434647	2.5m		RAILWAY PARCEL

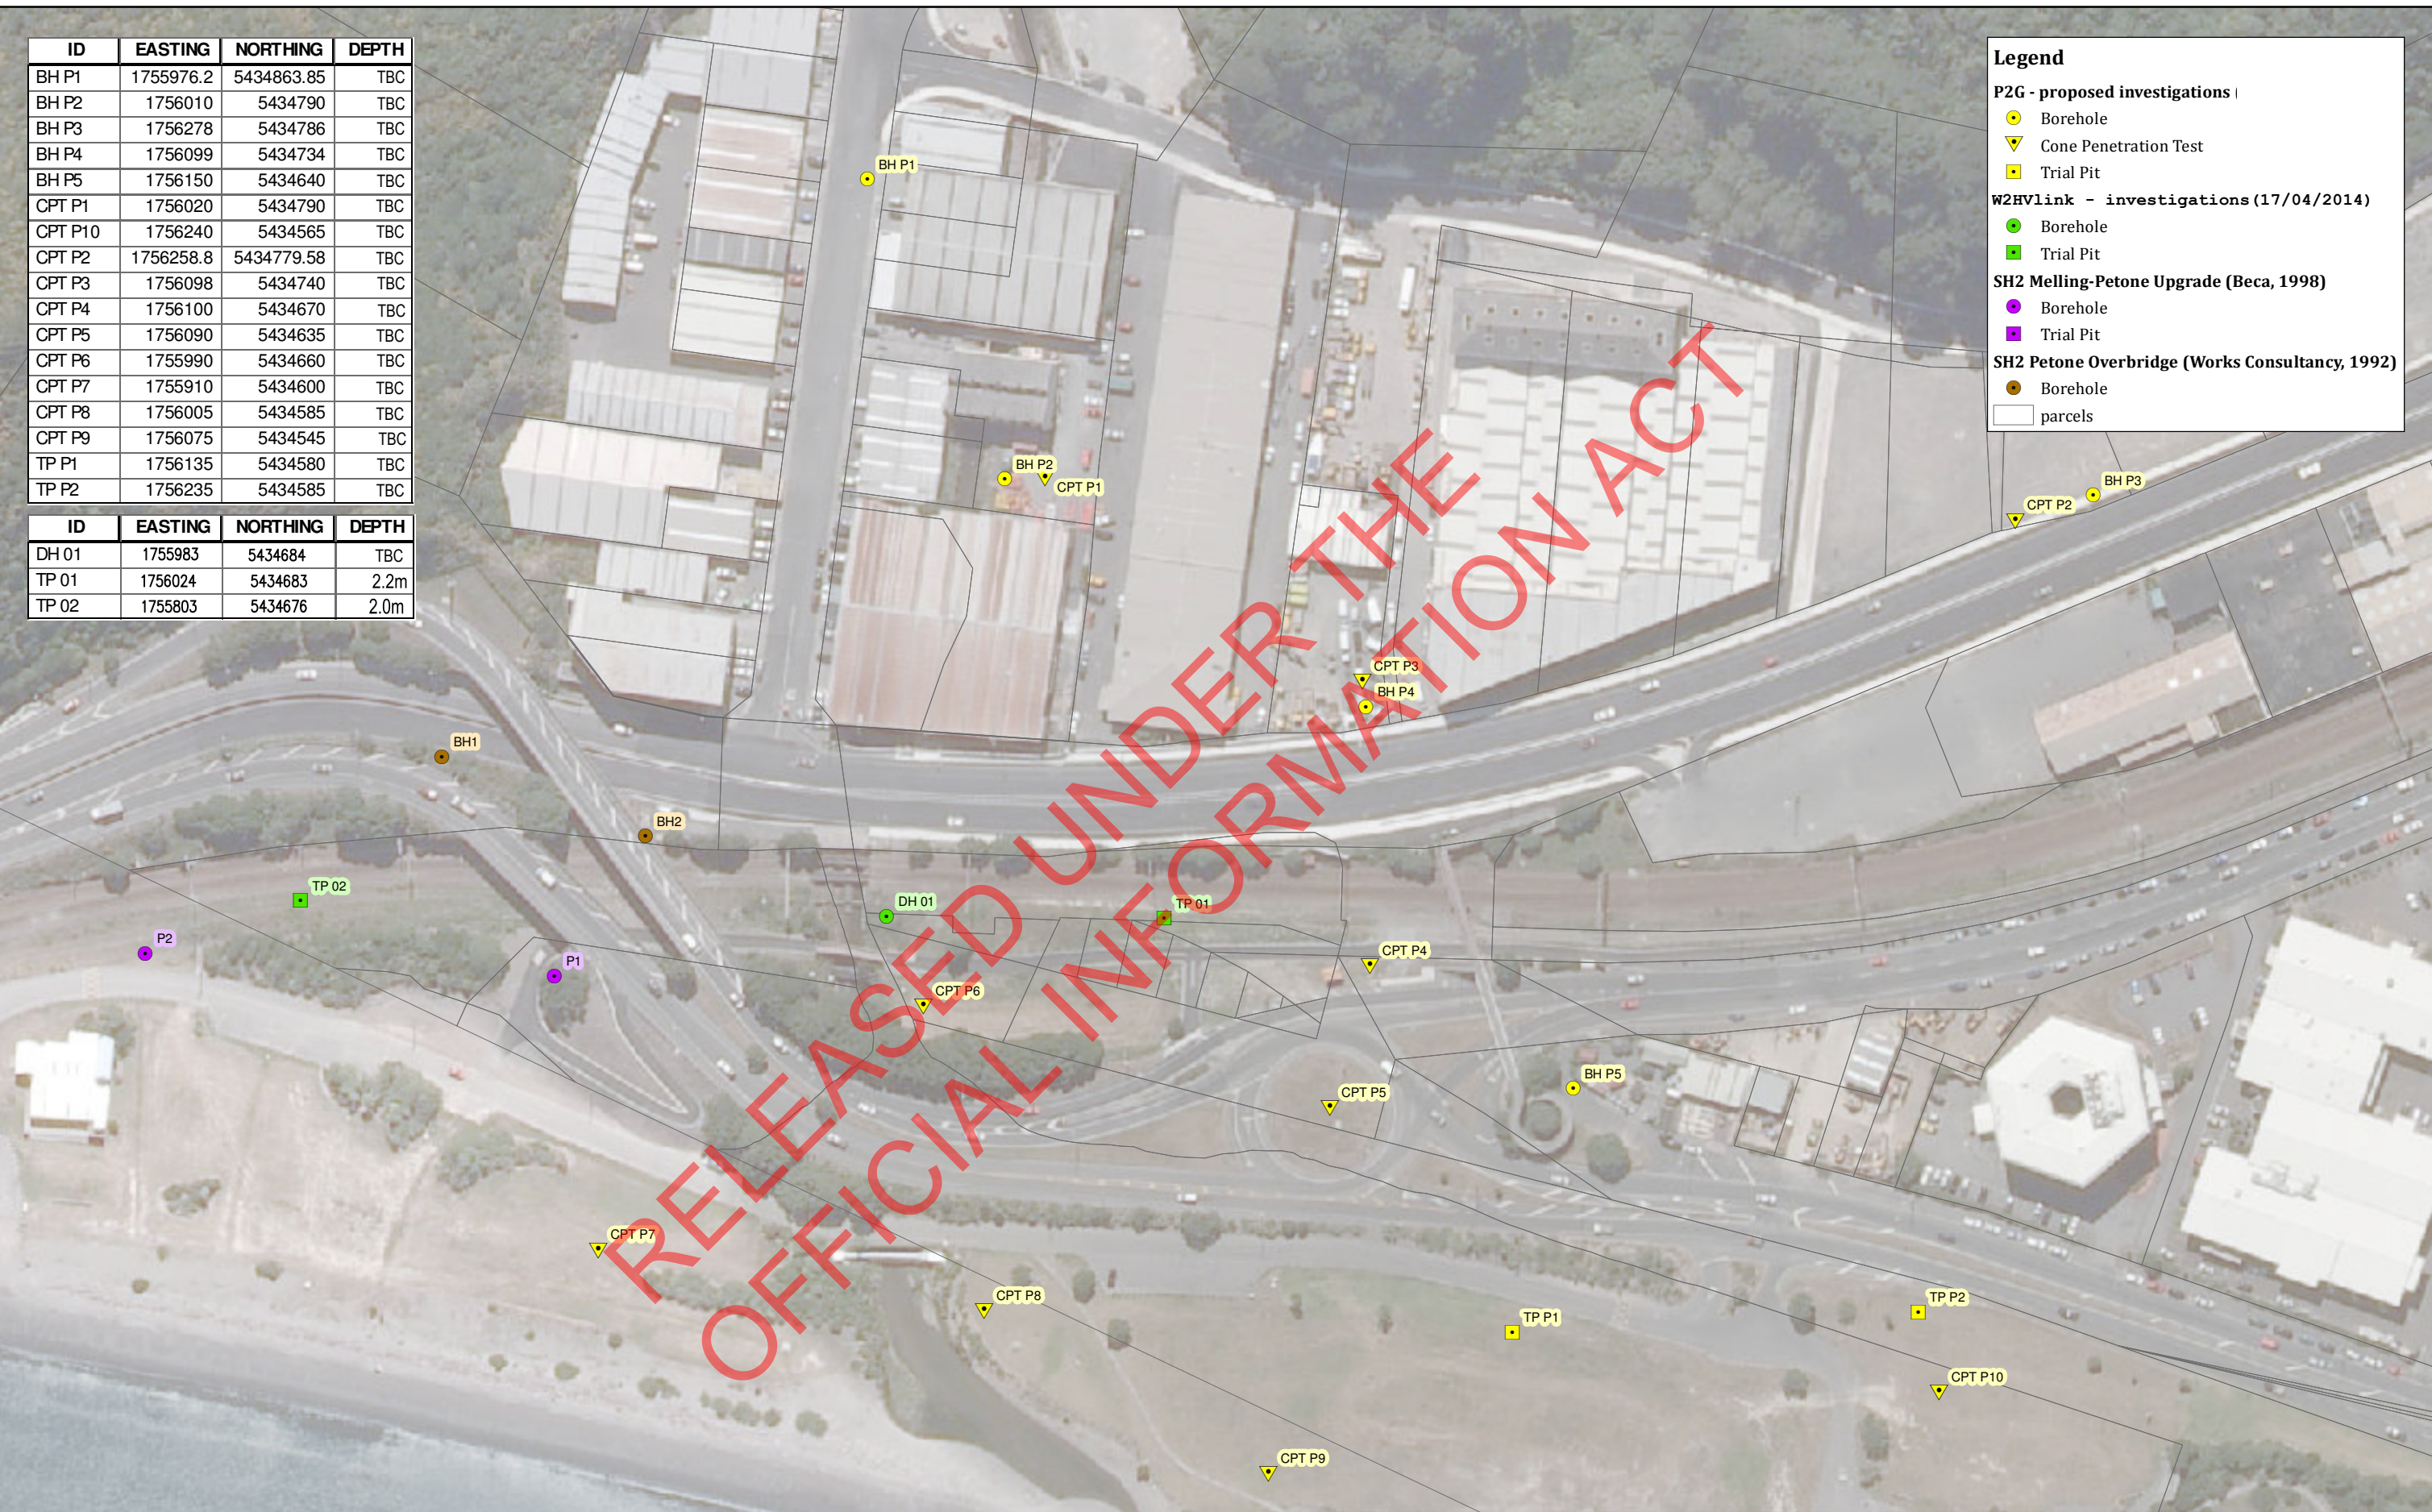
ID	EASTING	NORTHING	DEPTH
BH P1	1755976.2	5434863.85	TBC
BH P2	1756010	5434790	TBC
BH P3	1756278	5434786	TBC
BH P4	1756099	5434734	TBC
BH P5	1756150	5434640	TBC
CPT P1	1756020	5434790	TBC
CPT P10	1756240	5434565	TBC
CPT P2	1756258.8	5434779.58	TBC
CPT P3	1756098	5434740	TBC
CPT P4	1756100	5434670	TBC
CPT P5	1756090	5434635	TBC
CPT P6	1755990	5434660	TBC
CPT P7	1755910	5434600	TBC
CPT P8	1756005	5434585	TBC
CPT P9	1756075	5434545	TBC
TP P1	1756135	5434580	TBC
TP P2	1756235	5434585	TBC

ID	EASTING	NORTHING	DEPTH
DH 01	1755983	5434684	TBC
TP 01	1756024	5434683	2.2m
TP 02	1755803	5434676	2.0m

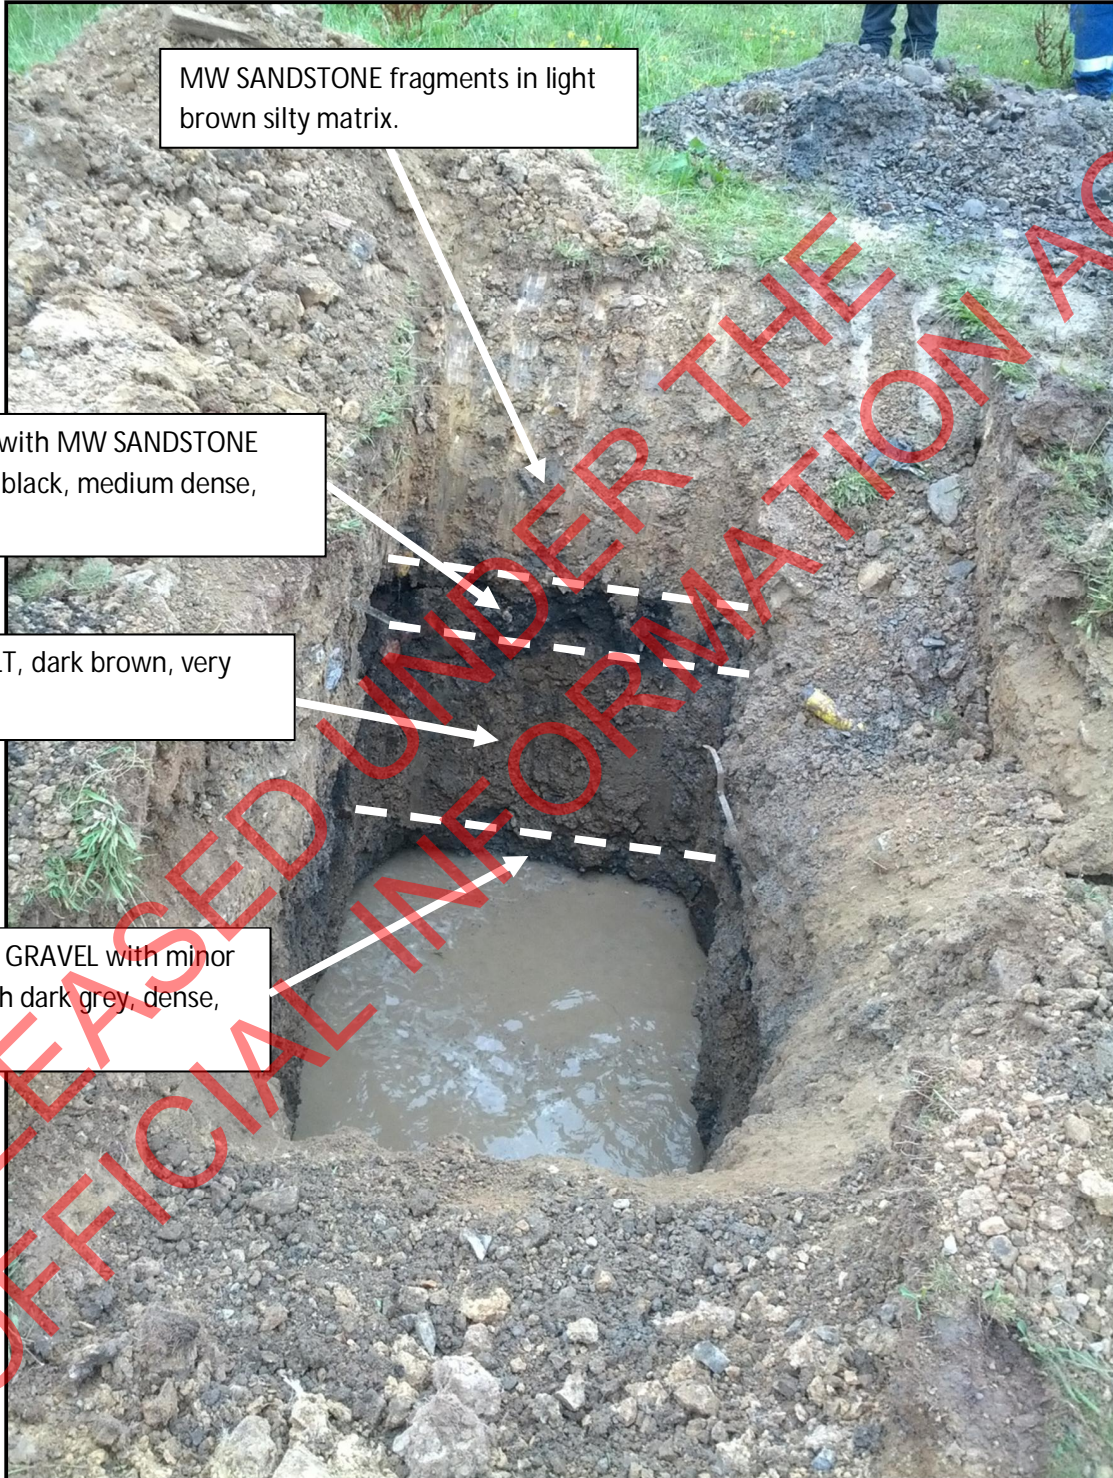
Client NZTA
 Project P2N Cycleway
 Project number 60306339

Co-ordinates 1755803mE 5434676mN
 Orientation -90° Elevation 2m (Approx)
 Location KiwiRail Wairarapa Line
 Feature Opposite Boat Ski Clubhouse

Depth	GEOLOGICAL DESCRIPTION <small>Weathering, Colour, Fabric, Rock Name, Strength, Discontinuities, Lithological Features (bedding, foliation, mineralogy, cement, etc)</small>	Test Records	Sampling	Dynamic Cone Penetrometer (Blows per 100 mm) 2 4 6 8	SOIL PROPERTIES	Graphic Log	Instrumentation
					Subordinate MAJOR minor, colour, structure. Strength, moisture condition, grading; bedding; plasticity; sensitivity, major fraction description; subordinate fraction description; minor fraction description etc Depth Related Remarks <small>(Joints, Bedding Seams, Shatter, Shear and Crush Zones, Foliation, Schistosity, Attitude, Spacing, Continuity, Roughness, Infilling, etc.)</small>		
0m	Old Ballast.			3	0m: GRAVEL with minor silt and fine to coarse sand; dark brown. Loose, dry, poorly graded. Gravel is fine to coarse, slightly weathered fine sandstone, very strong and subangular to angular.

0.4m							
0.6m							
0.8m							
1.0m							
1.2m					1.1 to 1.5m: Grades to moist, no boulders.		
1.4m				LB1			
1.6m	1.5m: Reworked COLLUVIUM and alluvial fan deposits				1.5m: GRAVEL with some fine to coarse sand and minor silt; dark greyish black. Medium dense, wet, well graded. Gravel is fine to coarse, slightly weathered fine sandstone, very strong and subrounded to rounded.

1.8m							
2.0m				LB2	1.8 to 2m: Grades to very dense.		
2.2m					TP02 terminated at 2m Unstable pit wall(s) / Spalling from pit wall(s)		
2.4m							
2.6m

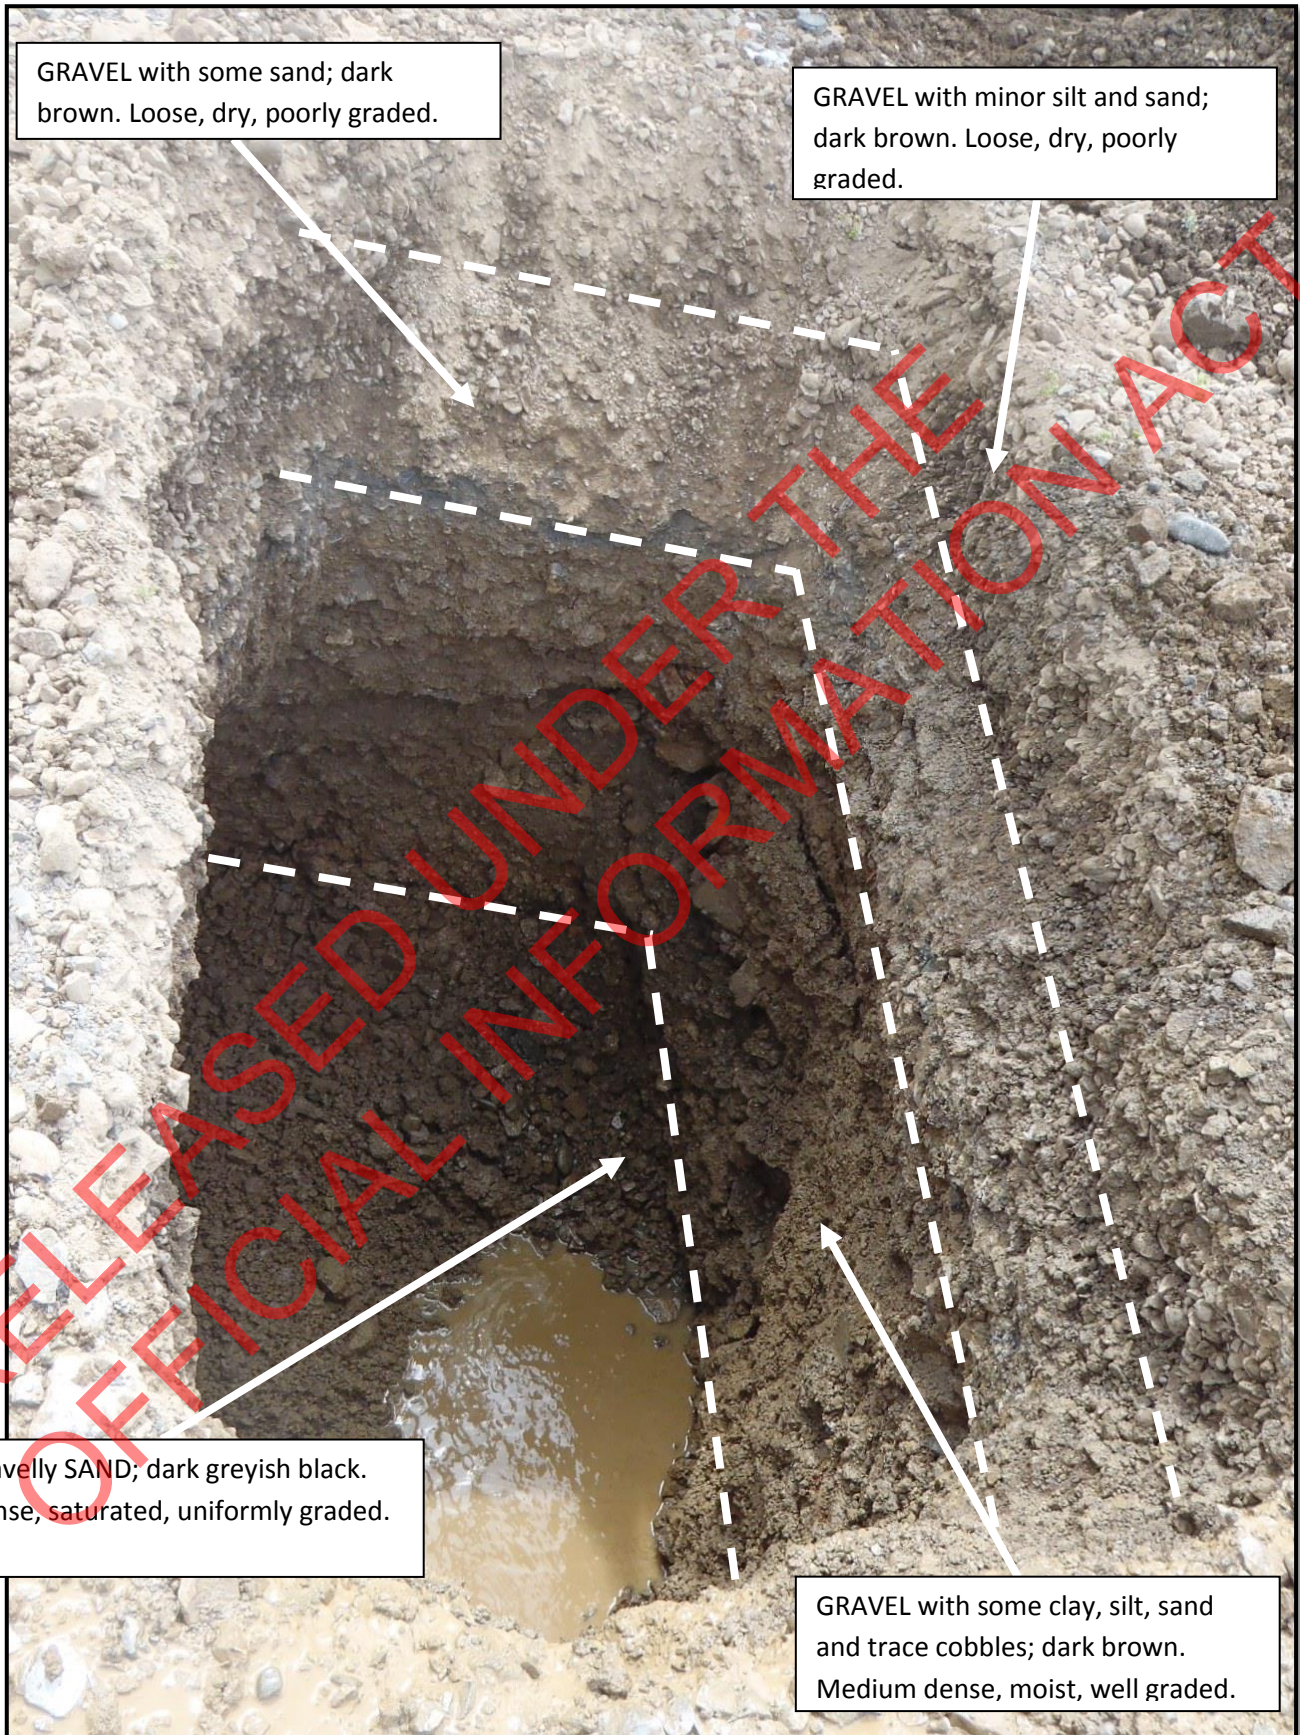
Client NZTA
 Project P2N Cycleway
 Project number 60306339

Co-ordinates 1755518mE 5434577mN
 Orientation -90° Elevation 2m (Approx)
 Location KiwiRail Wairarapa Line
 Feature 50m SW of Rowing Clubhouse

Depth	GEOLOGICAL DESCRIPTION <small>Weathering, Colour, Fabric, Rock Name, Strength, Discontinuities, Lithological Features (bedding, foliation, mineralogy, cement, etc)</small>	Test Records	Sampling	Dynamic Cone Penetrometer (Blows per 100 mm) 2 4 6 8	SOIL PROPERTIES <small>Subordinate MAJOR minor, colour, structure, Strength, moisture condition, grading, bedding, plasticity, sensitivity, major fraction description; subordinate fraction description; minor fraction description etc</small>	Graphic Log	Instrumentation									
					Depth Related Remarks <small>(Joints, Bedding Seams, Shatter, Shear and Crush Zones, Foliation, Schistosity, Attitude, Spacing, Continuity, Roughness, Infilling, etc.)</small>			DEFECT DESCRIPTION								
0m	Reclamation FILL for rail/road corridor				0m: GRAVEL with some silt, fine to coarse sand and trace cobbles, brick and glass; dark brown. Medium dense, moist, well graded. Gravel is fine to coarse, slightly weathered, strong and angular.											
0.2m																
0.4m																
0.6m					0.6 to 0.75m: Concrete block, 800mmx900mmx150mm.											
0.8m																
1.0m																
1.2m																
1.4m																
1.6m																
1.7m	Reworked COLLUVIUM and alluvial fan deposits				1.7m: Gravelly, fine to coarse SAND with minor silt; light grey and brown mottling. Medium dense, wet, poorly graded. Gravel is fine to medium, slightly weathered, strong and rounded to subrounded.											
2.0m																
2.2m					2m: Gravelly fine to coarse SAND; dark greyish black. Medium dense, saturated, uniformly graded. Gravel is fine to medium, slightly weathered, strong and rounded to subrounded.											
2.4m					TP04 terminated at 2.2m Unstable pit wall(s) / Spalling from pit wall(s)											
2.6m																
2.8m																
<p><i>For explanation of symbols and observations, see key sheet</i></p> <p>FLUID DEPTHS DURING DRILLING</p> <table border="1"> <thead> <tr> <th>Date</th> <th>Time</th> <th>Drilled Depth (m)</th> <th>Casing Depth (m)</th> <th>Fluid Depth (m)</th> </tr> </thead> <tbody> <tr> <td></td> <td></td> <td></td> <td></td> <td></td> </tr> </tbody> </table>				Date	Time	Drilled Depth (m)	Casing Depth (m)	Fluid Depth (m)						Length 2.5m Width 1.5m Stability Unstable	Excavation Method 12t excavator Orientation

Started 17/12/2013 Finished 17/12/2013 Date logged 17/12/2013 Logged JM Checked DAB
Date	Time	Drilled Depth (m)	Casing Depth (m)	Fluid Depth (m)												
Hand Held Shear Vane <i>Vane shear strength per NZGS guideline</i>				Remarks Wall caving in with hole at 1.7m depth. Test Pit was backfilled upon completion. No groundwater encountered		Page 1 of 1
