The information you requested – CAS-639610-N1P6C1

The new pedestrian crossing on Broadway Rd at Teed St was commissioned on 6 October 2022. An engineer from our Auckland Transport Operations Centre had implemented some settings and linking to align this new signal with other signals on Broadway Road.

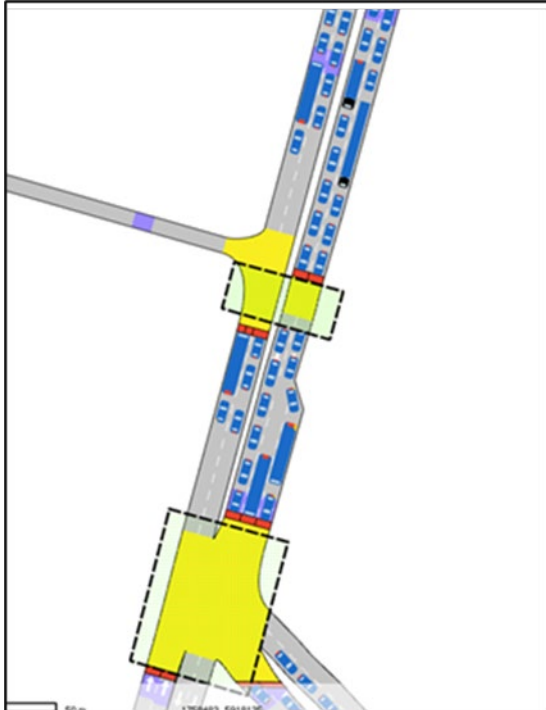
The analysis of 'Option 1' showed the crossing operating well. Vehicles would be held between the proposed crossing and the Broadway/Remuera Road intersection on the pedestrian crossing phase (phase C) which is illustrated in figure below. Modelling also showed a similar total travel time for vehicles over the 2-hour modelled period indicating no significant change to existing operation.

Please refer to image below which demonstrates this.

Please refer to 'Option 1' in the review as this was progressed into the construction phase. This option considered linking the new proposed crossing to the pedestrian phase at the existing Remuera Road/Broadway signalised intersection.
