Hawke's Bay Cyclone Gabrielle Rail Recovery

Make Safe work Napier - Wairoa

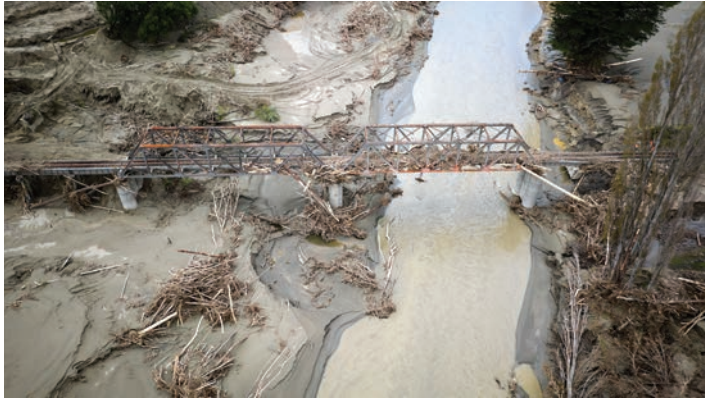
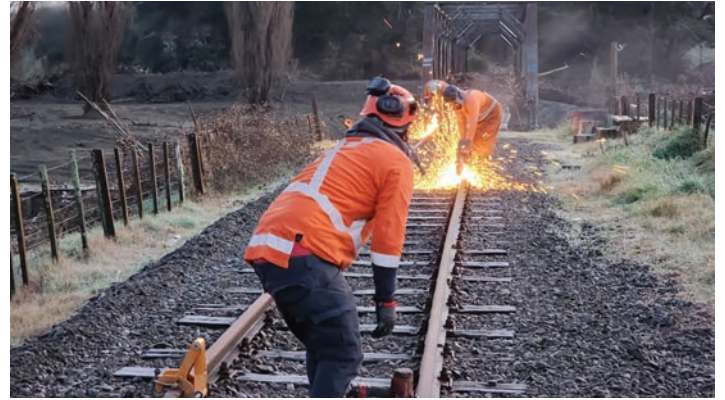
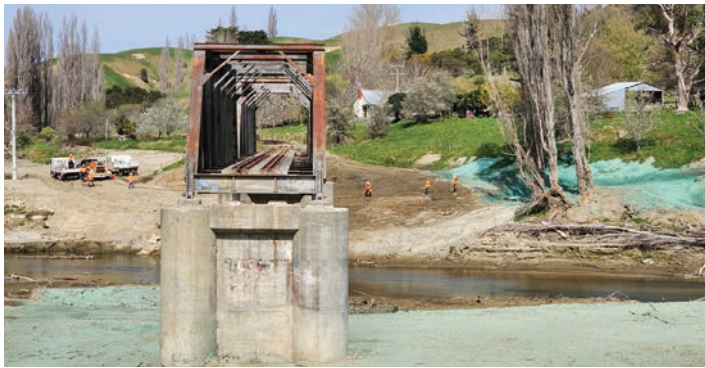
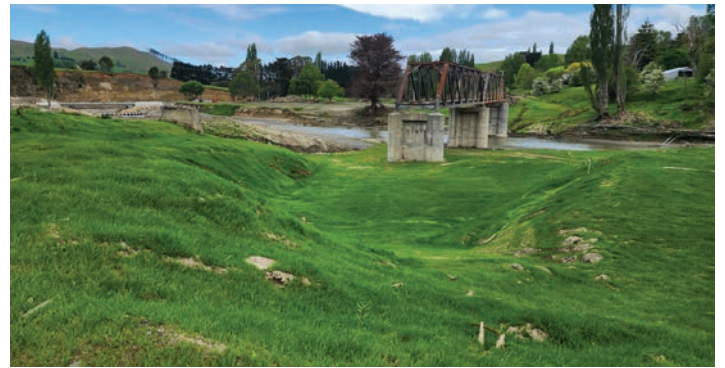
Here are before and after pictures of the clean up and hydro-seeding at Bridge 222 in the Esk River valley, north of Eskdale. Hydro-seeding helps to secure

exposed material from further weather damage. Damaged bridge piers and spans have been removed as they were unstable and damaged track was cut away.

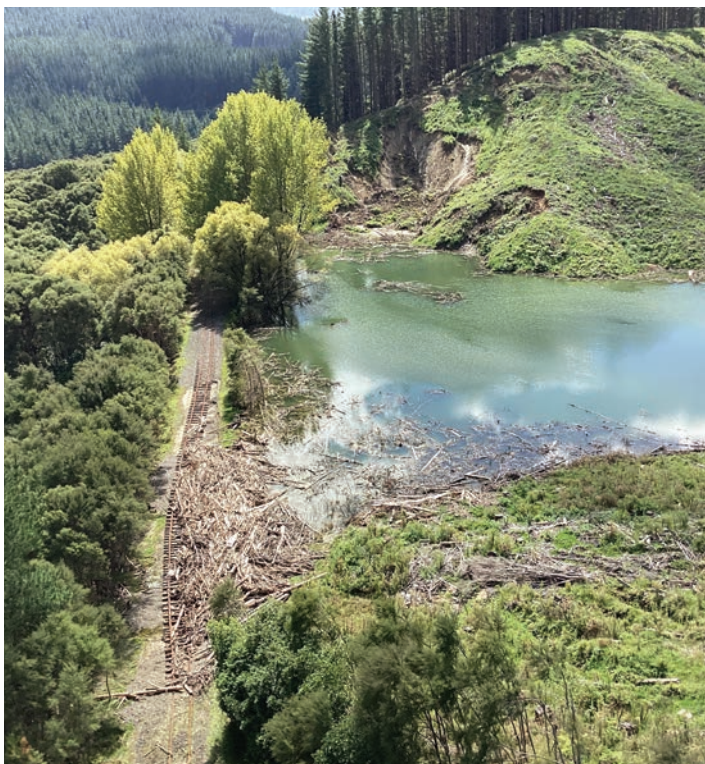
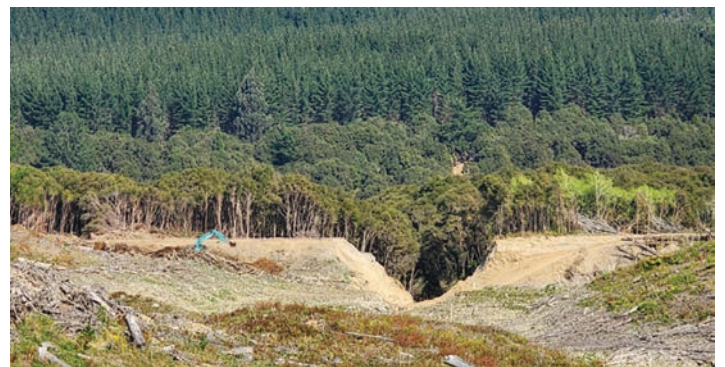
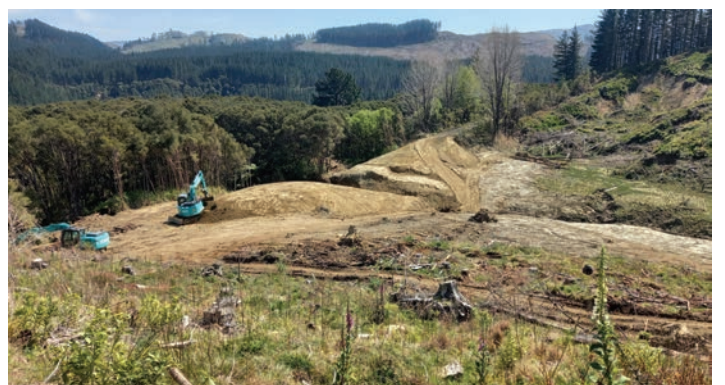
South of Waikou a large body of water built up behind the rail embankment during the cyclone, then broke through it shortly afterwards before we could get any machinery to the site. The pictures below show the scale of the original water build up and the mitigation work that followed.

Work ranged from removing hanging track, trimming back unstable washed out embankments, reopening drainage paths to manage water flows and creating access tracks for plant to get through the site.

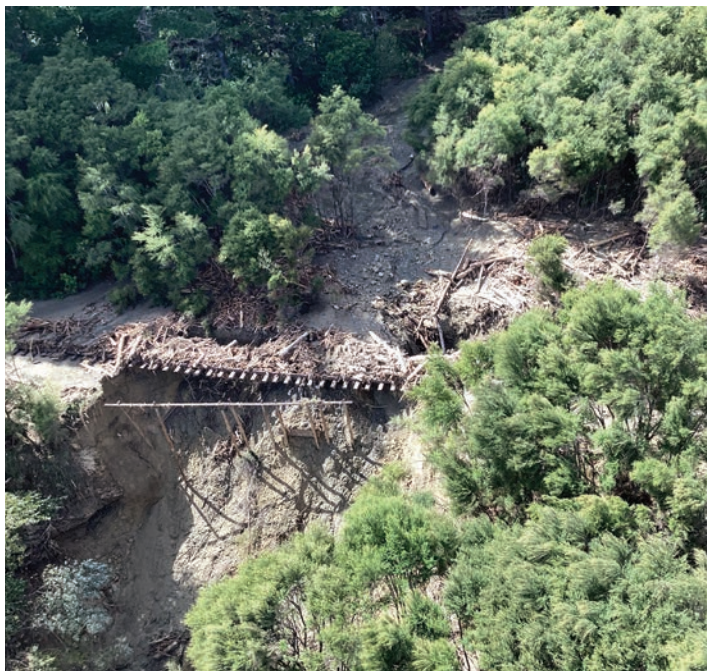
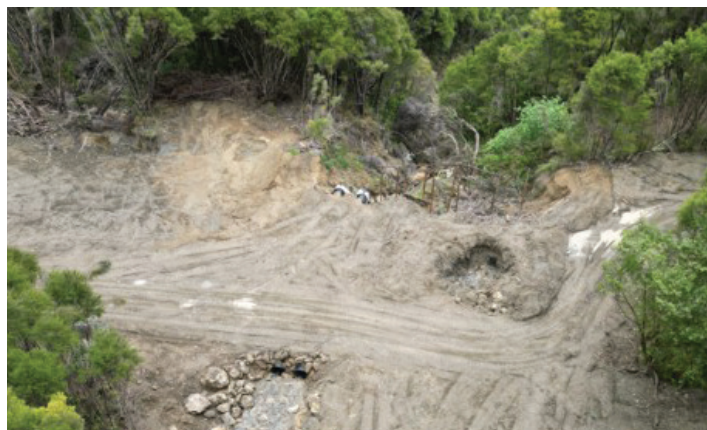
Here are before and after pictures of work at another area near Waikoau, where hanging and lengths of other damaged track was removed, unstable embankments trimmed, and drainage paths to manage water flows cleared. Culverts were installed to allow drainage paths through access tracks.

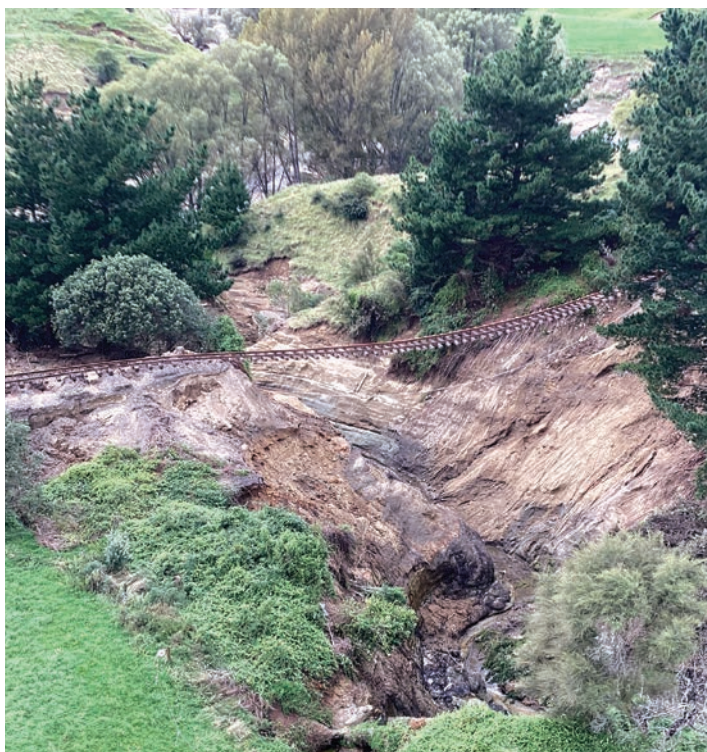
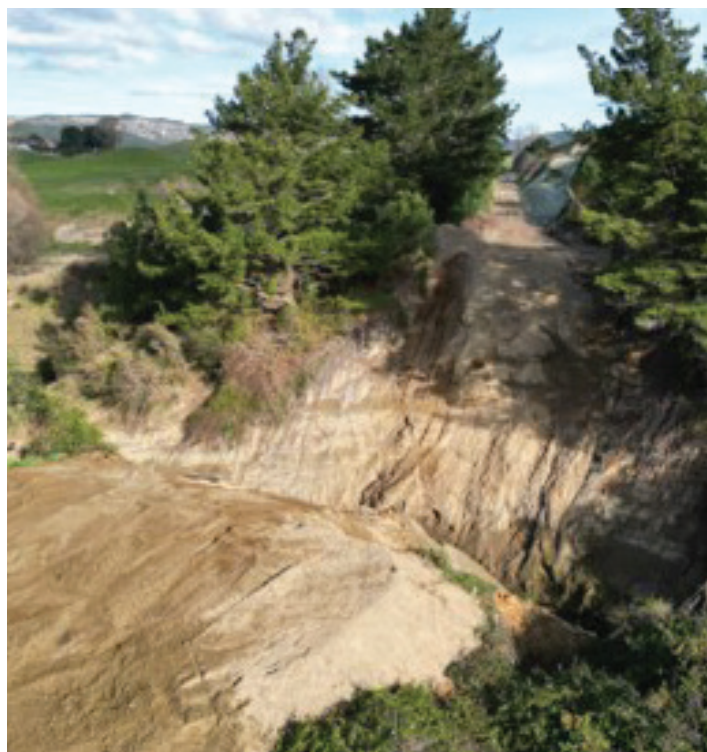
Before and after pictures of a major culvert and embankment washout north of Tutira. This massive, 20-metre-deep washout left around 60 metres of unsupported, hanging track. Works have since been undertaken to remove the track and stabilise the slopes at either end to prevent further deterioration.
