## Kāinga Ora Avondale Precinct

Preliminary Geotechnical Desktop Report

Reference: 510633

2020-11-19

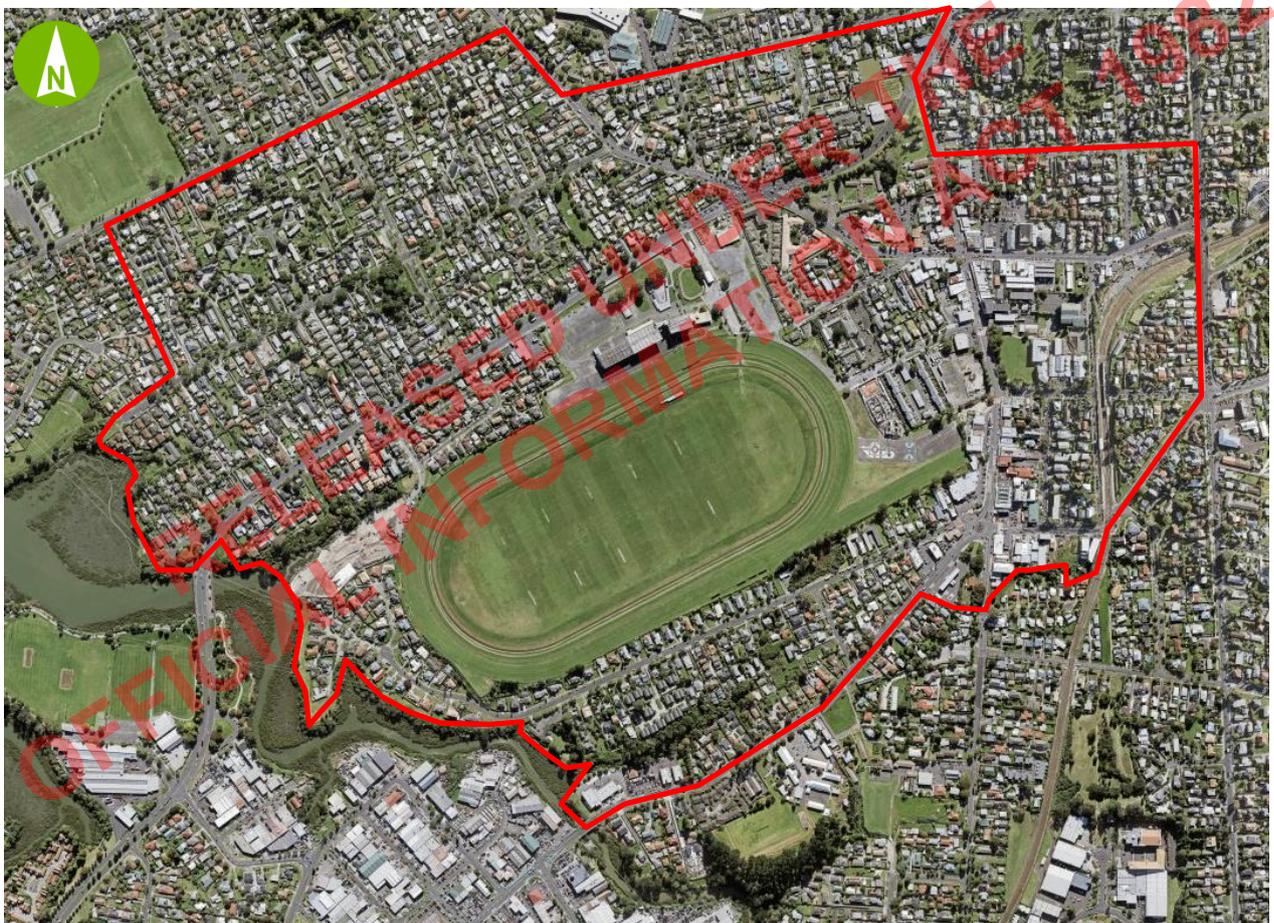
**Figure 1 Proposed development boundaries, Avondale, Auckland**

Kāinga Ora, formally Housing New Zealand Corporation have 38 sites proposed to be part of redevelopment to provide new state housing in Avondale, Auckland (Figure 1). The development has the potential to provide an estimated 4,413 dwellings on nearly 50ha of land. The dwellings will typically be two to three storey NZS3604 structures but are proposed to extend up to eight storeys towards Great North Road to the east.

The proposed Avondale Precinct development (see Figure 2) is to provide large scale state residential housing and potentially other community amenities (i.e. primary school). The residential housing is likely to be either:

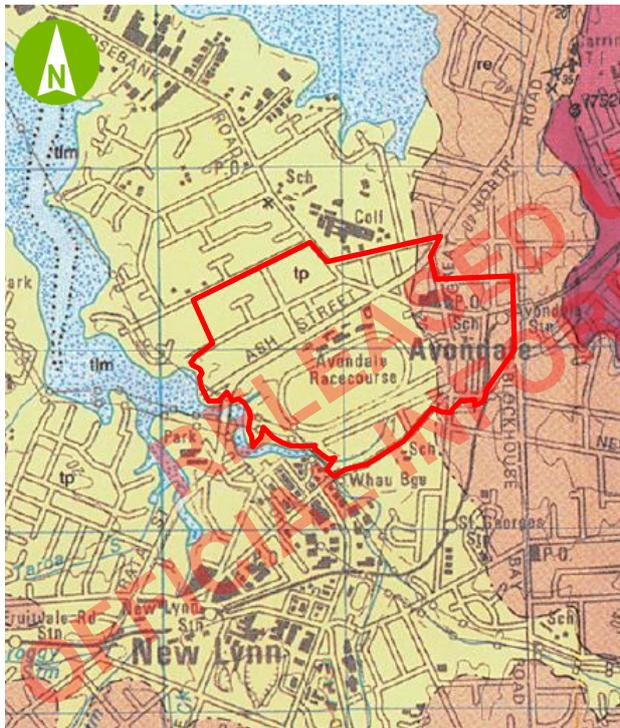
Figure 4 1:50,000 Auckland geology map (Kermode, 1992)

The regional geology for the area is described in the 1:50,000 (Kermode, 1992) and 1:250,000 (Edbrooke, 2001) scale geological maps of the Auckland Area and the associated publication (refer to Figure 4 and 5 respectively). The Avondale Precinct is located about 1km west of the Auckland Volcanic field.

The 1:50,000 geological map indicates that the geomorphology of site is the *Puketoka Formation (tp)* - light grey to orange brown pumiceous mud, sand, and gravel with black muddy peat and lignite. The 1:250,000 geological map indicates that the geomorphology of site is as per the 1:50,000 map but uses different notation (*Pup*).

The 1:50,000 geological map indicates that the geomorphology of site is the *East Coast Bays Formation (re)* - greenish grey, alternating muddy sandstone and mudstone, with occasional interbedded lenses of grit. The 1:250,000 geological map indicates that the geomorphology of site is as per the 1:50,000 map but uses different notation (*Mwe*).

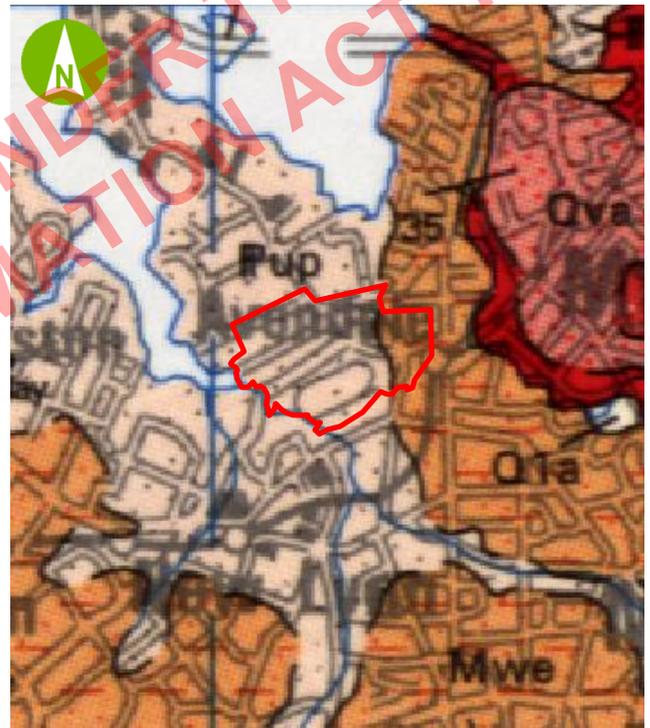
Figure 5 1:250,000 Auckland geology map (Edbrooke, 2001)

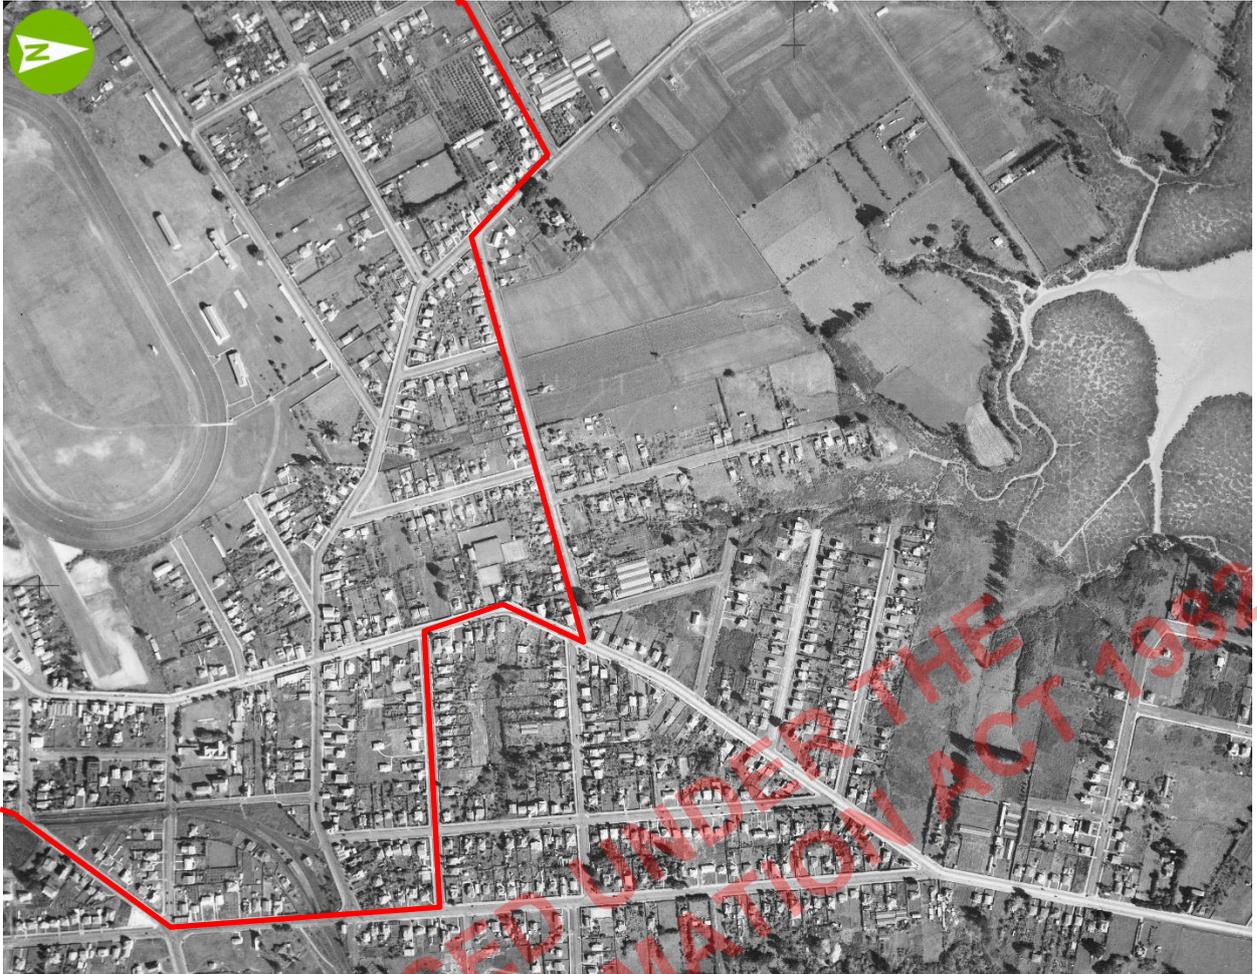
**Figure 6 Historic aerial photograph of Avondale, Auckland taken 22 April 1940**

Figure	Date	Description
A1	22/04/1940	Aerial Photograph of the Avondale area. The racecourse has been constructed as per modern layout. Residential development is concentrated around Great North Road, with some small agricultural land use present to the north of the racecourse.
A2	09/09/1955	Aerial Photograph of the Avondale area. Minor land use shift towards residential. Avondale College has now been constructed.
A3	14/04/1972	Aerial Photograph of the Avondale area. Almost all the agricultural land has been repurposed to residential zoning. Residential roads have been extended west to near the Whau River.
A4	01/02/1988	Aerial Photograph of the Avondale area. All the agricultural land near the site has been repurposed to residential zoning.

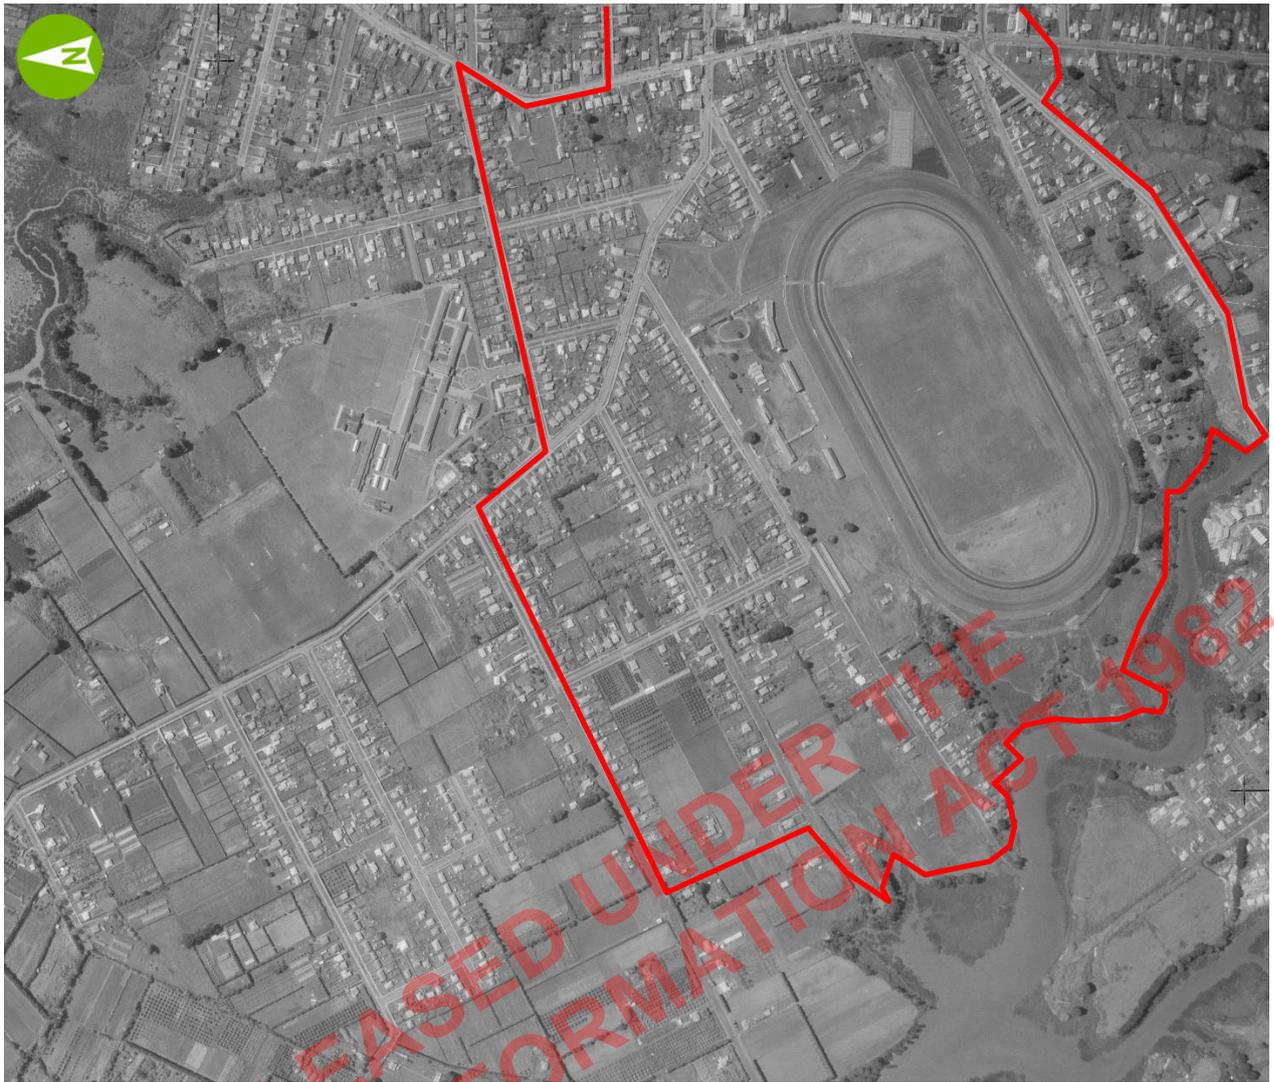
**Figure 7 Historic aerial photograph of Avondale, Auckland taken 9 September 1955**

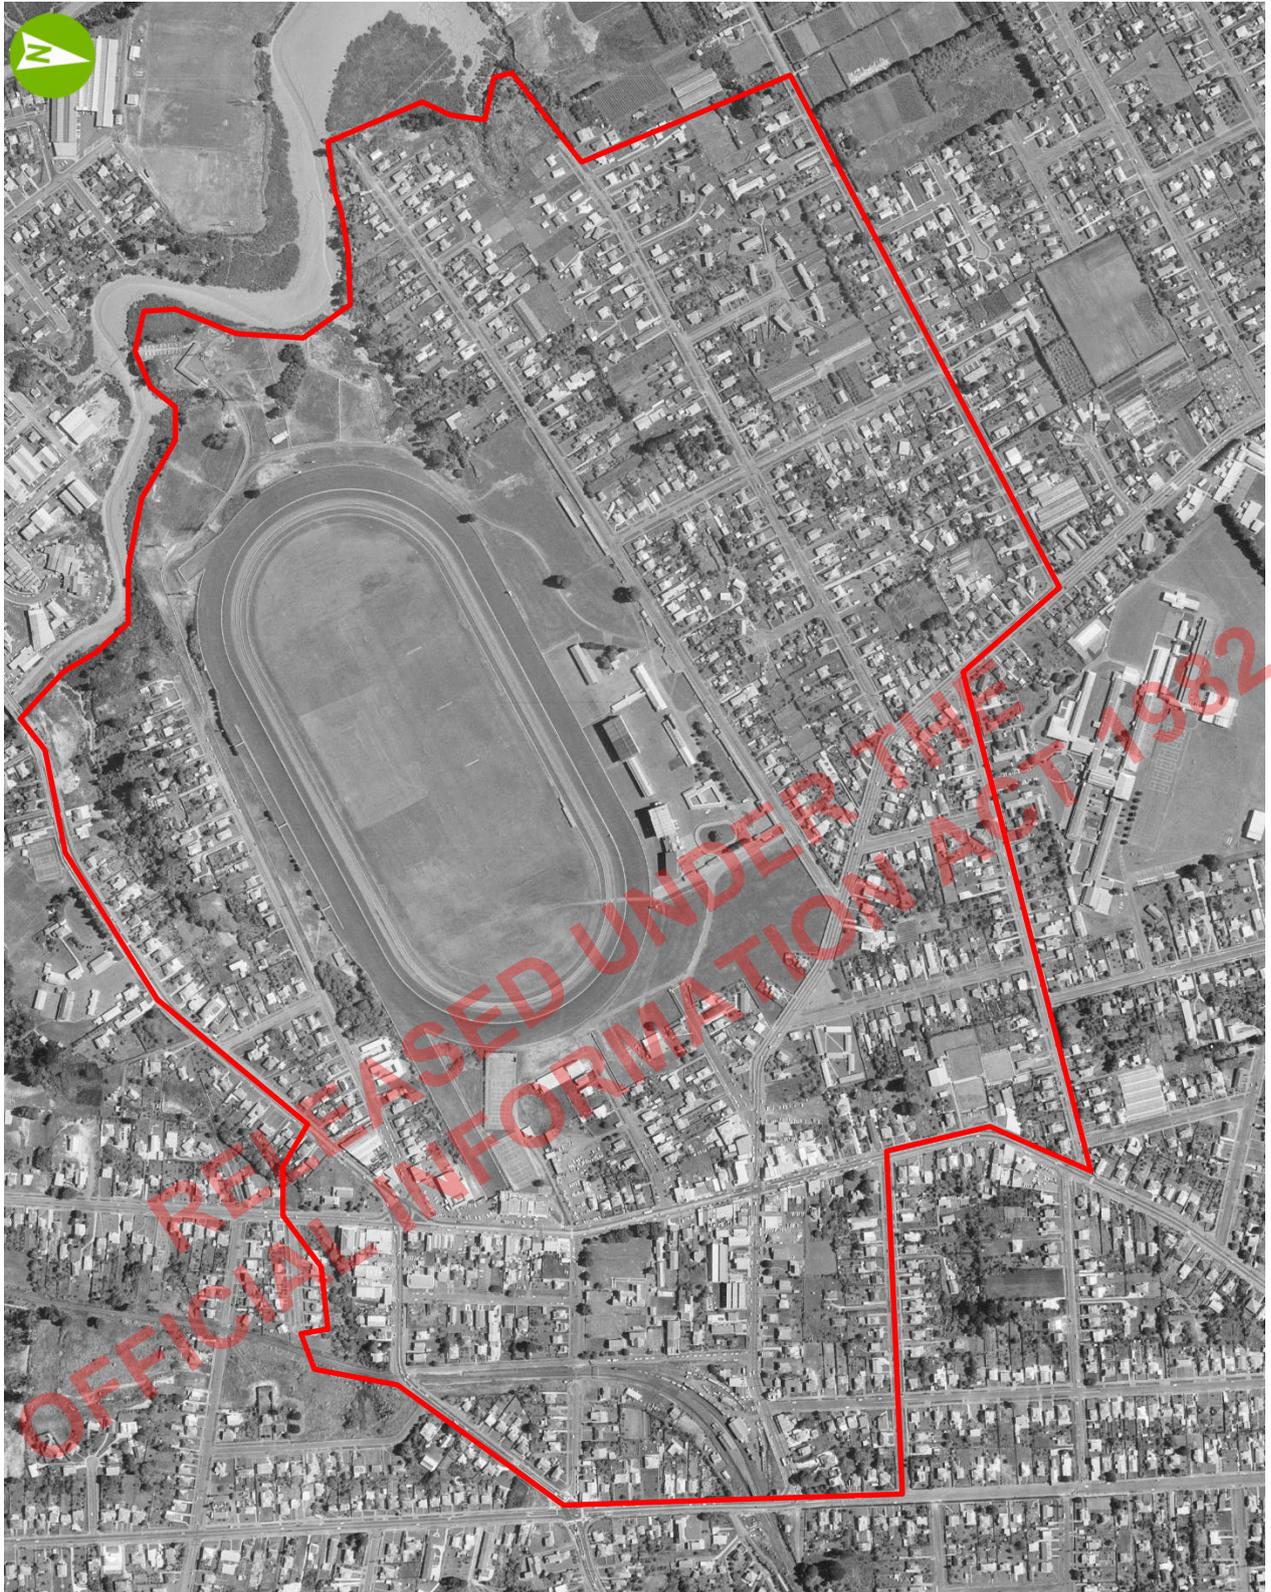
**Figure 8** Historic aerial photograph of Avondale, Auckland taken 14 April 1972

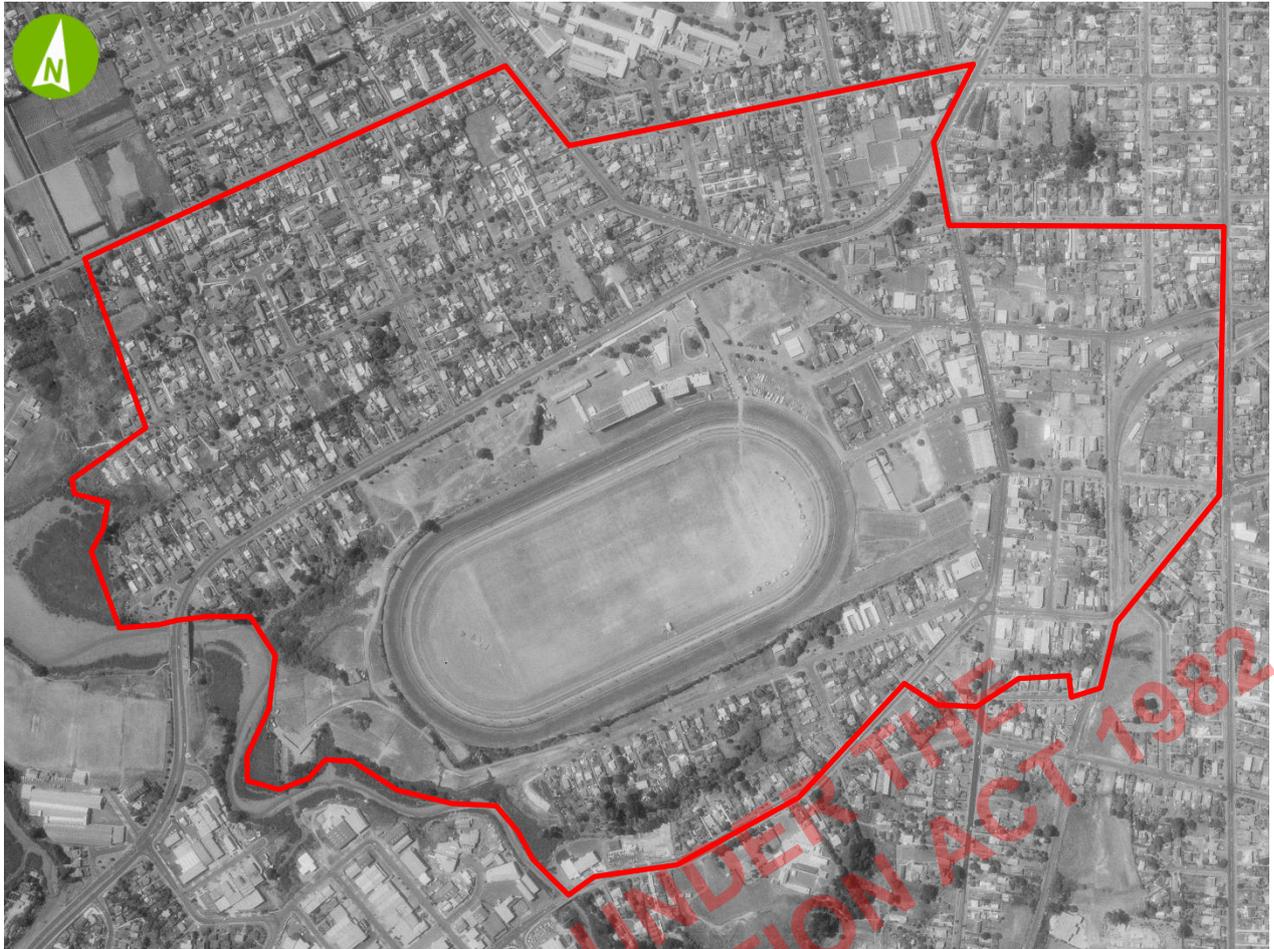
**Figure 9 Historic aerial photograph of Avondale, Auckland taken 1 February 1988**
