## FIRE INVESTIGATION REPORT

Catherine Place, Henderson, Auckland

Incident Information: F3237517 Suspicious Fire 8:17 p.m. 6 May 2021

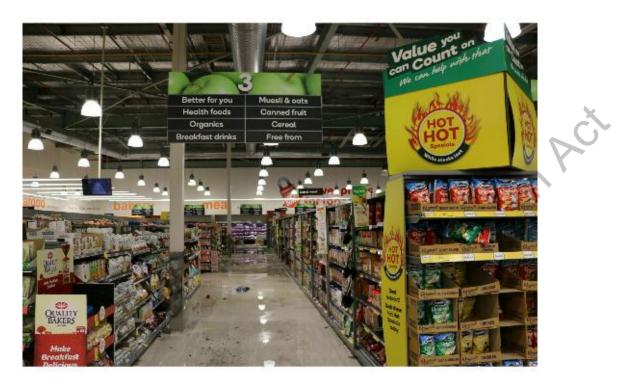
Photo 7: Aisle number 2.

Aisles 5, 6 and 7 were the only aisles that showed signs of smoke and heat damage. All other aisles showed only water damage from a combination of the activation of the sprinkler system and firefighting delivery hoses. See photos 6 through 19 for the aisles showing only water damage.
