Annual Inspection

Auckland Council Ventia Wha

Llyod Elsmore(by pool)

Inspection Ref: 1374932

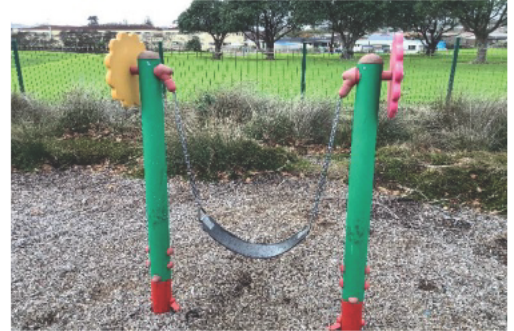
Item: 1 Bay 1 Inclusive 1 Flat Swing
Manufacturer: Playground People
Surface Type: Woodchip
Item Part Number: 1000071791
Item Quantity: 3
Equipment Compliance: N/A
Surface Area Compliance: N/A
Life Expectancy: 3 - 5 Years
Total Findings: 1

This item is satisfactory - no work required -

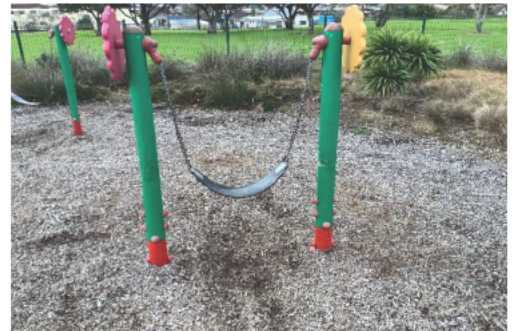
Item: 1 Bay 1 Inclusive 1 Flat Swing
Manufacturer: Playground People
Surface Type: Woodchip
Item Part Number: 1000071767
Item Quantity: 3
Equipment Compliance: N/A
Surface Area Compliance: N/A
Life Expectancy: 3 - 5 Years
Total Findings: 1

This item is satisfactory - no work required -

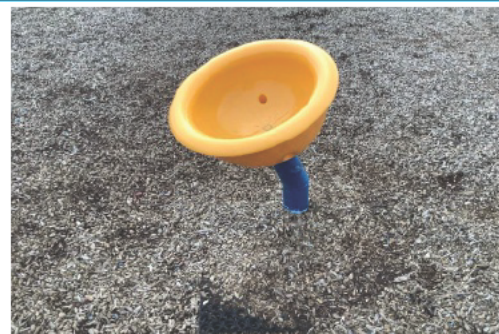
Item: Spinner Bowl
Manufacturer: Playground People
Surface Type: Woodchip
Item Part Number: 1000071793
Item Quantity: 3
Equipment Compliance: N/A
Surface Area Compliance: N/A
Life Expectancy: 5 -10 Years
Total Findings: 1

This item is satisfactory - no work required -

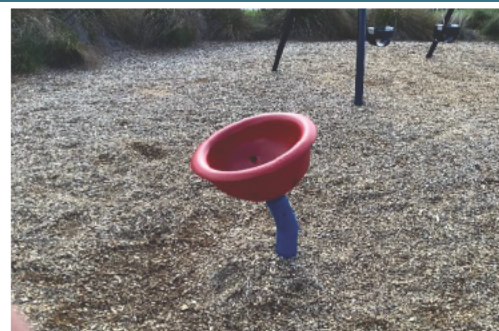
Item: Spinner Bowl
Manufacturer: Playground People
Surface Type: Woodchip
Item Part Number: 1000071793
Item Quantity: 5
Equipment Compliance: N/A
Surface Area Compliance: N/A
Life Expectancy: 5 -10 Years
Total Findings: 1

This item is satisfactory - no work required -
