Whirokino Trestle and Manawatu River Bridge Replacement
Post Construction Road Safety Audit

July 2021

This audit is a Post Construction (Pre-Opening) Stage Safety Audit of Whirokino Trestle and Manawatu River Bridge Replacement. This audit includes all works completed prior to the shifting of traffic onto the new alignment. Elements not audited include:

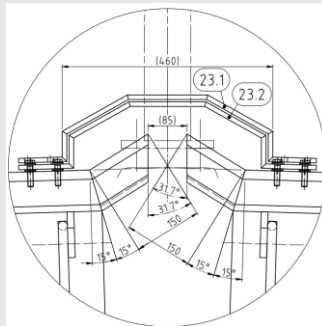
The mountable kerb (concrete nose and metal side covering) at the expansion joint is a hazard. Impacts to the kerb nose (particularly when adjusted for barrier posts) and sides by errant motorcyclists or vehicles could cause harm, however infrequent they may be.

Novare: The cover plates are provided to mitigate the safety hazard caused by the upstands in the expansion joint as shown in the sketch below. The mountable kerb is provided to mitigate the hazard further. The kerb or plate cannot be removed as it will create a further safety issue.

The length of the mountable kerb can be increased along road centreline to increase the transition length of the mountable kerb and mitigate the impact risk.

BBO: Extending the mountable kerb nose will require relocation of the barrier posts. As discussed in 2.1.1 above, the existing system should perform adequately when impacted by cars. For motorcycles to hit the kerb they will already have impacted the WRSB so outcomes will already be severe. Propose no change be made.

Safety Engineer	Considering the overall length of the barrier and the relatively short length of mountable kerb, the risk is low that it will be struck and if struck the risk will be low that the system will fail.
Client Decision	Agree with BBO and Safety Engineer's responses. No further action required.
Action Taken	N/A

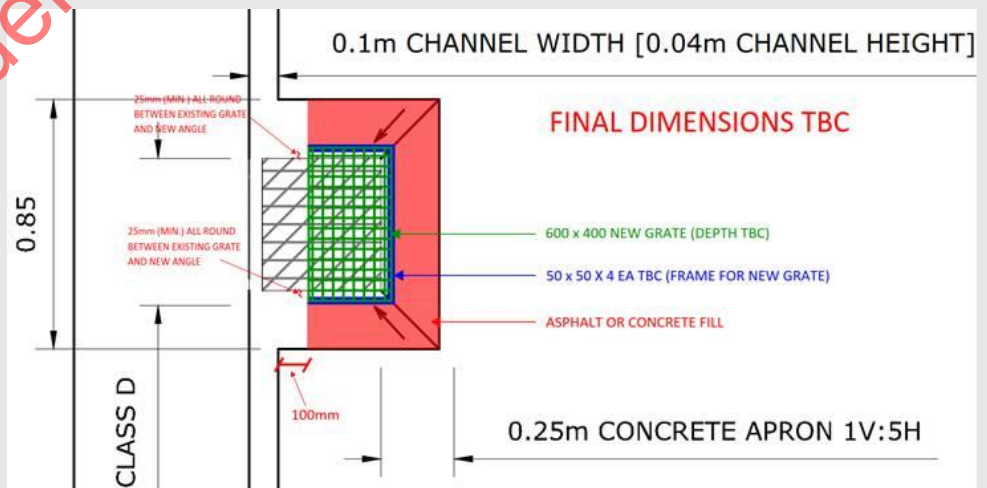
Sumps along the sealed shoulders of the bridges are located approximately 50 mm below the seal surface. On the Moutoa Floodway Bridge (Whirokino) sumps are spaced approximately every 50 m. “Confident and courageous” type of cyclists will use the shoulder rather than the shared path. The dips at 50 m spacing will create an uncomfortable ride for cyclists who consistently use the shoulder, and will cause them to ride on the non-undulating surface closer to the traffic lanes, increasing their risk.

Consider a sump solution level with the surfacing.

Designer Response: *Novare:* A solution has been proposed. If we get a go-ahead from everyone, we can start working on the details.

BBO: The Contractor has also been asked to investigate using a concrete planer to reduce the slopes surrounding the sump, as an alternative to the above solution. If feasible, this would be preferred by BBO.

Safety Engineer	In deciding between the two options, the Novare solution would be superior with respect to cyclist comfort. Rising the grate would also deal with the issues in 2.6.1 where Novare recommends raising the sump grate height to deal with the likelihood of the drain blocking due to debris.
Client Decision	Agree with the Safety Engineer's response. Given the shoulder width is only 1.5m, from a safety perspective, the full width needs to be available for cyclists at all times and at present, this is not the case. Furthermore, the planning option (without raising the level of the sump grate) is really only a partial mitigation measure as the perceived hazard still remains. Very careful thought needs to be given to the final solution, as any works will result in delay and disruption to road users and is likely to attract negative feedback if the comms are not handled appropriately.
Action Taken	June 2021 update: Grates have been raised level with the road surface. No further action required.
