SEDDON EARTHQUAKES
DETAILED DAMAGE REPORT

WCC CIVIC ADMIN BUILDING (CAB)

WELLINGTON CITY COUNCIL

CIVIC ADMIN BUILDING – DETAILED DAMAGE REPORT

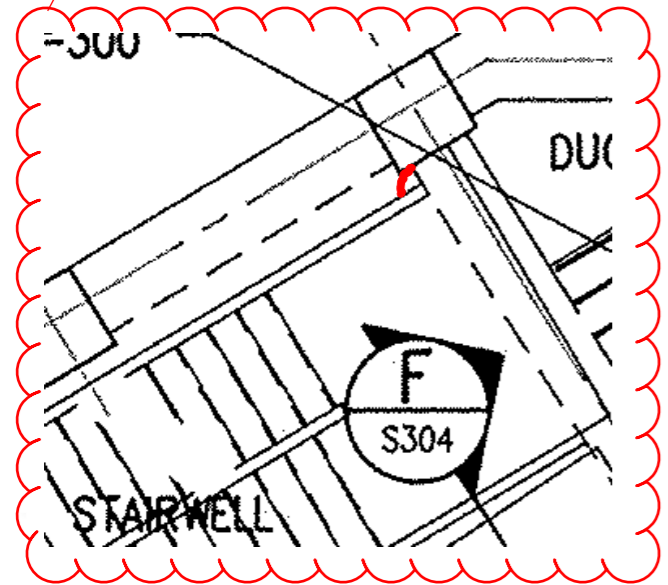
Floor of Level Two

Floors – raised floor tiles were removed at corners and ends of the building to check for cracking/tearing of the floor diaphragm adjacent to end frame beams. Some recent cracking was evident which suggests low levels of geometric frame elongation may have occurred (including the onset of corner columns being jacked out). Level of cracking was generally minor-moderate and not typically requiring remediation. However, this damage reinforces the need to progress previously recommended seismic securing works.

Note:
End of line indicates
the extent of crack
that was visible
during inspection
rather than the actual
length of crack

Key:
Cracking <1mm seen
Cracking >=1mm seen
