Department of Building and Housing

Diagnosis of Buildings for weathertightness

Guidelines for building surveyors

Draft report at
6 May 2007

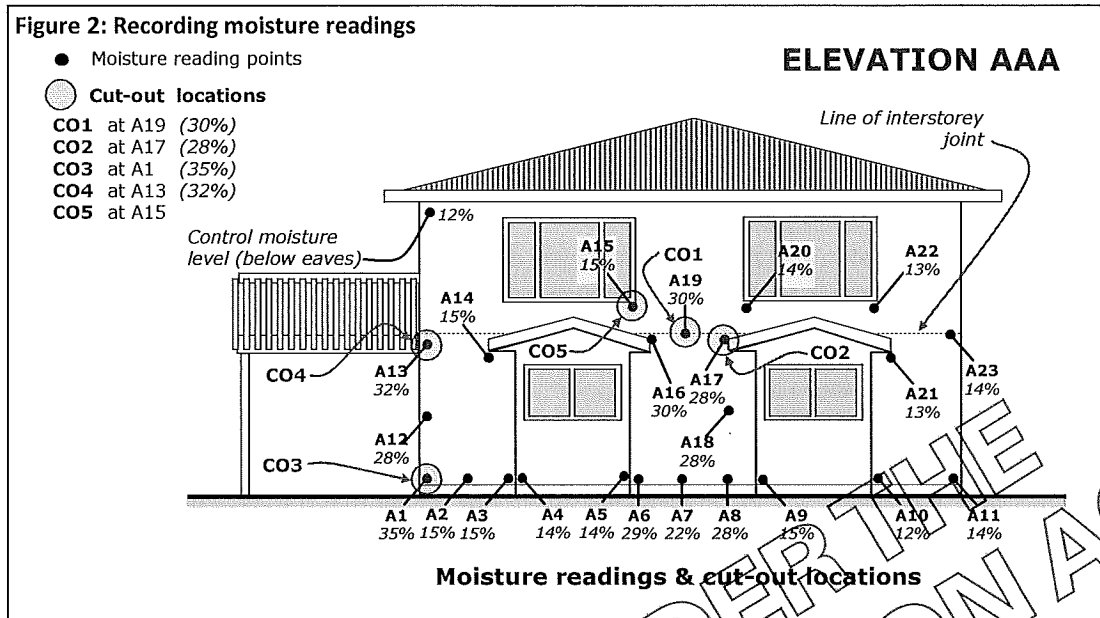
Positions of moisture readings and cut-outs should preferably be shown in a photo of the elevation. If photographs are not suitable, an elevation may be used as shown in *Figure 2*.

The position of cut-outs should also be shown on the elevation photo or diagram showing moisture contents. This allows the reader to gain an appreciation pictorially of both the high moisture content areas and where cut-outs have been made (refer also to **Figure 2: Recording moisture readings** on page 15).

- Findings are best shown on elevation photo (or diagram) – cross referenced to a Table of Moisture readings (refer **Figure 2: Recording moisture readings** and **Table 4: Table of moisture readings** on page 15)
- Elevation photos (or diagrams) give good idea of areas of high moisture content
